# TECHNICAL BULLETIN

**MODEL/DERIVATIVE:**  
**100, New 200, New 400, Mini**

**Bull. No:** 0024  
**CDS. Ref:** R6707bu  
**Issue:** 1  
**Date:** 03.04.96

**PROBLEM:**  
**ALARM ECU CONNECTOR PINS DAMAGED BY TEST PROBES**

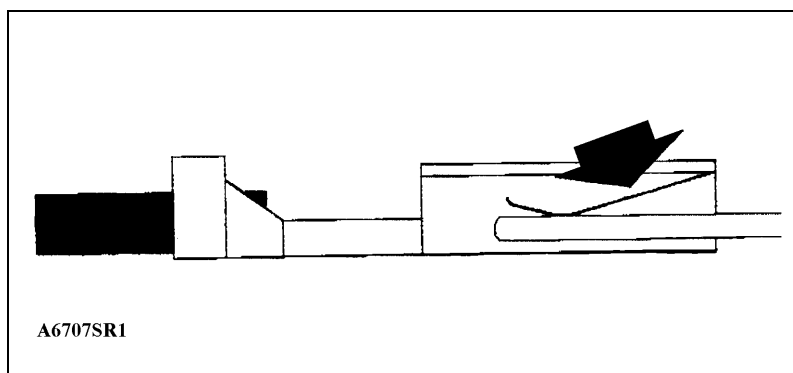
Intermittent immobiliser and alarm problems caused by damage to the ECU connector pins, this condition may follow a previous repair where incorrect probes have been used.

**CAUSE:**  
The connector uses 2 sizes of contacts pins, 040 and 070. Incorrect test probes will cause damage to the contact spring leaf (arrowed in illustration) and result in intermittent failure.

**ACTION:**  
The only tools that should be used to probe the connectors on their mating faces are TestBook part numbers DTC0009A or DTC0036A, these contain a male orange probe which can be used for 070 size pins, however there is no probe for size 040 pins.

If size 040 pins require to be probed or if the Testbook tools are unavailable, the only satisfactory way is to snap up the anti-backout flange on either side of the connector and probe from the side where the wires enter.
