# TECHNICAL BULLETIN

**Mini**

*Bull. N°:* **0018**

**ENGINE MISFIRE, HESITATION, ETC - CAM RELUCTOR**

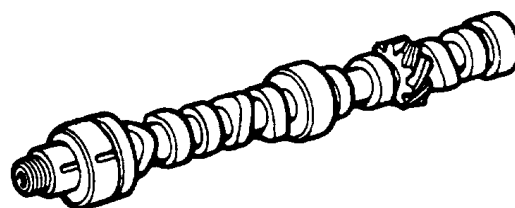
**A7303RM1**

**Camshaft reluctor teeth not to specification resulting in irregular cam sensor pick-up. Since the cam sensor only requires synchronising on start-up, it is likely that some starts will not detect an error resulting in normal running for that journey.**

**Condition described above will be apparent from new even though condition may not occur on every journey. If no other faults are apparent, e.g. ignition or fuel related then replace camshaft. If symptoms develop after a period of time suspect causes other than cam reluctor.**
