# TECHNICAL BULLETIN

**Mini**

*Bull. N°:* **0019**

**OIL LEAK FROM PRIMARY DRIVE GEAR - GALLERY PLUG**

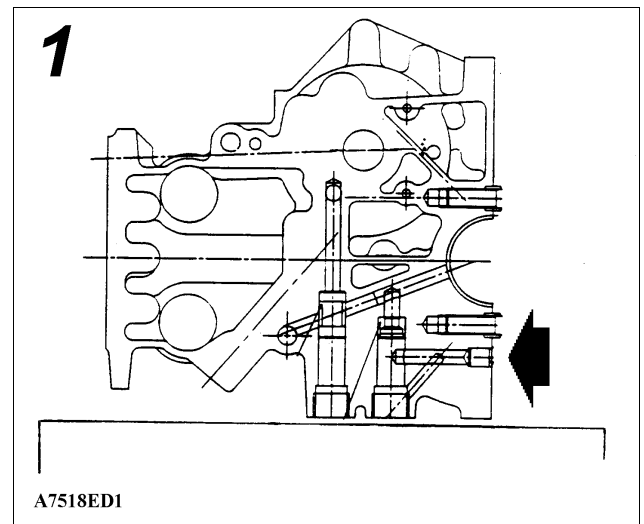
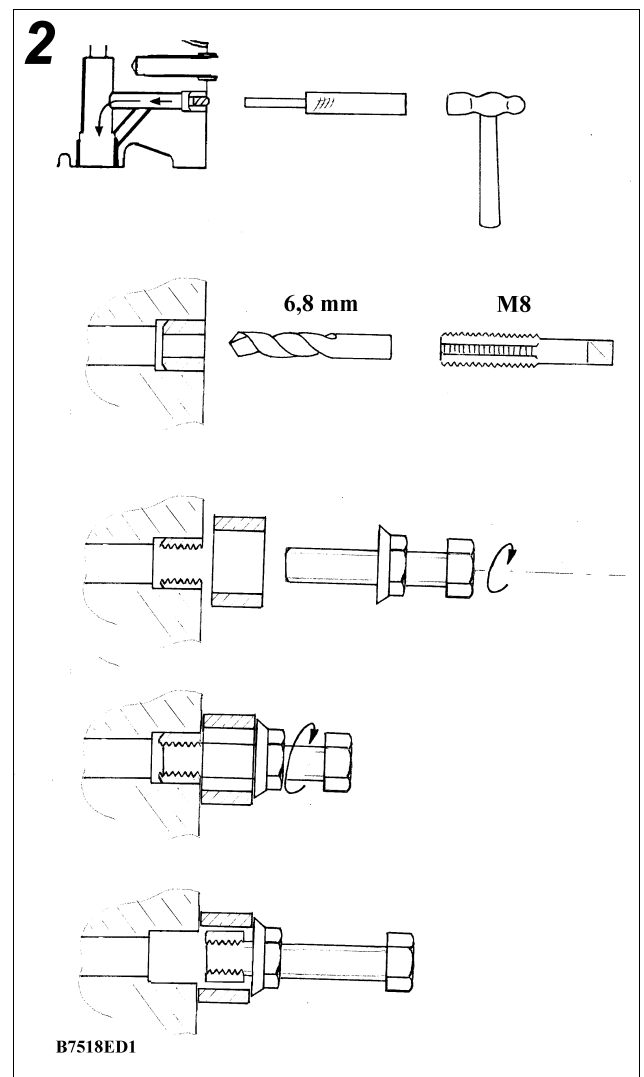
**Sealing Plug Removal Procedure:**  
Referring to illustration 1 and 2

**Oil leaking between primary drive gear and crankshaft.**

**Condition is caused by a recent modification to the relief valve drain exit drilling in the cylinder block.**

- Locate the oil sealing plug (arrowed in illustration 1) situated adjacent to the rear main bearing cap. The plug outer is aluminium and the centre core made from steel.
- Using a suitable flat ended punch (illustration 2), gently tap the steel core of the plug until level with the aluminium plug body.
- Using a smaller punch (3 mm dia), tap the plug centre core completely through, it should drop clear from the relief valve hole and onto the bench, if it doesn't, lift the engine slightly and retrieve with a magnet.

The centre core must be retrieved and discarded.

- Drill out plug with a 6.8 mm drill and tap hole with an M8 tap, load both with grease to reduce swarf contamination.
- Assemble an M8 nut bolt and washer/spacer and extract the remainder of the plug by tightening the nut against the spacer.
- Clean the surrounding area of swarf and flush out the relief valve hole.

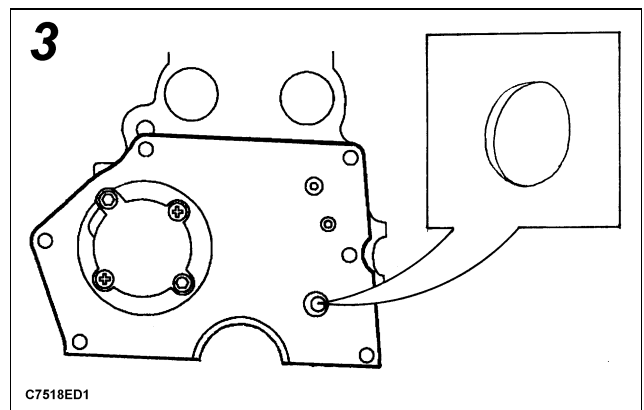
Referring to illustration 3

- Locate the oil drilling in the end face of the cylinder block (arrowed), this is a large shallow countersunk drilling leading into a smaller hole.

Carefully remove all traces of oil from oil drilling and tapered plug using a suitable degreaser.

- Obtain tapered plug, part number LCM 100140. Apply a bead of Loctite 638 around the taper portion of plug and tap securely into the position shown.
- Wipe off any surplus Loctite and clean excessive oil from primary gear, flywheel and flywheel housing before re-assembly.
- Rebuild engine observing correct torque figures etc.
