# TECHNICAL BULLETIN

**MODEL/DERIVATIVE:**  
**MINI**

**Bull. N°:** 0031  
**CDS. ref:** R7532bu  
**Issue:** 1  
**Date:** 19.11.97

**PROBLEM:**  
**SEAT CUSHION DAMAGED - UNRESTRAINED TIPPING**

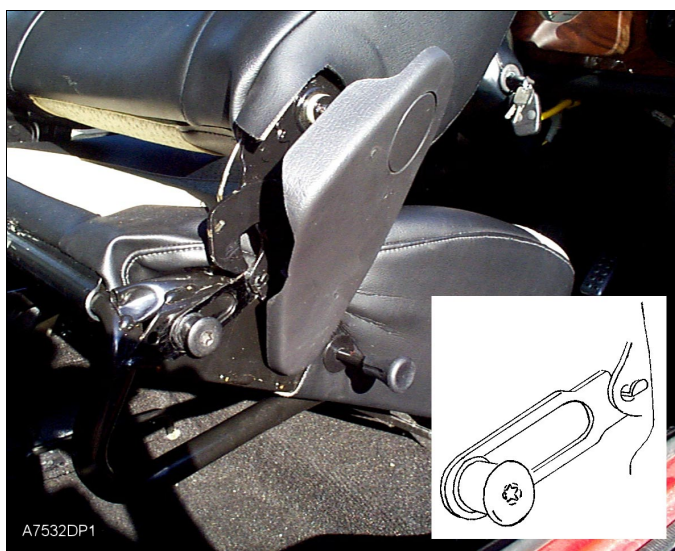
**Seat cushion cover damaged by hinge escutcheon when seat squab is tipped fully forward.**

**CAUSE:**  
**Unrestrained squab tipping resulting in hinge escutcheon fouling cushion cover.**

**ACTION:**  
The damaged seat cushion cover(s) will require replacement.  
To prevent re-occurrence of seat cover damage, fit two check straps per seat part number HZU 100050.  
This modification should be applied to both front seats even if opposite seat has not sustained damage requiring cover replacement.  
All vehicles from Vin 151917 onwards have check straps fitted.
