# TECHNICAL BULLETIN

*MODEL/DERIVATIVE:*  
**Mini**

*Bulletin N°:* **0007**  
*CDS. ref:* **X8419bu**  
*Issue:* **1**  
*Date:* **17.03.99**

*PROBLEM:*  
**BRAKE WHEEL CYLINDER SUSPECT LEAKAGE**

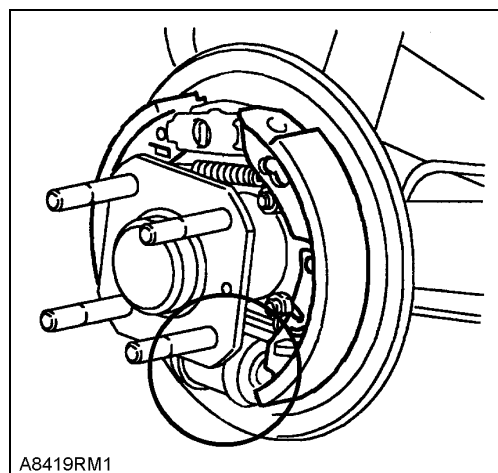
Wheel cylinders considered to be leaking when carrying out routine service inspection.

*CAUSE:*  
Incorrect diagnosis. In the majority of instances, fluid seen around a wheel cylinder boot is assembly fluid. Assembly fluid is used by the wheel cylinder manufacturer to assist the piston to cylinder assembly process. If excess amounts are used inadvertently, fluid may be forced past the cylinder boot and become visible.

*ACTION:*  
**DO NOT** replace brake wheel cylinder if fluid signs are isolated to cylinder boot only and are showing no additional brake fluid loss or lining contamination signs.
