# TECHNICAL BULLETIN

**MODEL/DERIVATIVE:**  
**Mini**

**Bulletin N°:** 0025  
**CDS. ref:** X8420bu  
**Issue:** 1  
**Date:** 2.06.99

**PROBLEM:**  
**ENGINE STEADY BUSHES WEAK - MODIFICATION**

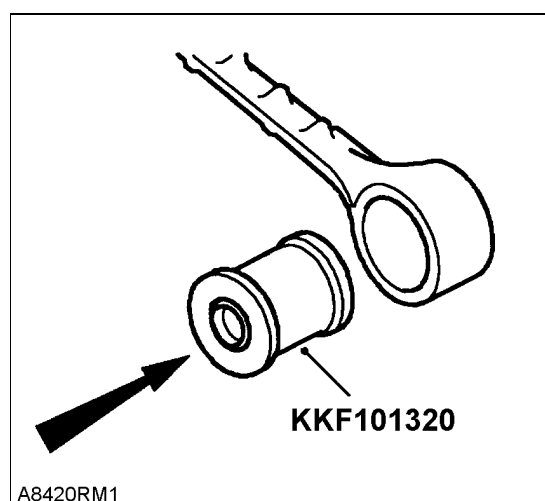
**Knock from engine compartment when clutch is engaged or throttle is applied.**

**CAUSE:**  
**Upper engine steady bushes not capable of withstanding increased engine torque\*. Therefore bushes have become weak or worn prematurely.**

**ACTION:**  
**To increase upper engine steady bush durability, replace the 2 upper rubber bushes for single bush part number KKF101320.**

- 1. Remove upper engine steady from vehicle and remove worn bushes and spacer tube from steady.**
- 2. Press new single bush KKF101320 complete with bonded internal spacer tube into engine steady. To assist fitment, the new single bush assembly can be pushed into steady with the help of a vice and a suitable spacing tube such as a socket, (there is no special tool available for this purpose).**
- 3. Refit upper engine steady to vehicle.**
