12006 West Con Path

## PRECISION INSPECTION

10/26/06

## TEXAS OFFICIAL WOOD DESTROYING INSECT REPORT

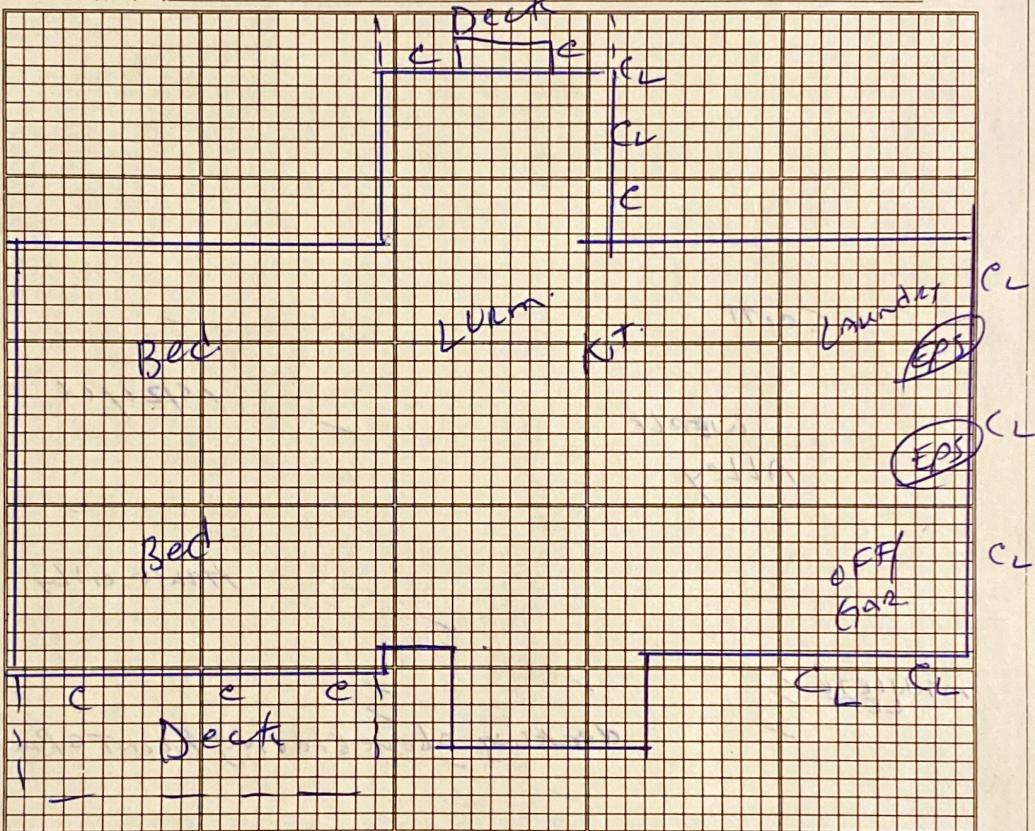
## Diagram of Structure(s) Inspected

Debris under or around structure (K)  Wood to Ground Contact (G)  Formboards left in place (I)  Excessive Moisture (J)   
Planter box abutting structure (O)  Footing too low or soil line too high (L)  Wood Rot (M)  Heavy Foliage (N)   
Insufficient ventilation (T)  Wood Pile in Contact with Structure (Q)  Wooden Fence in Contact with the Structure (R)   
Other (C)  Specify: decking above siding

STONE FOUNDATION JOINTS Alley

old SUBTERRANEAN TERMITES AT BACK RIGHT

EXTERIOR WALL + 1/2 BATH

*RETREAT House conducive conditions  
FOR SUBTERRANEAN TERMITES*
