# IP6.a

## Modernization of a Legacy 3D Printer System

| <b>Printer Model</b> | <b>BIBO 2 Touch</b> |

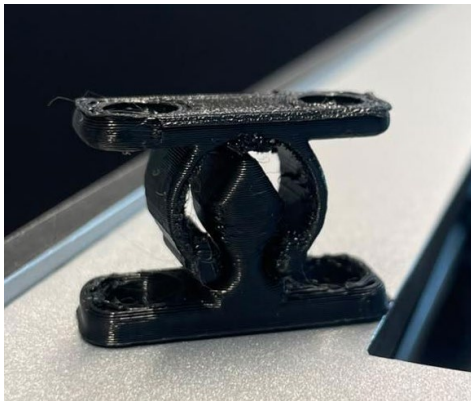
The front acrylic door currently has no latch and closes on its own due to vibration or air movement during printing. A holding mechanism will be added, fabricated using additive manufacturing. Because the printer is a fully enclosed design that retains heat, the structural component will be printed in PETG or ABS to withstand elevated chamber temperatures without deforming. The design will use either a magnetic or friction-fit catch and will not require permanent modification of the acrylic panels.

**Remaining work:** *none — the door latch is installed and functioning as intended.*

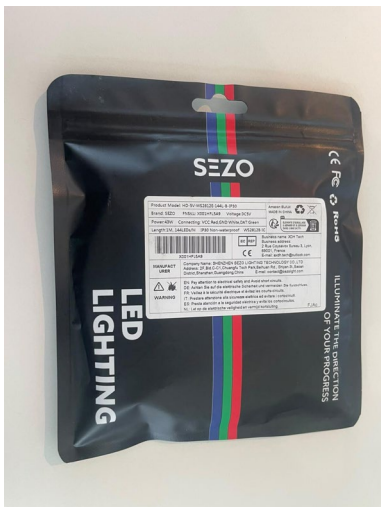
### 7.1.5 Internal LED Lighting — *Status: Completed*

- **No internal lighting:** The interior of the printer is poorly lit, making it difficult to observe the print process or identify early failure signs.

A 12 V LED strip has been installed along the inside of the top frame of the enclosure, connected to a spare output on the control board / power supply. This has significantly improved visibility of the print area during operation and is a prerequisite for any future camera-based monitoring.

**Remaining work:** *none — installation and wiring complete; cable routing will be tidied up during the general cable-management pass (Section 7.2).*

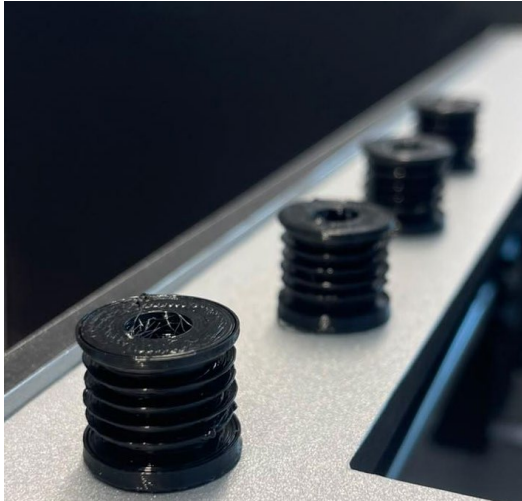
### 7.1.6 Vibration Damping Legs — *Status: Completed*

| <b>Root cause</b> | The printer frame was directly touching the table so the vibration of the printer moves to the table |

To mitigate structural resonance and the resulting print artifacts (ringing), the stock rigid feet have been replaced with custom-printed damping legs in TPU (Shore hardness ~95A). This balances structural stability with vibration absorption and has noticeably reduced table-borne noise and vibration during printing.

**Remaining work:** none — the legs are fitted to all four corners of the frame.

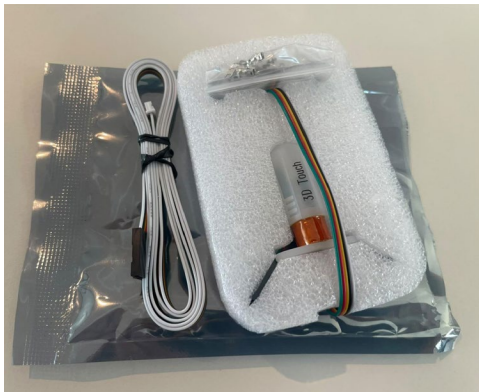
#### 7.1.8 3D Touch Auto-Bed Leveling Sensor — *Status: Incompleted*

To completely automate and correct bed balancing tolerances, a 3D Touch matrix probe sensor was planned to be integrated into the print head assembly. The wiring was routed to the control board and the probe offsets were configured in the firmware. However, due to time constraints and the

complexity of the calibration process, the physical Z-offset could not be successfully tuned and saved. This upgrade remains incomplete and the sensor is not currently operational.

**Remaining work:** Complete Z-offset calibration and test the bed mesh compensation functionality.
