KT_GIGA_WIFI-Wave 2 has a stack overflow vulnerability

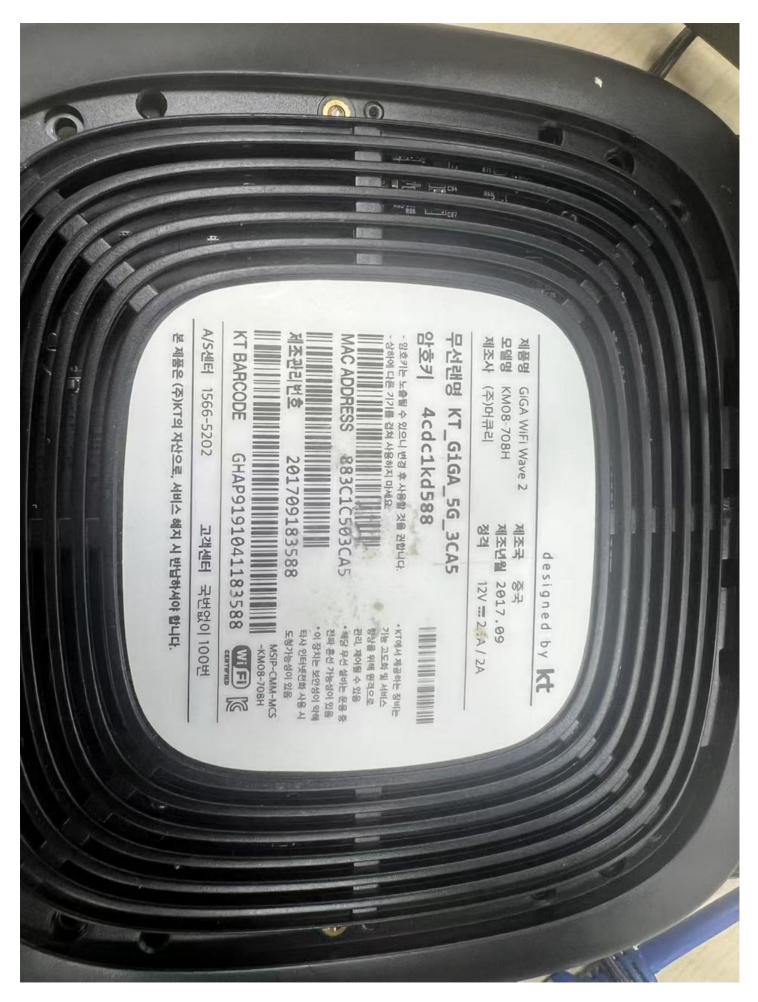
The device information is as follows

According to the web interface, the firmware version is KM08-708H 1.1.14

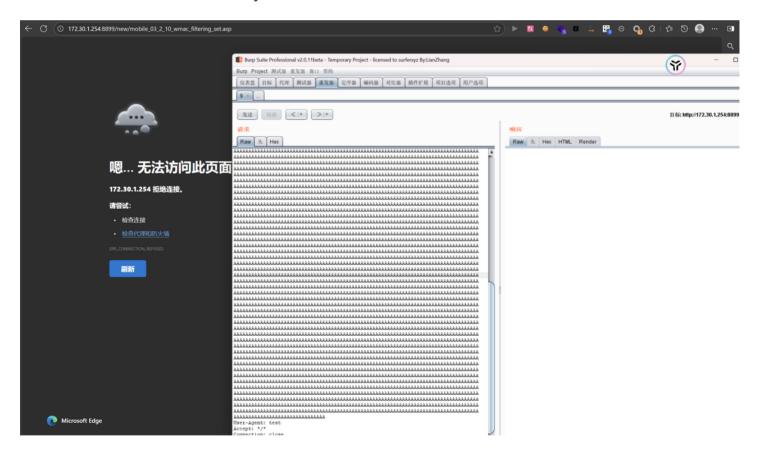
Web service crashes successfully
