# Failure Analysis Report

UvA Master Programme Conservation and Restoration of Cultural Heritage

Name of student (student number): Moje Ryoo (13837486)

Course: Mechanical Properties of Materials in Art

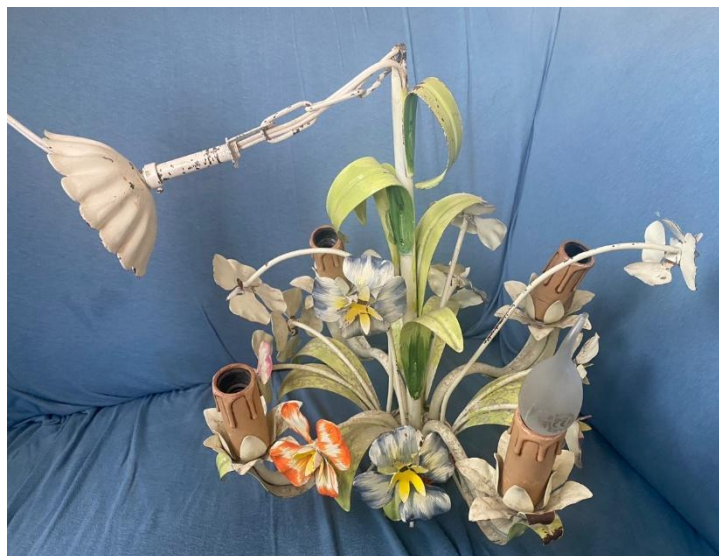
Fig. 1. An overview of painted metal chandelier

The chandelier is covered in an unknown grey dust, with significant paint peeling around the edges. The damage is primarily observed on the surface of the paint; numerous cracks in the paint layer are visible to the unaided eye. While no metal parts are broken or torn, severe corrosion occurs where the paint layer has peeled off, resulting in red powdery grains on the surface. Since it was found on the street, there is no information about what this object has endured or what kind of impact it may have experienced. Therefore, it is possible that overall deformation or bending occurred after its original geometry was manufactured. A detailed examination of the mechanical surface damages: cracking, peeling, and rust bubbles will be explored in the Types of Mechanical Failures and Theories on Failure Modes sections below.

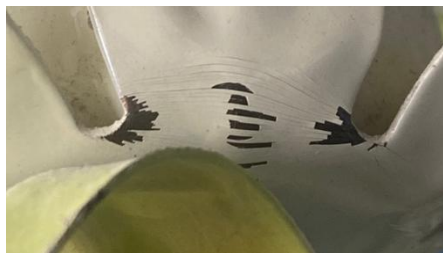
The metal chandelier component exhibits cracks and peeling, mostly along its curved section. In some areas, cracks and peeling occur together; all cracks are accompanied by peeling, visible to the unaided eye, while some chipped regions exist without cracks (Fig.4 and 5).

Fig. 4. Cracks and peelings

When selecting paint, three key factors must be considered: flexibility, adhesion power, and thermal expansion characteristics. Cracks and peeling likely result from insufficient paint flexibility relative to metal movement. The conservation material requires balanced flexibility. If too brittle, it may crack under minor movements, while if too flexible, it may lose shape during drying. Strong adhesion power is essential to prevent detachment under environmental stresses like humidity, temperature fluctuations, or vibrations. Additionally, choosing paint with a coefficient of thermal expansion (CTE) close to that of the metal minimizes fatigue from differential expansion. Considering the general condition, **Epoxy resin** paint could be suitable for the metal object.<sup>12</sup>

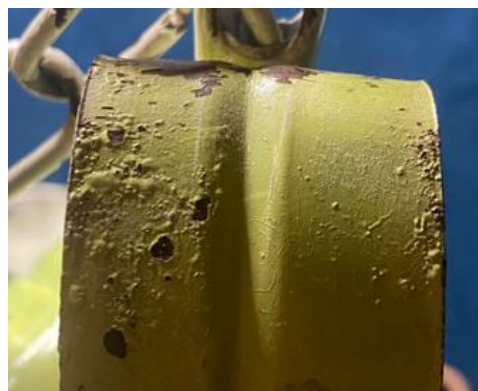
Some areas show blistering. Blistering of paint films on metal manifests as localized delamination, resulting in bubble-like protrusions on the painted surface.<sup>2</sup> The cause of blistering may vary, but this phenomenon inevitably involves adhesive failure between the paint film and the metal substrate. On this object, blistering areas are accompanied by corrosion of the metal surface (Fig.6).

Fig. 6. Blistering on the surface

In areas with blistering, the paint film bulges outward (Fig. 6). This deformation likely occurs because as the metal corrodes, the resulting products expand beyond the original metal volume, pushing against the adhered paint film.

The same considerations for paint including flexibility, adhesion power, and thermal expansion, apply to coating materials, with the additional requirement of compatibility with the paint layer. As a coating layer, **Paraloid B-72** provides effective metal conservation through corrosion protection, flexibility, good adhesion, and stability.<sup>15</sup> However, as same as the paint selection, the coating material's CTE still should be compared with the CTE of the metal and paint to ensure compatibility.

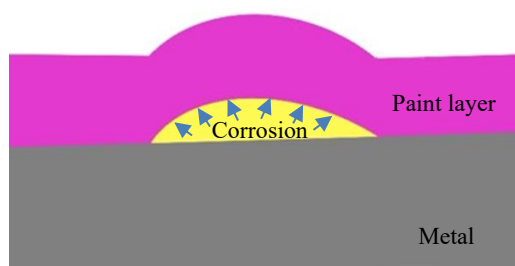
Fig. 10. Schematic representation of how the new volume of corrosion pushes the paint layer outwards.

Corrosion initiates when water and oxygen reach the metal surface through micro defects or cracks in the paint caused by various forces. Soluble corrosion products like  $\text{Fe}(\text{OH})_2$ , ferrous chloride hydrate, and ferrous hydroxy sulphate form beneath the film, generating osmotic pressure.<sup>7</sup> Once a blister forms, its isolated internal environment accelerates corrosion. The additional volume of rust ultimately pushes the paint layers outwards and causes delamination of the paint film, which was originally applied flush to the metal surface (Fig.10).

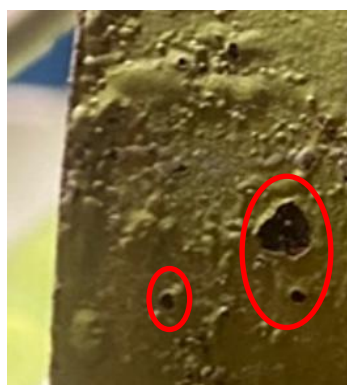
As shown in Fig. 11, the expanding corrosion products push outward against the paint layer where adhesion is weakened, stretching the paint film. If the dried paint is sufficiently ductile, blisters keep their bulging shape; if not, the layer tears, exposing the damage. These tears create additional pathways for corrosive elements to contact the metal, allowing corrosion to continue spreading between the metal surface and the paint layer.

Fig. 11. Torn blisters

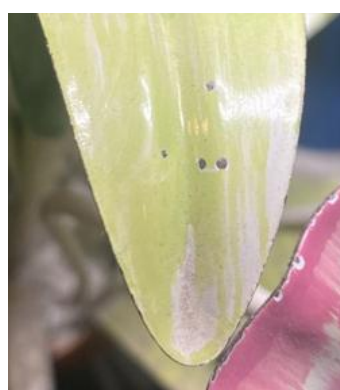
In contrast, relatively fresh chipping areas that display a silvery metal surface without reddish corrosion show no blistering yet (Fig. 12). Disregarding potential chemical bonding-related reactions within the paint itself, the delamination appears to be primarily caused by the mechanical force of expanding corrosion products pushing outward against the paint layer, which weakens adhesion between the metal and the paint layer over time.

Fig. 12. Fresh chipping without blistering

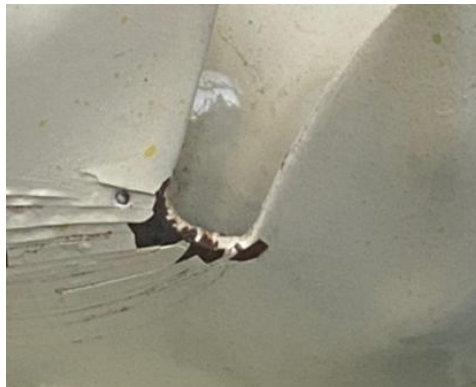
Cracks initiate from points of stress concentration. When a crack forms in the paint layer and experiences continuous or larger stress, it can lead to the peeling of the paint film. If peeling occurs, it indicates that this area has undergone more severe stress than the cracked area. Examining the peeled paint reveals that the highest stress is concentrated at the notch on the inside corner of the petal (Fig. 13). In certain geometric features, like the notch, they inherently experience more stress. Bill Wei's research shows that the stress in a metal sheet with a notch can be up to four times higher than in a region without a notch (Fig. 14).<sup>8</sup> While multiple types of tensile stress may act simultaneously on the petal, it is evident that indented areas, such as the peeling paint region, are subjected to higher stress.

Fig. 13. Notched area on the petal

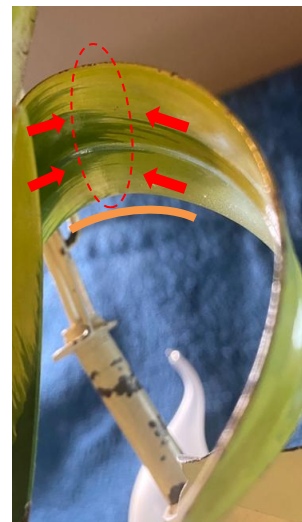
The more severe the deformation of the shape, the greater the residual stress will be posed within the material. When comparing two leaves with different angles of curvature, as shown in Fig. 15 and 16, the metal in Fig. 15 is steeply bent, so the residual stress is more significant than in the gently bent part shown in Fig. 16. As a result, cracks and peeling damage occurred inside the concave curvature due to compressive stress. In Fig. 15, the stress concentration on the curvature area was high enough to crack the paint layer, while that in Fig. 16 was not able to make a visible crack.

Fig. 16. Larger radius of curvature without damage
