# WILLOWMERE PHASE 3

Winter condition survey of the depot buildings and northern boundary

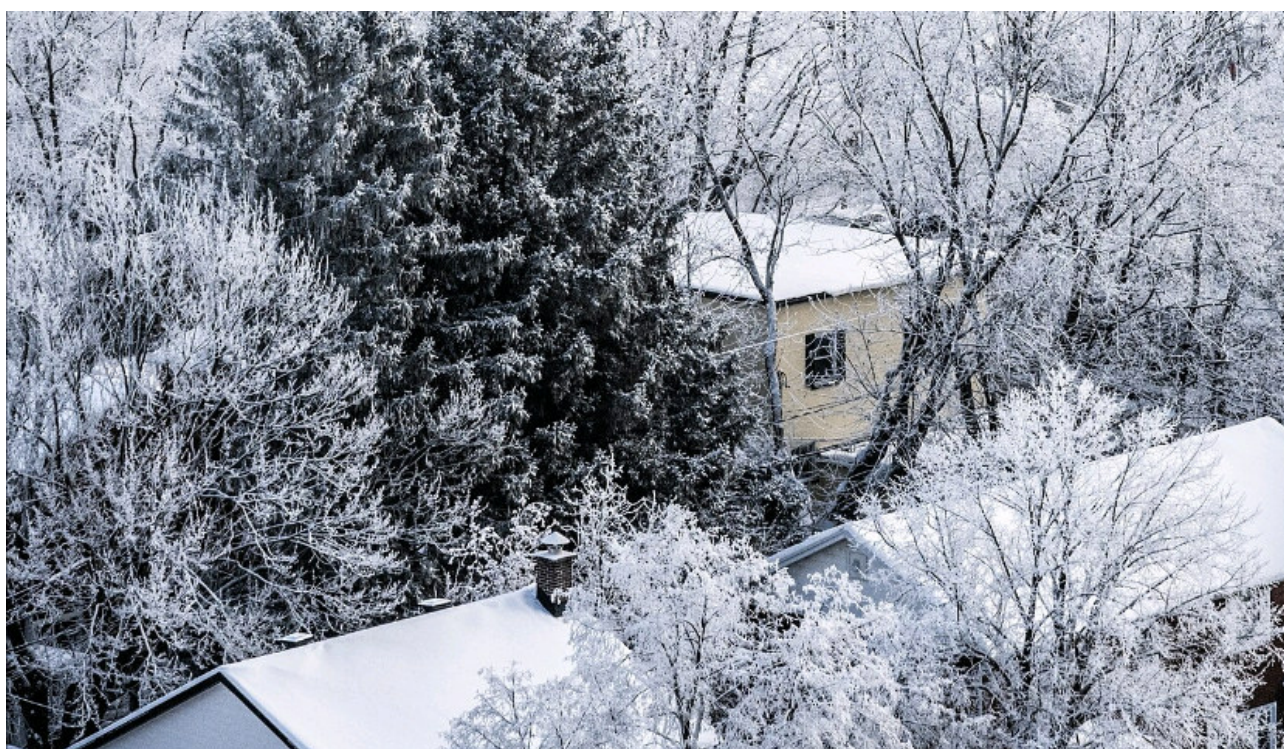
*Plate 3 - northern boundary planting from fixed point 4, 14 February 2026. The mature spruce at centre is outside the demise and is noted for the shading it casts on the north range rather than for its own condition.*

The boundary planting is in good condition and is performing the screening function it was retained for. No storm damage was evident. The self-seeded ash on the eastern return has reached a size at which it will begin to lift the wall footing and should be taken out this winter while access is still open.
