CHIESA E MONASTERO DI SANTA CHIARA

RESTAURO E CONSOLIDAMENTO DELLA CHIESA
E DI UNA PORZIONE DEL MONASTERO DI SANTA CHIARA
DANNEGGIATI DAGLI EVENTI SISMICI DEL 30/05/2016 E SUCCESSIVI

PROGETTO PRELIMINARE

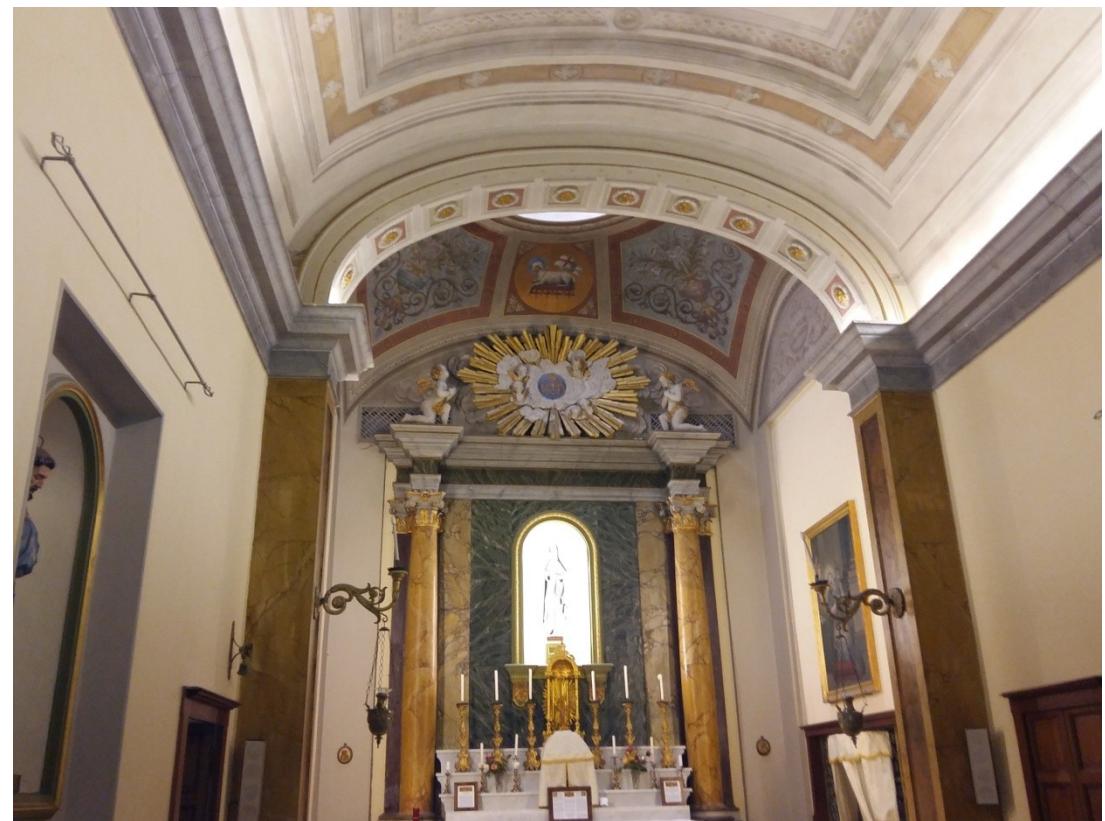
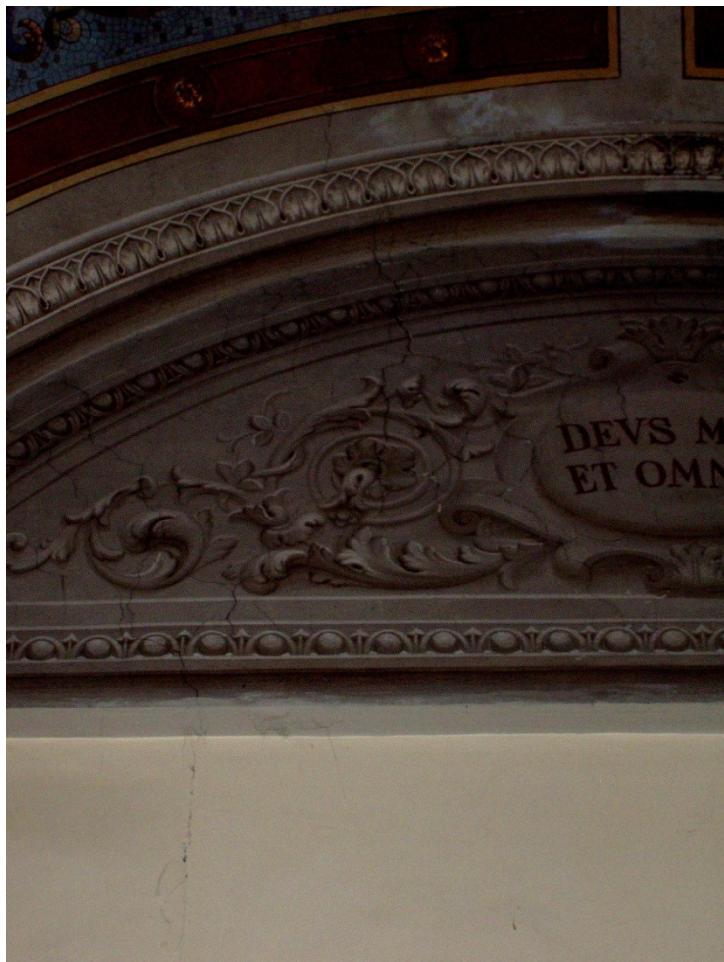
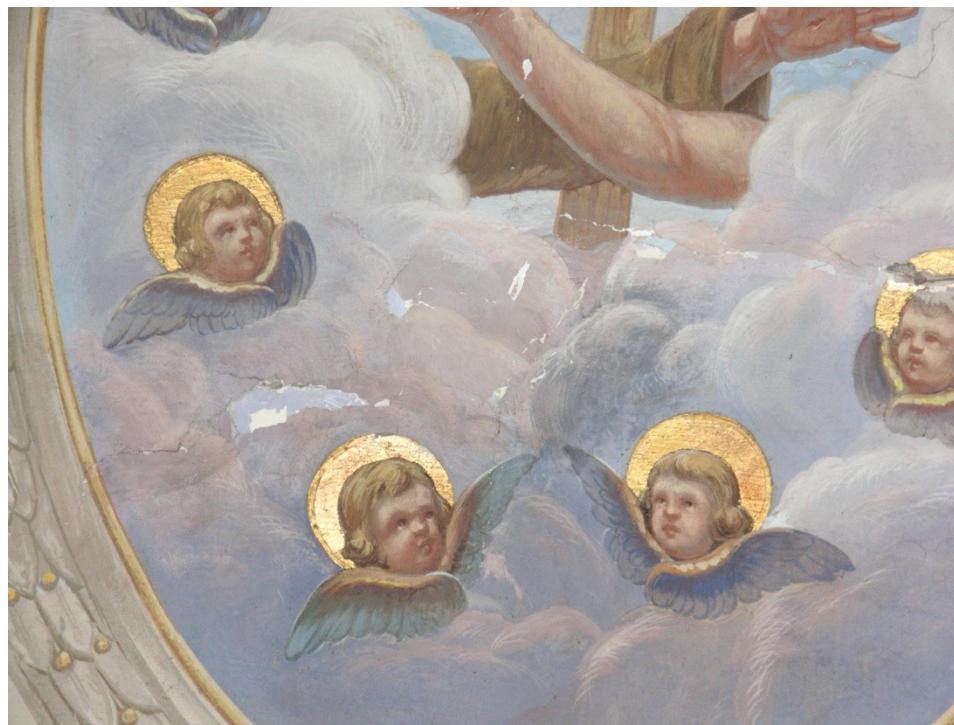
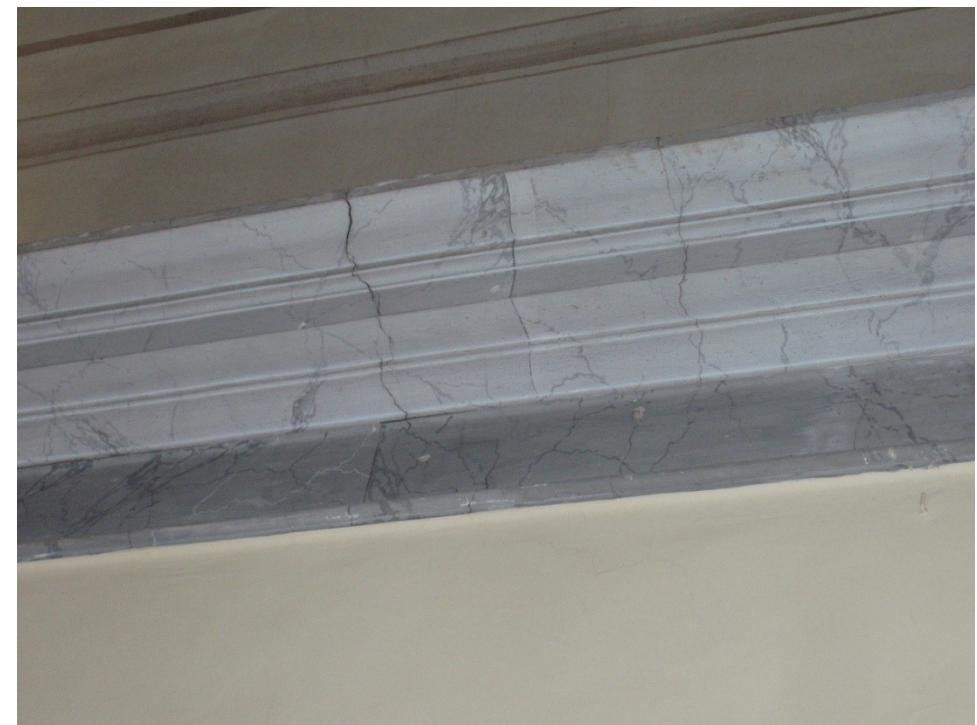
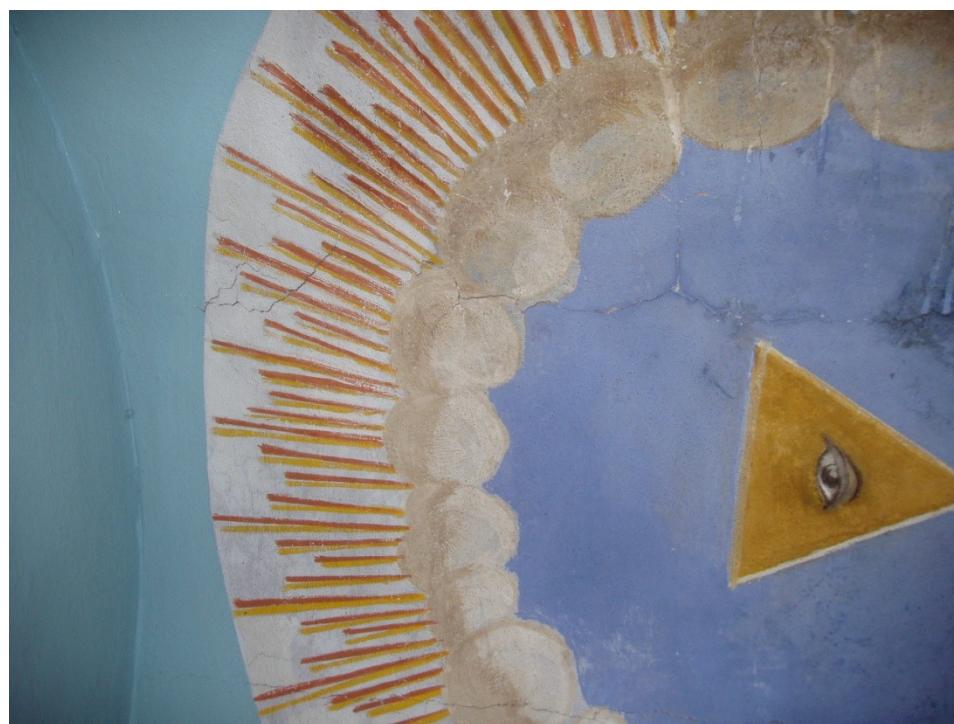
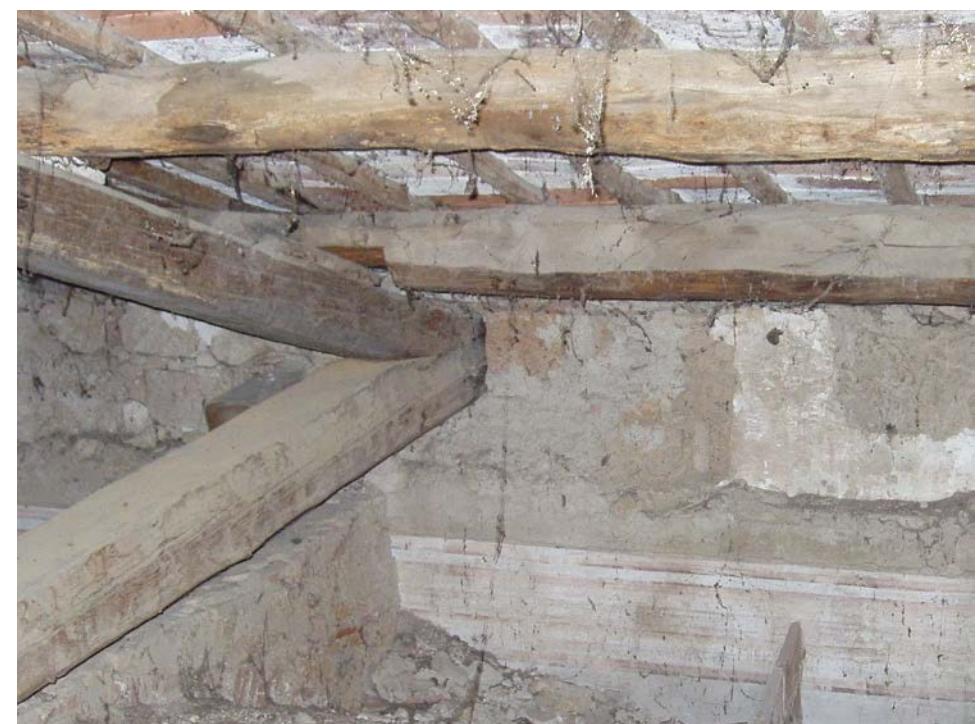
THE CHURCH

The portion of the Church is that which apparently seems to be less damaged, although it bears a transversal lesion midway in the church, rightly at the center of the decoration of the existing barrel vault , given to the rotation of the shutters.

Besides, on going to analyze more closely, it presents, in the space under the roof, between the vault and the wooden covering, evident lesions on the topmost part of the walls and the displacement of some beams from the covering, provoked by the action of the seismic events (see the photographic documentation). Such situations should be sorted out with urgency, in order to avoid further possible damage to the stability and functionality of the same covering, which today is precarious.

Even some part adjacent to the church show significant criticalities, in fact on the wall of the back of the church, where there is the organ of wooden structure constructed on a wooden platform lying on beams hanging out from the wall, there is an opening at the first floor of the Monastery, where there is the proper choir balcony, of which the topmost arch presents an important apical lesion – which zone is immediately above the parlor. Such lesion results understandably from the presence of the great opening, being this the weakest point of the entire back wall, without the presence of a horizontal support.

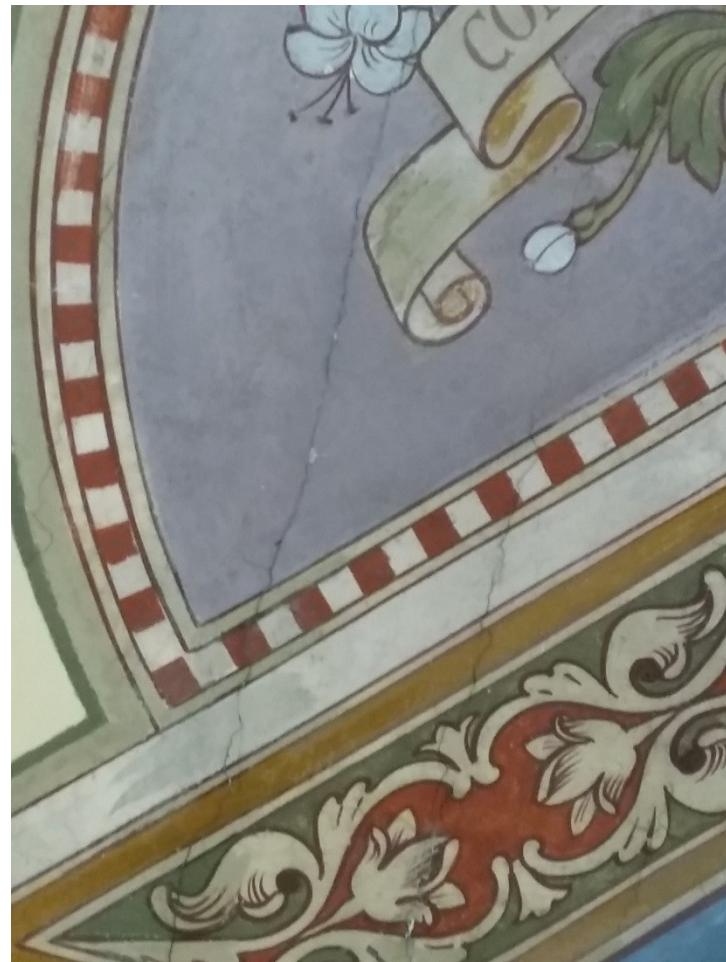
THE CHOIR

Besides, the space of the choir, with overhead a vault with lowered “sails”, shows evident lesions that start from the summit of the internal angles of the place and run through part of the same vault because of the deformation of the level; in order to evaluate more precisely the damages of the vault and eventually of the covering overlying it one needs to go into the attic which in this part is not accessible. It is necessary, therefore, to better inspect the vault after having removed part of its covering.

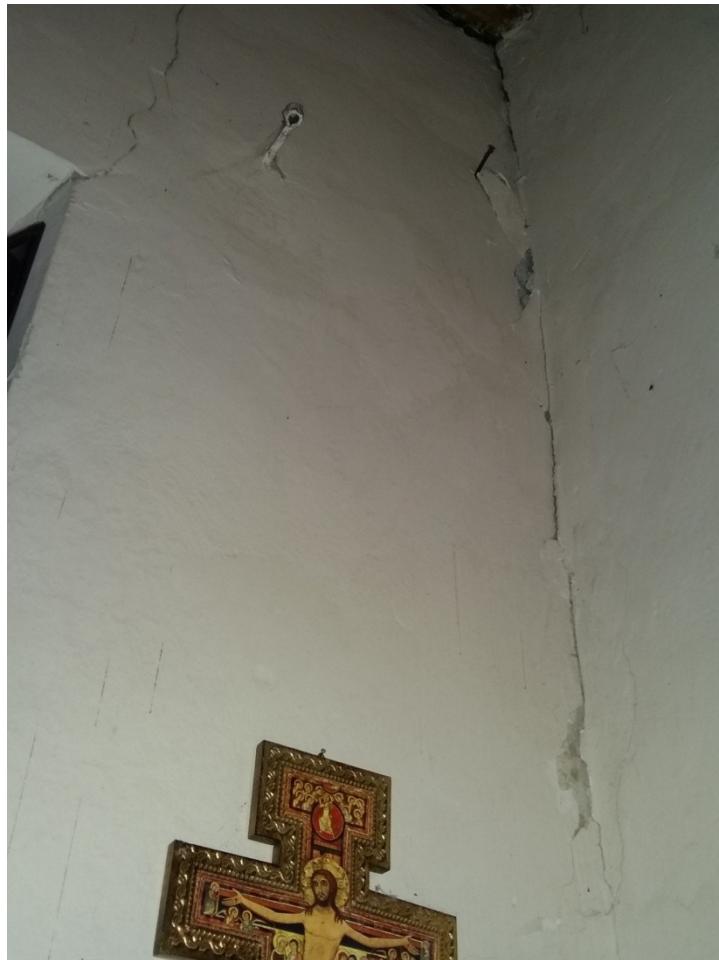
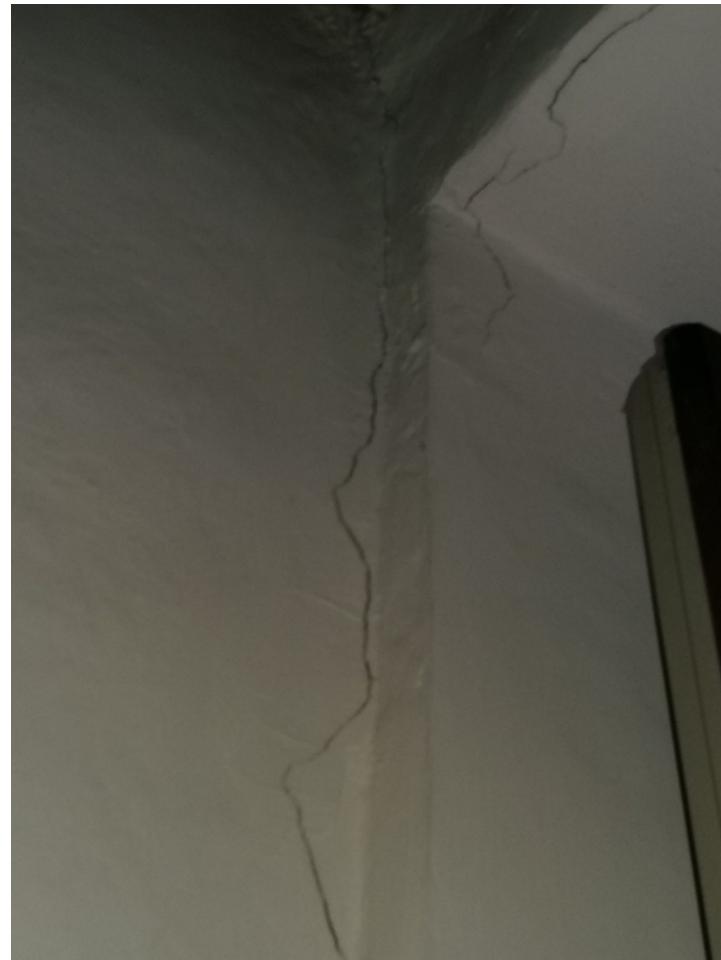
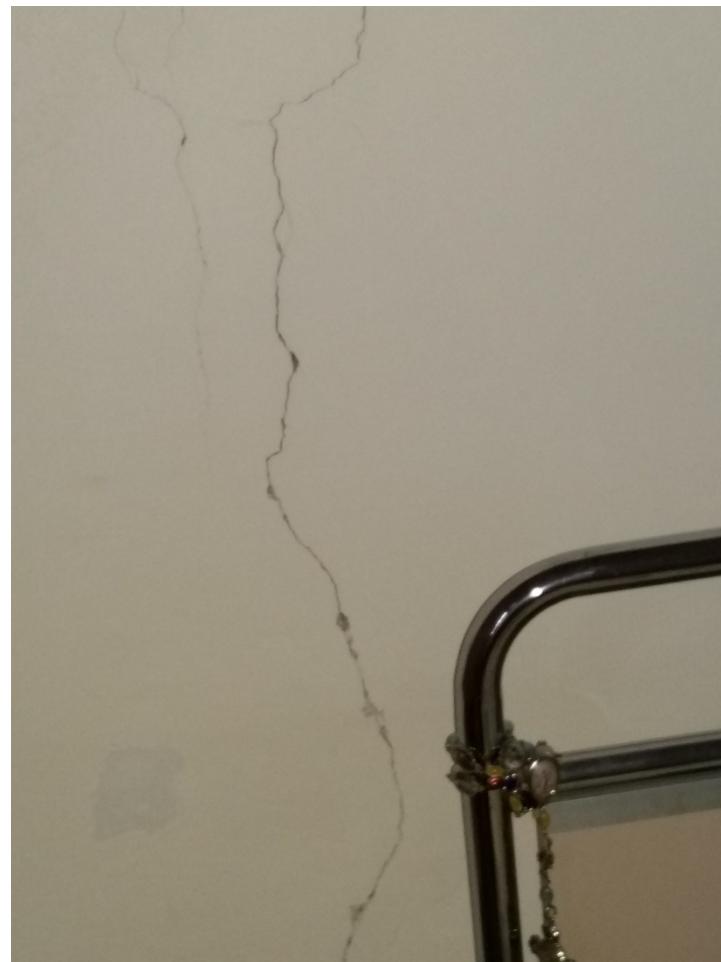
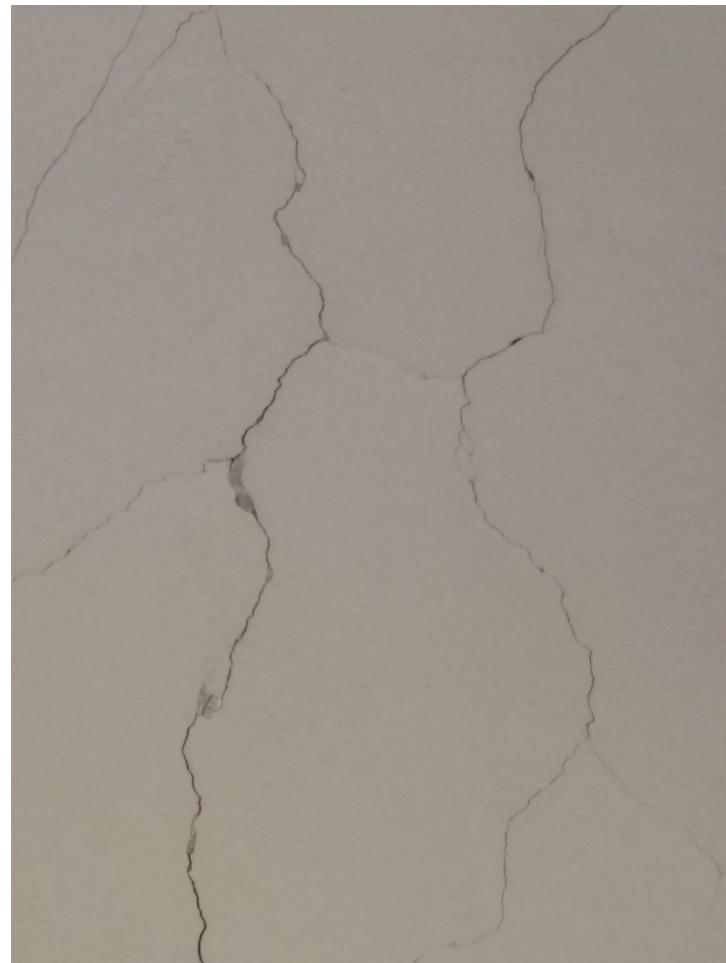
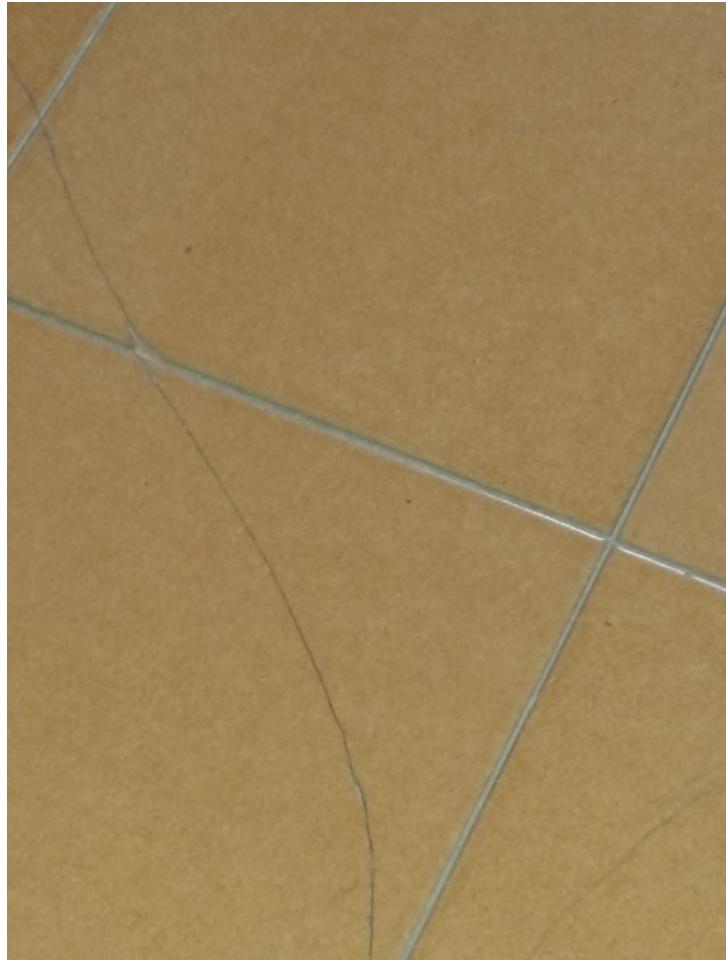
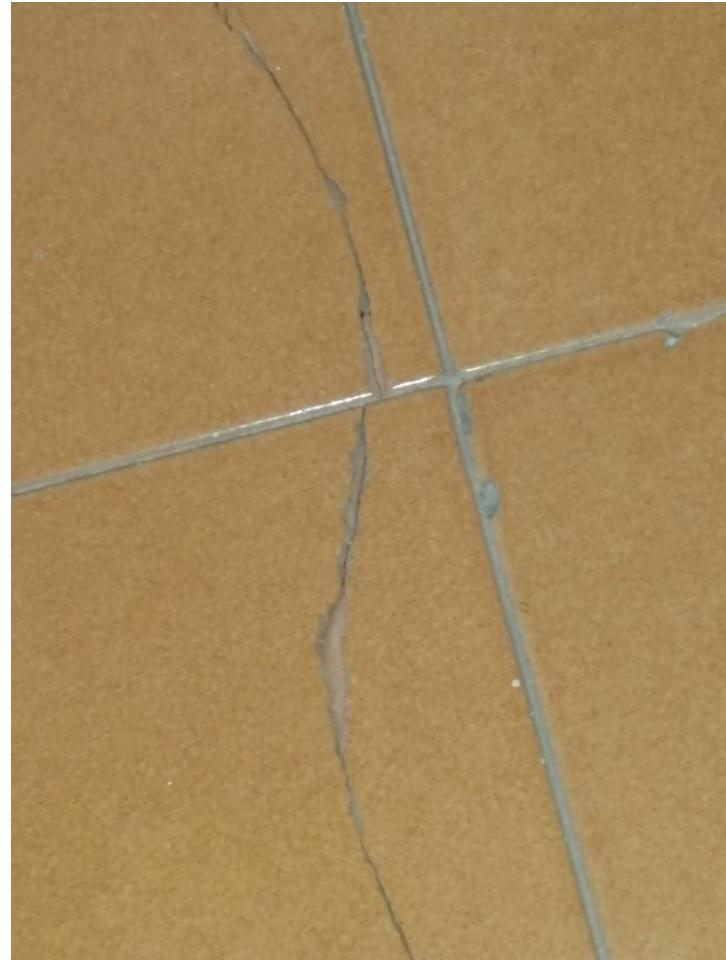
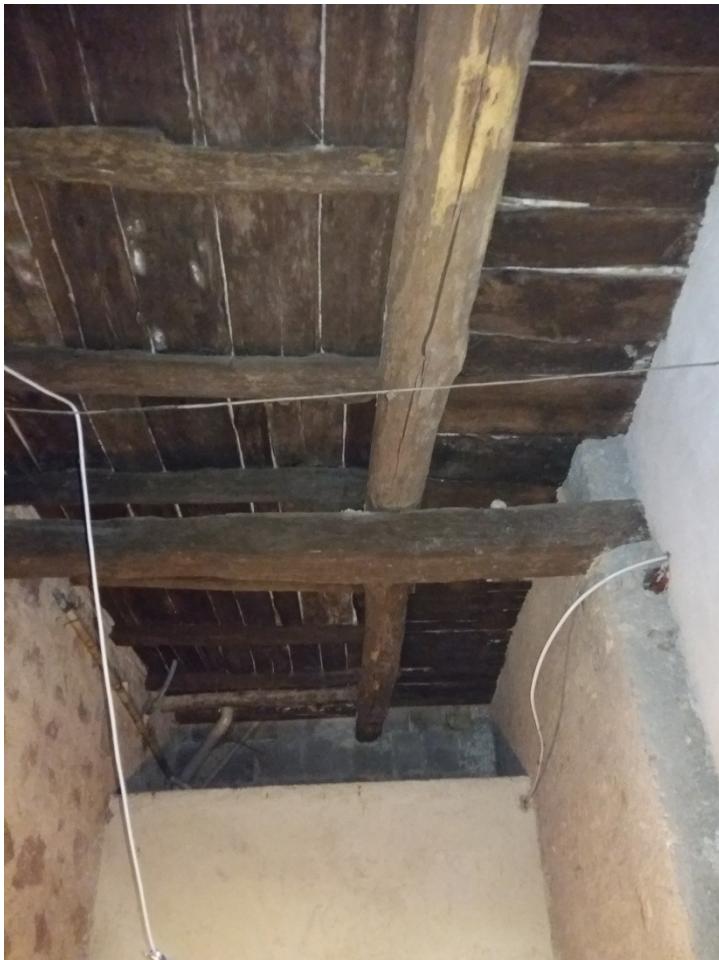
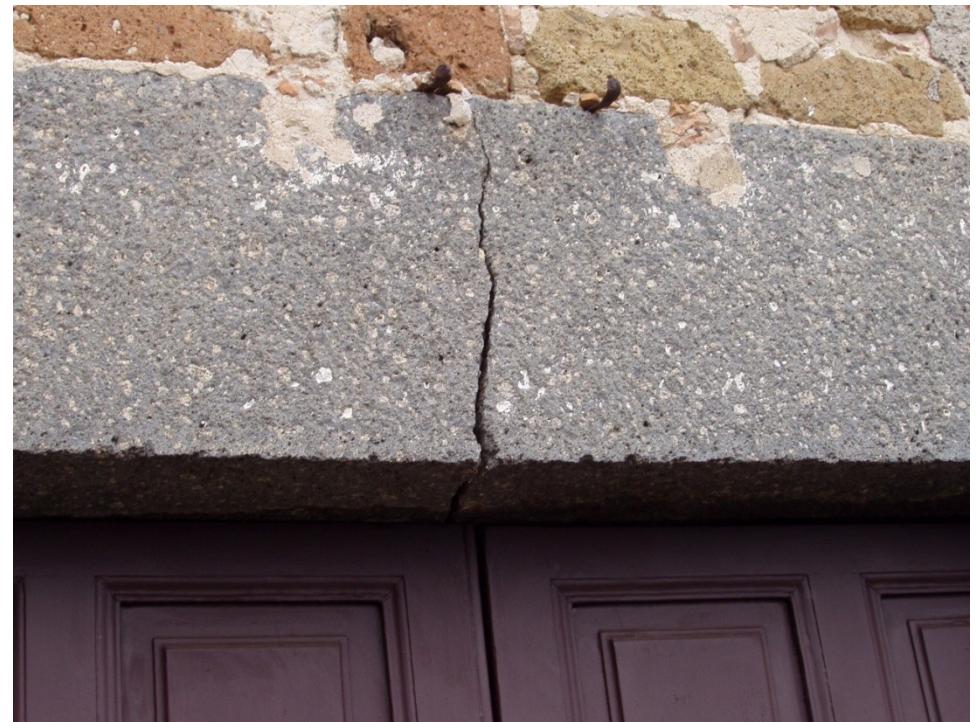
THE NOVITiate

Particularly, the main portion, that which overlooks Via Malintoppa, highlights an overturning mechanism, well underlined by the crevices visible in the corridor and in the cells of the overlying Novitiate.

Besides, the external part of the same Novitiate, overlooking north-east, seems to have suffered diagonal lesions on the walls of the corridor; such lesions would seem to be caused by the excessive height of the wall that lacks any horizontal connection. This part of the building requires urgent intervention because it is to be considered at risk in case of new seismic phenomena.
