# CHIESA E MONASTERO DI SANTA CHIARA COMUNE DI ACQUAPENDENTE (VT)

RESTAURO E CONSOLIDAMENTO DELLA CHIESA  
E DI UNA PORZIONE DEL MONASTERO DI SANTA CHIARA  
DANNEGGIATI DAGLI EVENTI SISMICI DEL 30/05/2016 E SUCCESSIVI

## PROGETTO PRELIMINARE

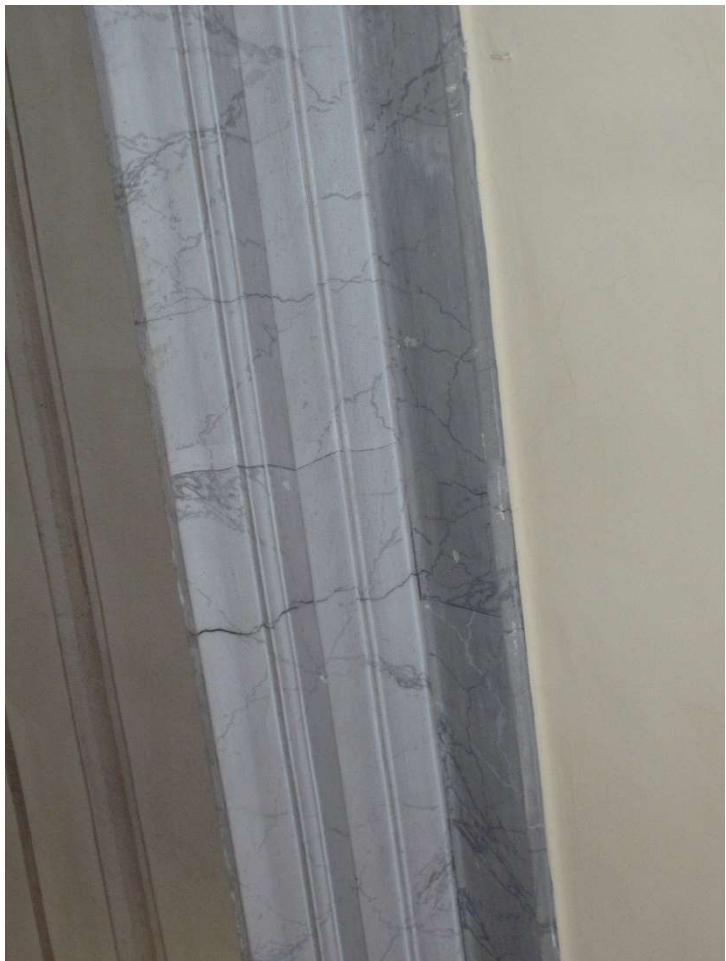
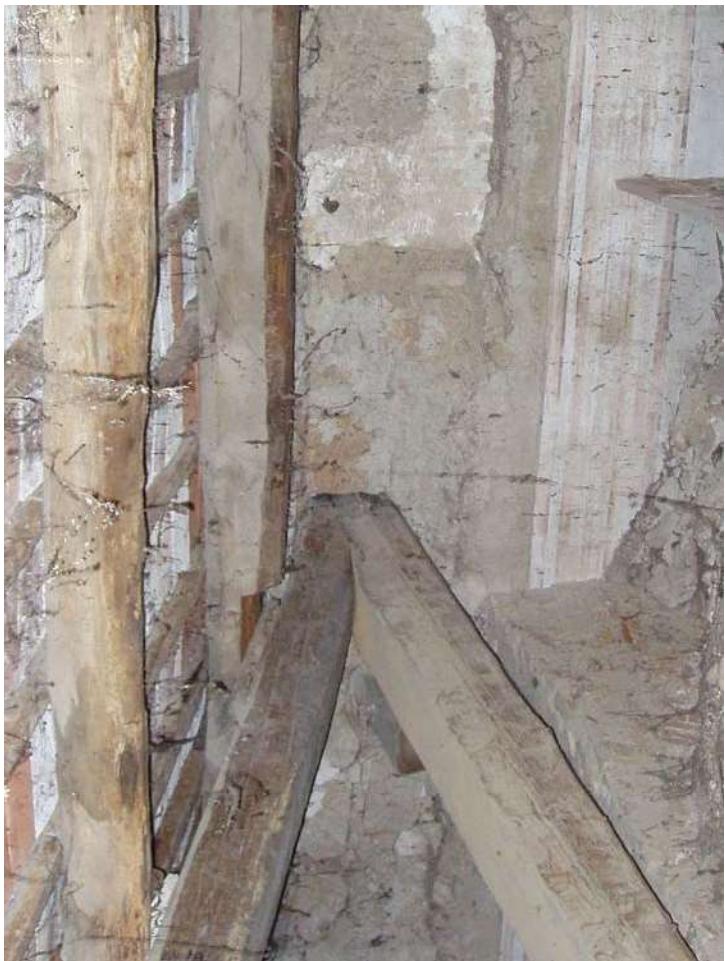
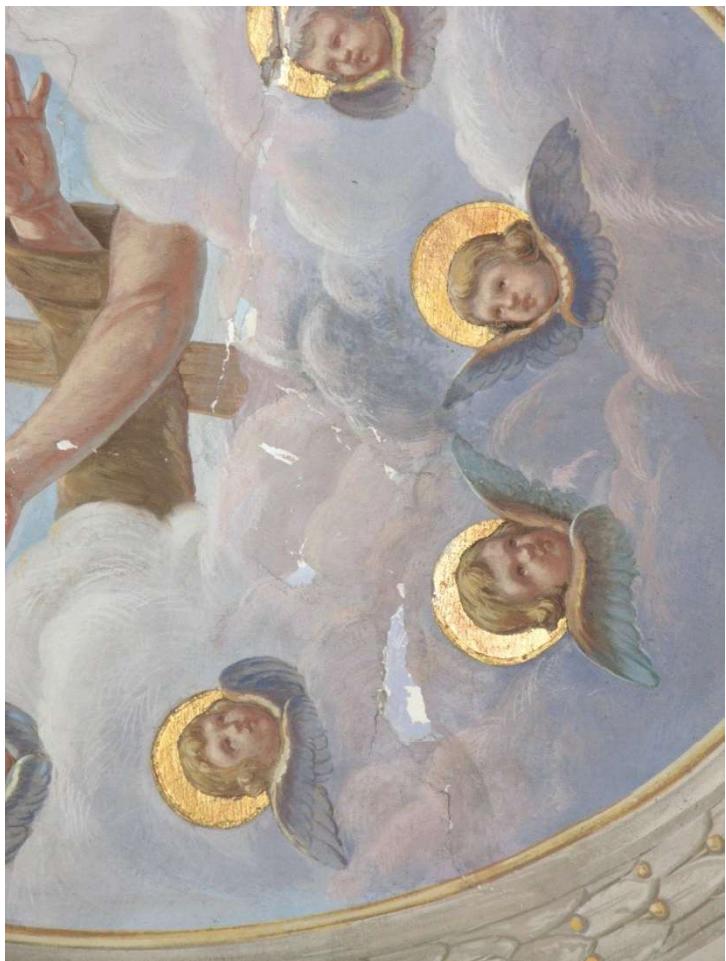
## THE CHURCH

The portion of the Church is that which apparently seems to be less damaged, although it bears a transversal lesion midway in the church, rightly at the center of the decoration of the existing barrel vault , given to the rotation of the shutters.

Besides, on going to analyze more closely, it presents, in the space under the roof, between the vault and the wooden covering, evident lesions on the topmost part of the walls and the displacement of some beams from the covering, provoked by the action of the seismic events (see the photographic documentation). Such situations should be sorted out with urgency, in order to avoid further possible damage to the stability and functionality of the same covering, which today is precarious.

Even some part adjacent to the church show significant criticalities, in fact on the wall of the back of the church, where there is the organ of wooden structure constructed on a wooden platform lying on beams hanging out from the wall, there is an opening at the first floor of the Monastery, where there is the proper choir balcony, of which the topmost arch presents an important apical lesion – which zone is immediately above the parlor. Such lesion results understandably from the presence of the great opening, being this the weakest point of the entire back wall, without the presence of a horizontal support.

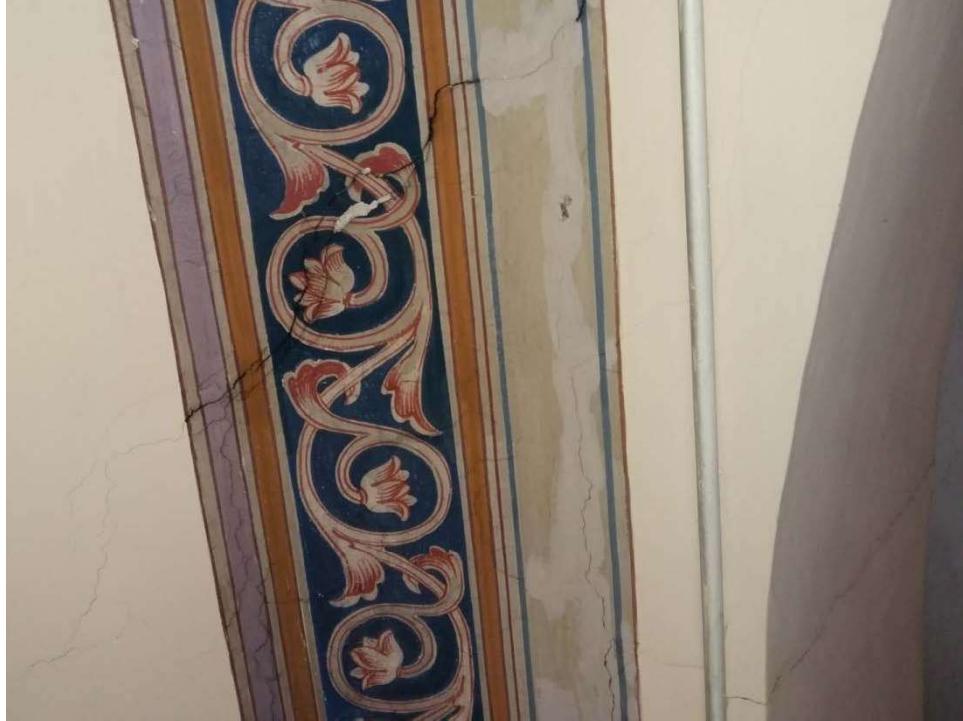
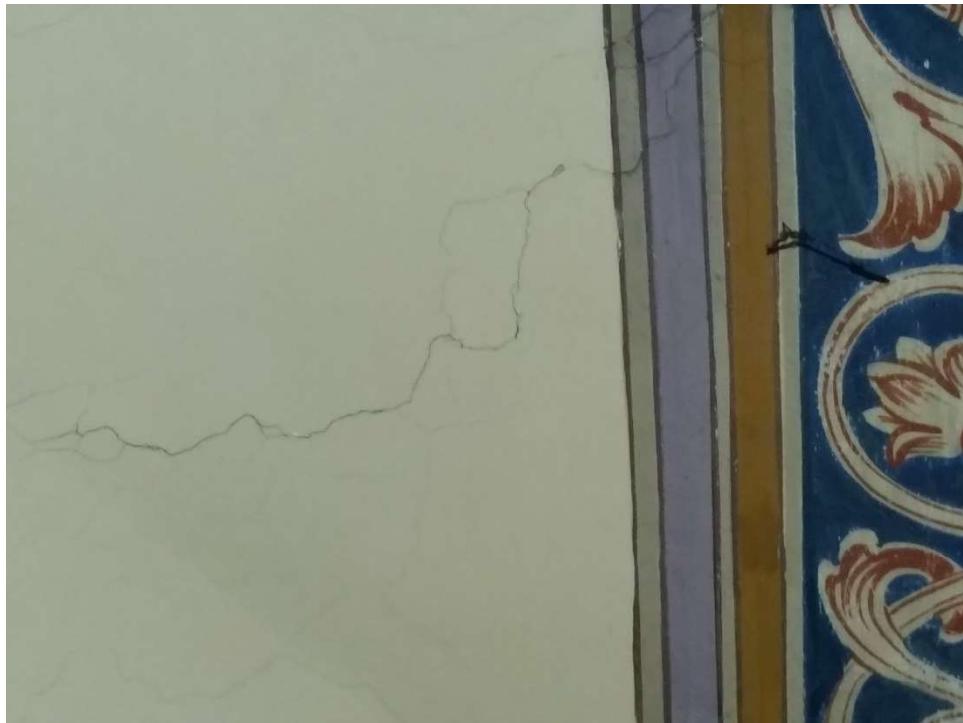
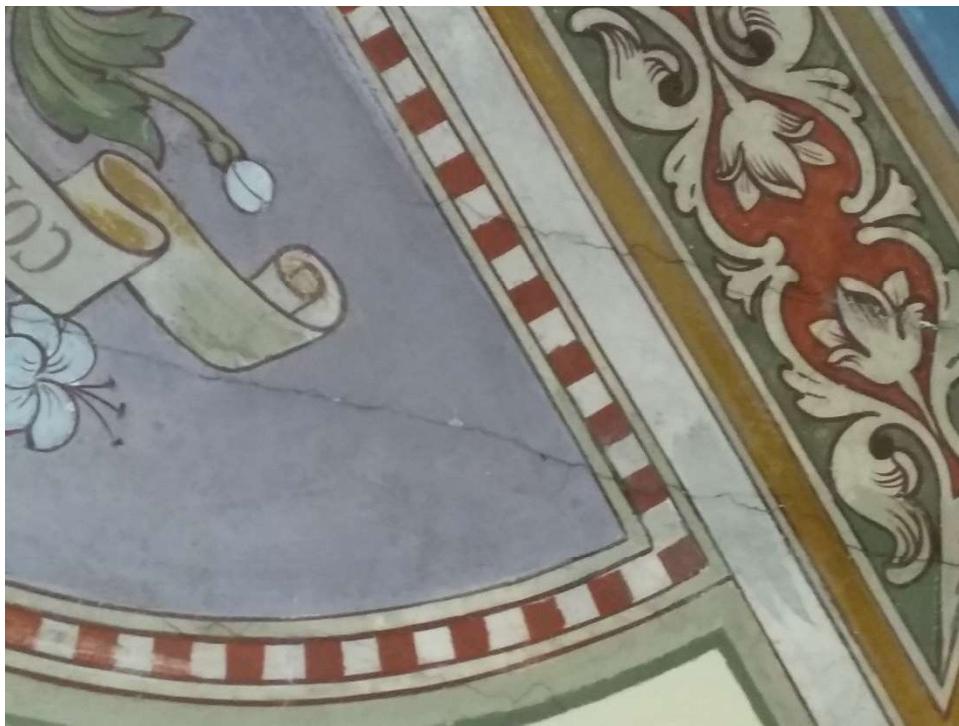
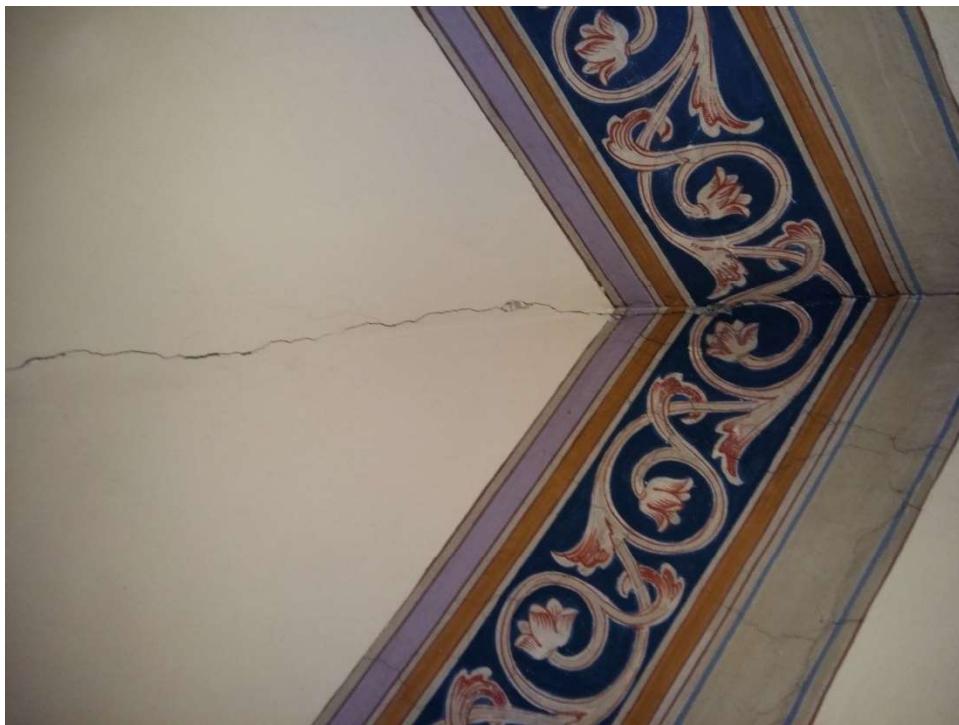
## THE CHOIR

Besides, the space of the choir, with overhead a vault with lowered “sails”, shows evident lesions that start from the summit of the internal angles of the place and run through part of the same vault because of the deformation of the level; in order to evaluate more precisely the damages of the vault and eventually of the covering overlying it one needs to go into the attic which in this part is not accessible. It is necessary, therefore, to better inspect the vault after having removed part of its covering.

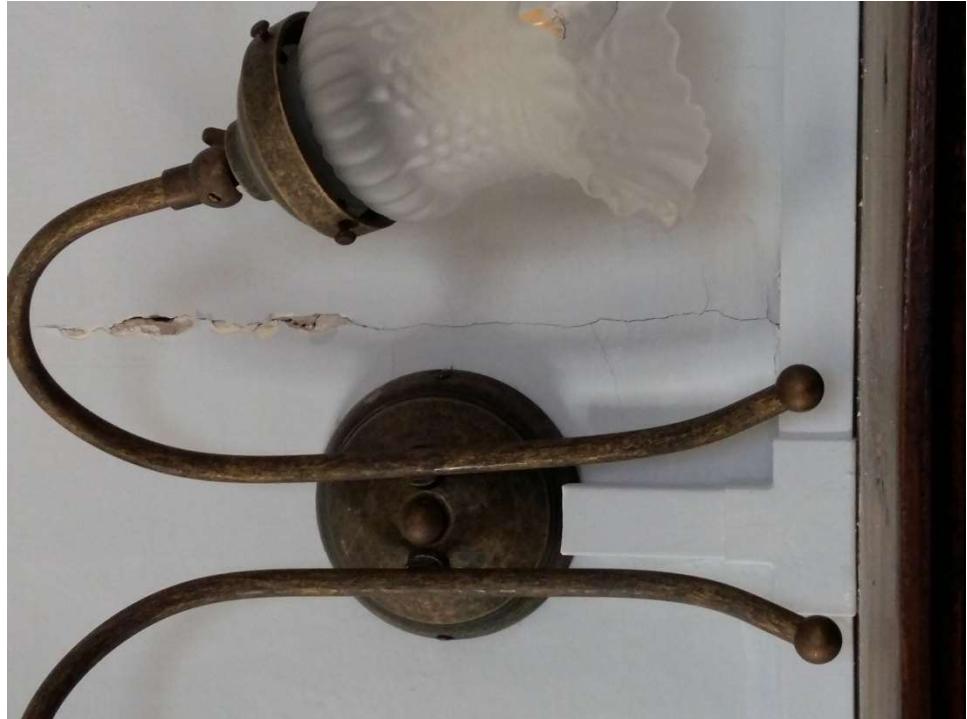
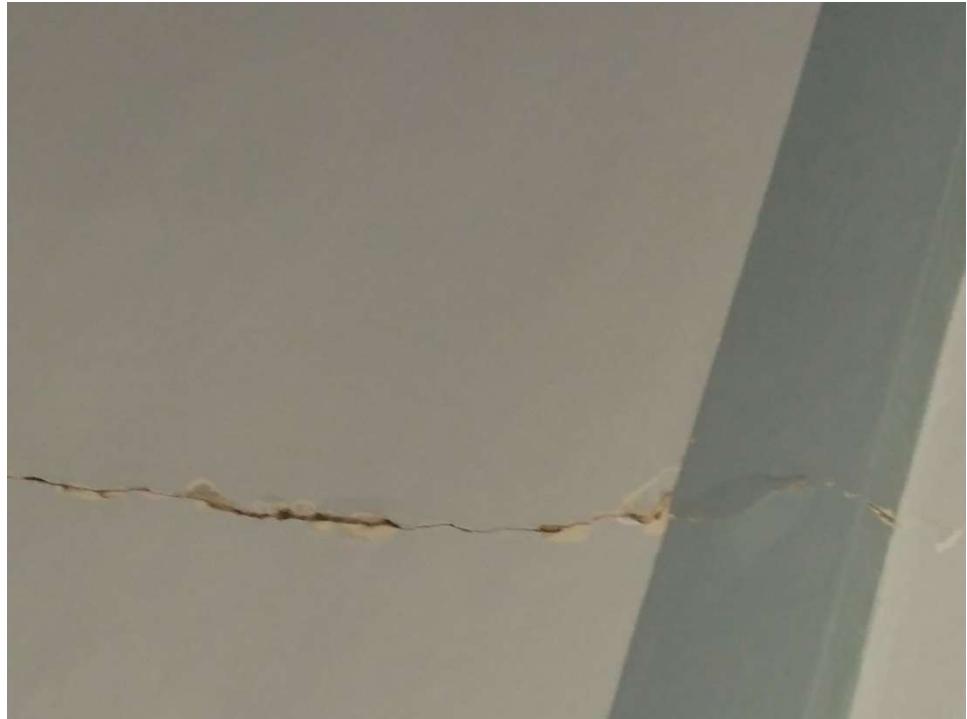
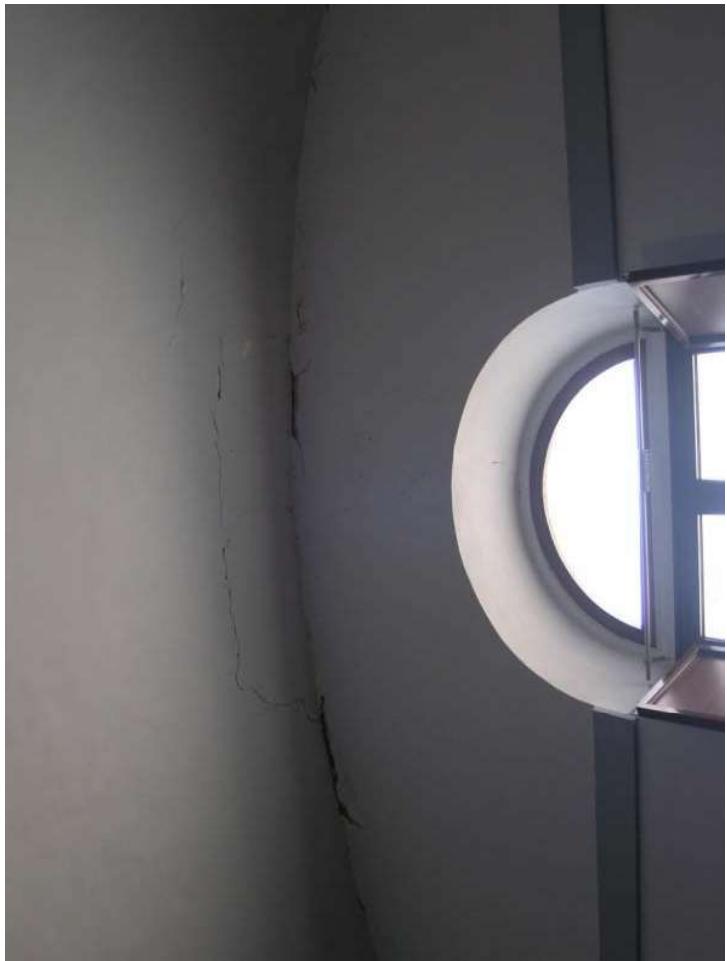
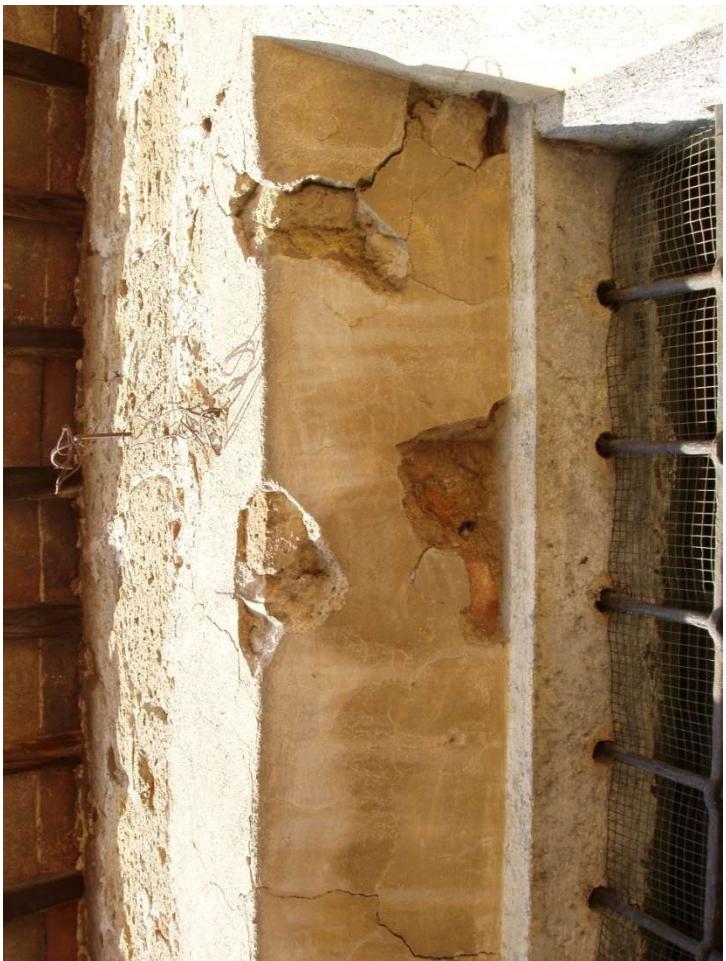
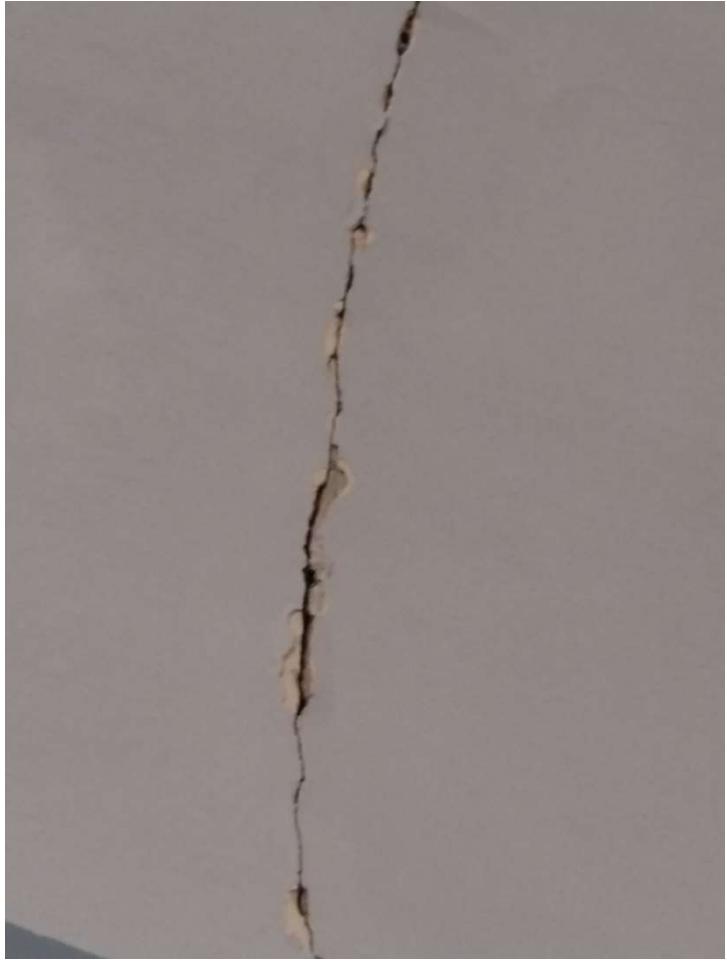
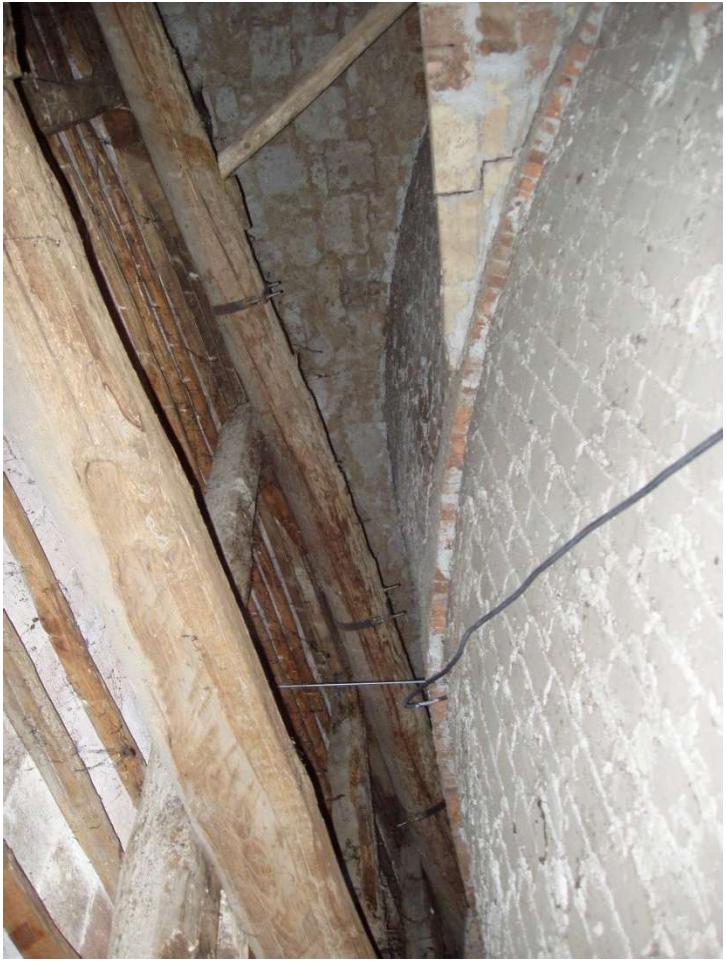
## THE ENCLOSURE CHOIR

disposte lungo la pendenza della copertura stessa, e non siano efficacemente ancorate per evitare spinte sulle murature (vedi il caso del coro claustrale nell'allegata documentazione fotografica). Inoltre, in ragione alla vetustà e al degrado degli elementi in legno, oltre alla presenza di sconnessione tra gli elementi, sono presenti problemi di stabilità ai carichi verticali. In aggiunta al più grave difetto che le capriate producono concentrazioni di sforzo puntuale che determinano la compromissione locale delle murature.

The enclosure choir, place behind the main altar is also made on a building that is different from that of the church, and it shows also lesions that are not secondary both at the conjunction with the wall of the altar, as well as, mostly on the opposite side where there is a big window, where at its top there are various signs of detachment from the overlying vault. In this “High Choir” there are present transversal lesions midway in the room both on the wall and on the same level of the vault. Even in this case, the damages is caused by the rotation of the shutters of the barrel vault.

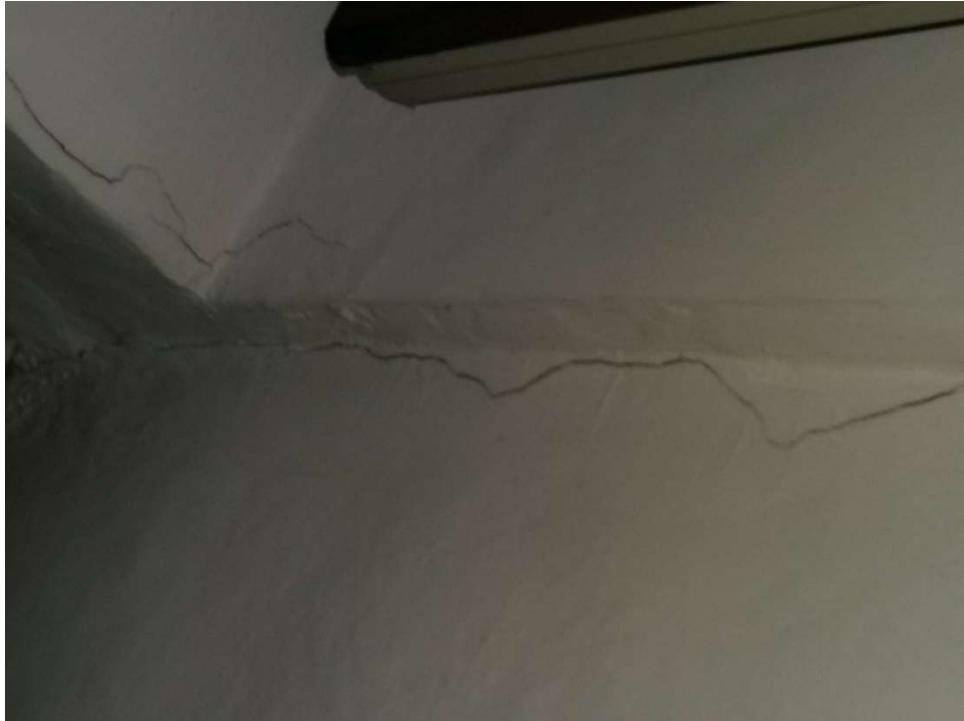
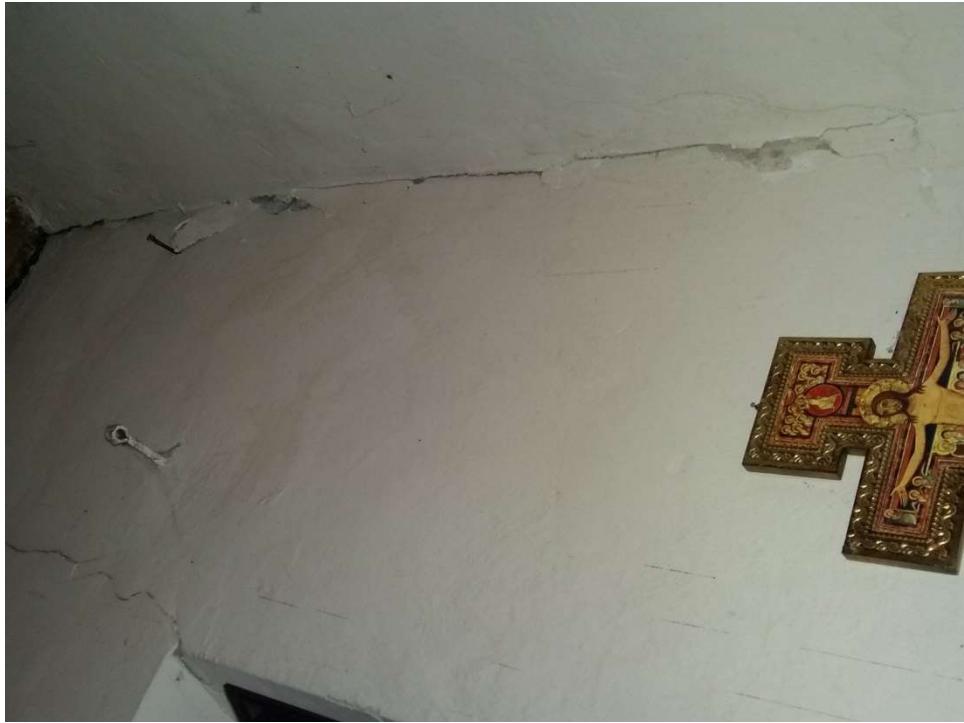
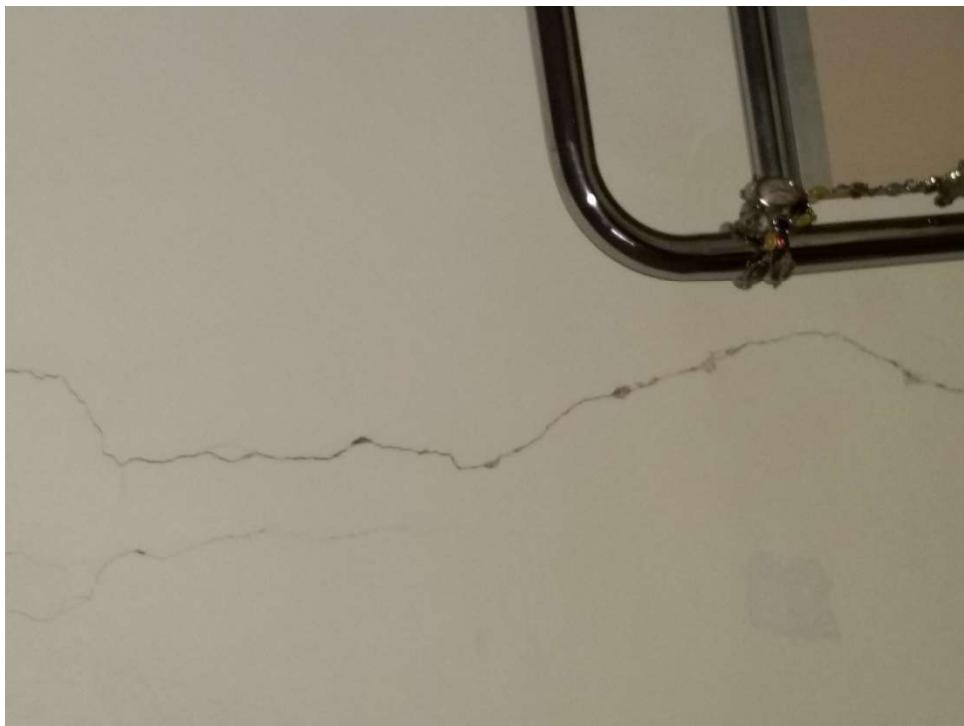
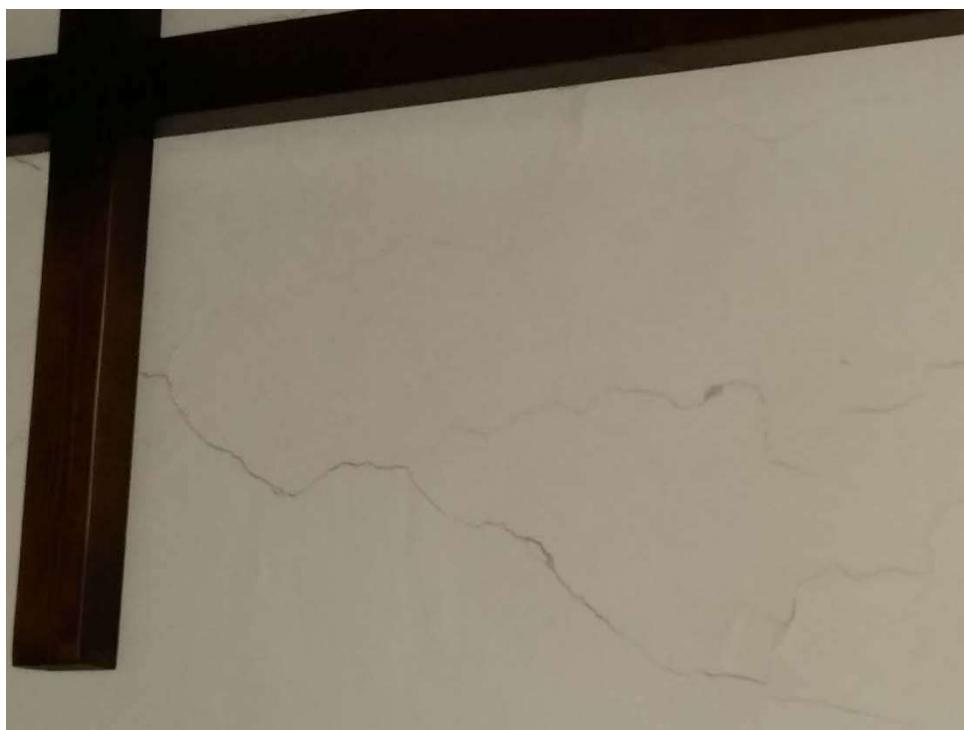
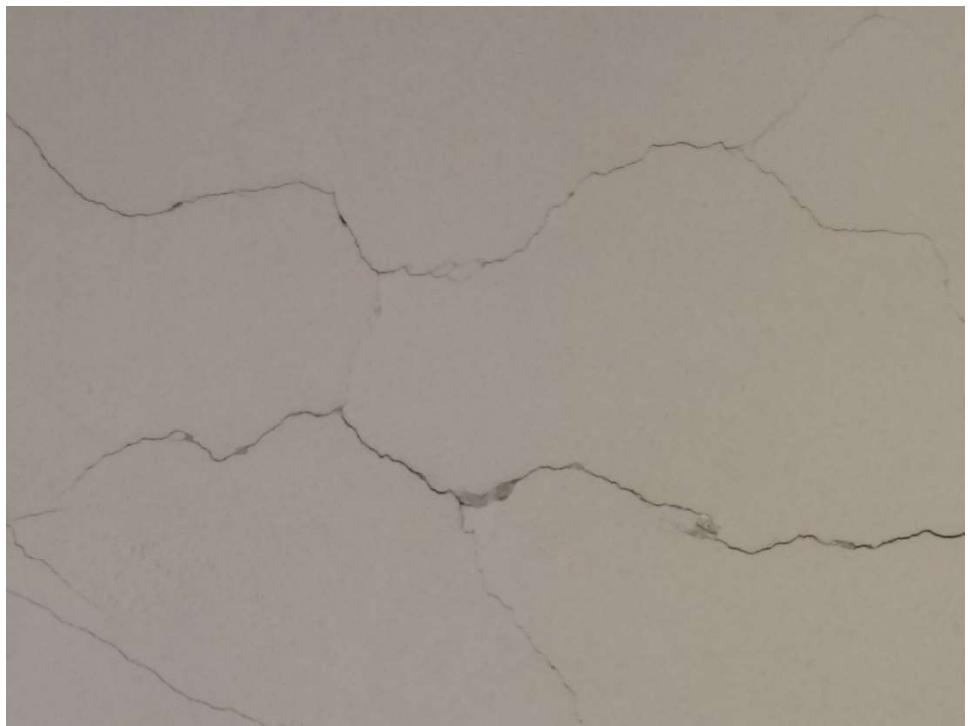
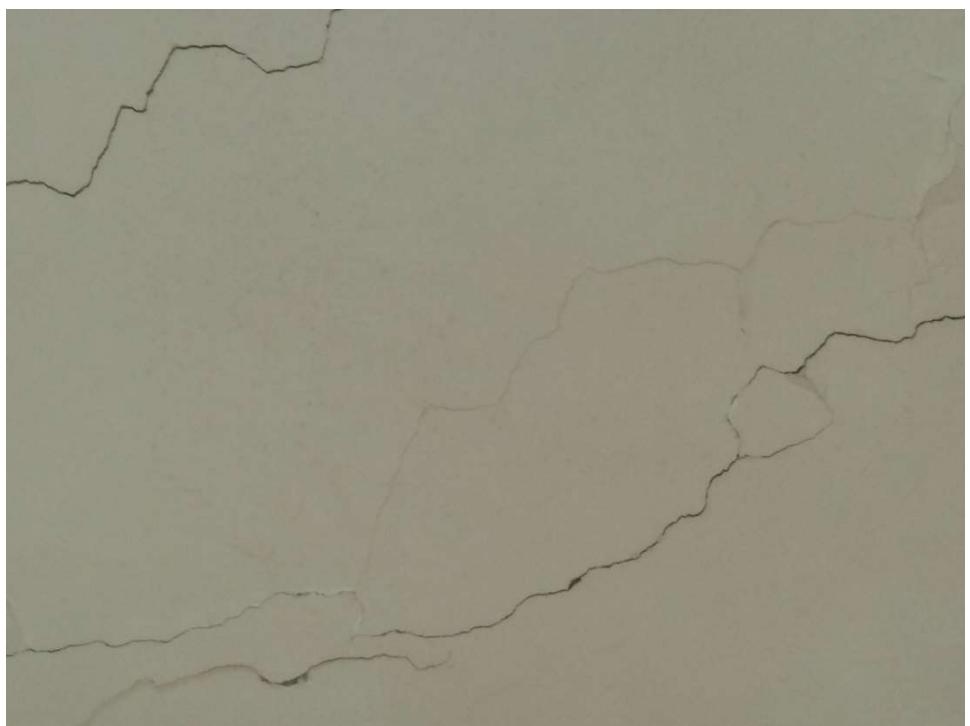
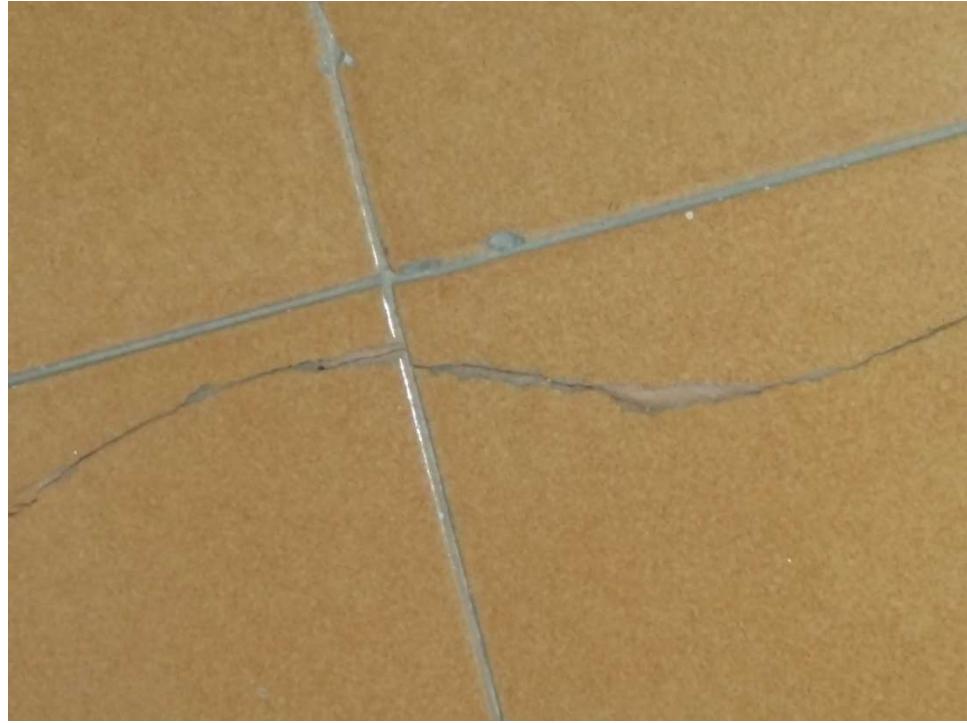
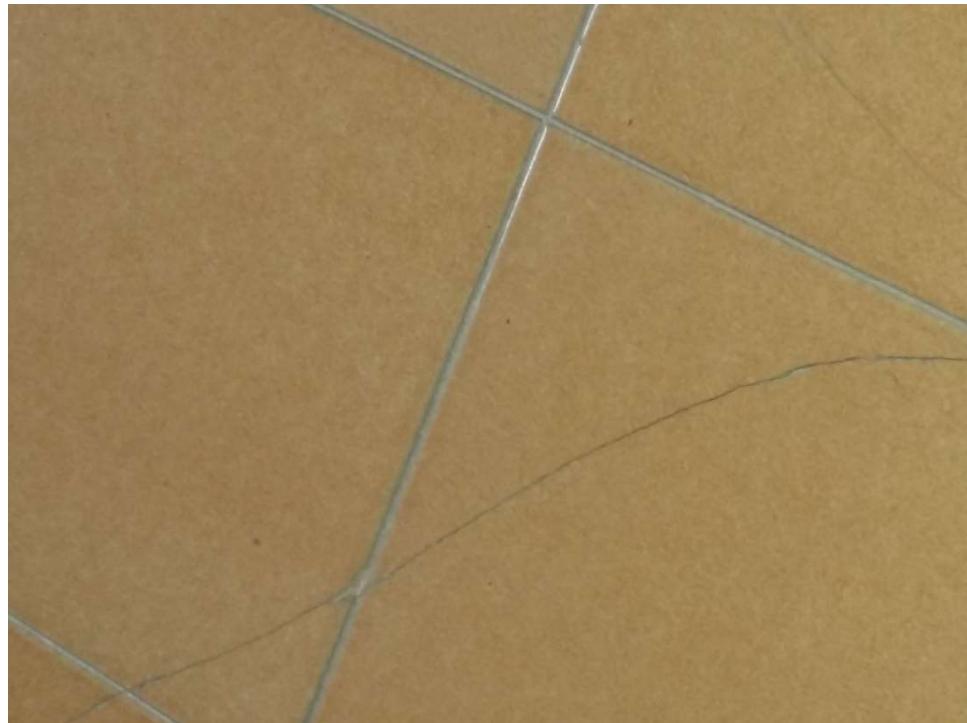
## THE NOVITiate

Particularly, the main portion, that which overlooks Via Malintoppa, highlights an overturning mechanism, well underlined by the crevices visible in the corridor and in the cells of the overlying Novitiate.

Besides, the external part of the same Novitiate, overlooking north-east, seems to have suffered diagonal lesions on the walls of the corridor; such lesions would seem to be caused by the excessive height of the wall that lacks any horizontal connection. This part of the building requires urgent intervention because it is to be considered at risk in case of new seismic phenomena.
