Report No. : APTX26124  
 Issued date : 21 May 2026  
 NSK Asia Pacific Technology  
 Centre (Thailand) Co., Ltd.  
 Approved by : T. Ikeda 5/21 T.Ikeda  
 Checked by : E. Watanabe E. Watanabe  
 : C. Pastraporn Pastraporn  
 Prepared by : T. Theera T. Theera

## Investigation Report of Returned Front Wheel Bearing from Indonesia

These hub bearings were returned from Indonesian market due to abnormal noise. NSK-APTC has performed an investigation to find out the cause of trouble.

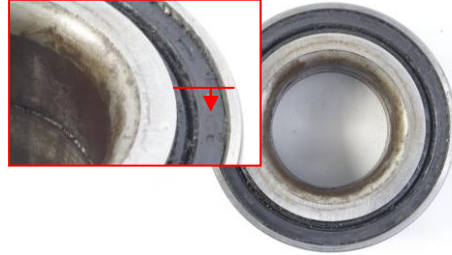
**Condition as received : Outboard**  
Bearing was returned in complete condition.  
Seal out of position from dismounting process was found since received.  
Rough hand rotating feeling was found.

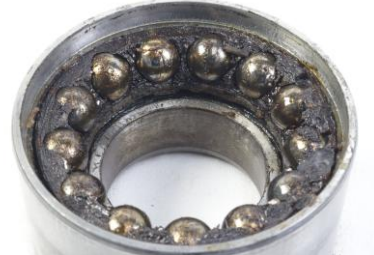
**Internal condition : Outboard**  
Grease color had changed but base oil remained enough.

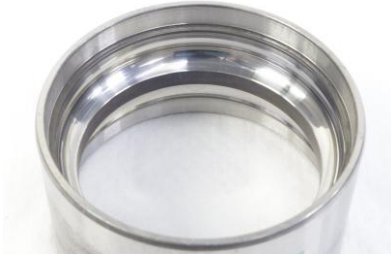
**Outer ring condition : Inboard**  
No abnormality was found.

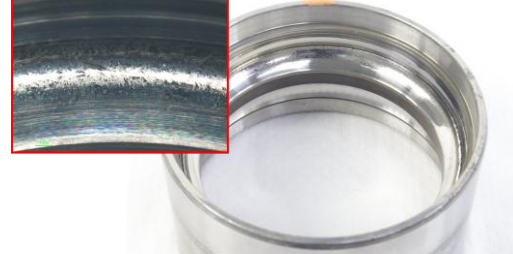
**Outer ring condition : Outboard**  
Indentation was found on raceway.

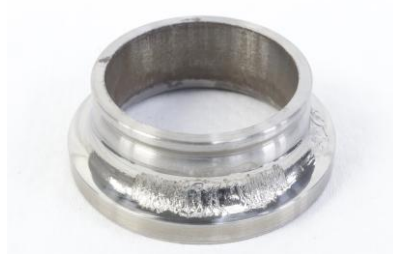
- Group D, 4 bearings : Bearing No. 1L, 3L, 4R and 5R.  
 : Flaking was found on raceway. Hence the vehicle noise was caused by this failure. Also high moisture content in grease was found.  
 This type of flaking is typically generated by water penetration.

**Inner ring condition : Outboard**  
Flaking was found on raceway.

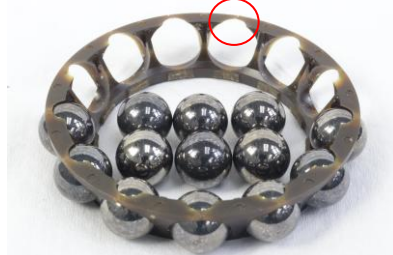
**Balls and cage condition : Outboard**  
Indentation was found on balls surface.  
Breakage was found on cage.

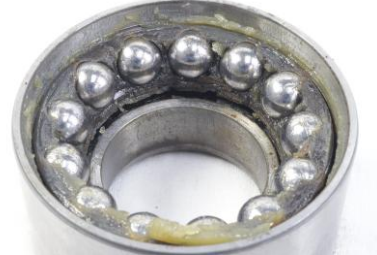
**Internal condition : Inboard**  
Grease color had changed but base oil remained enough.

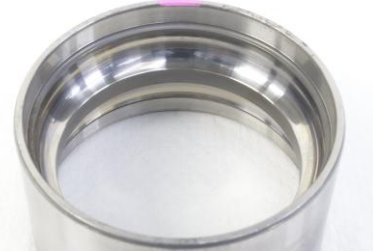
**Outer ring condition : Outboard**  
No abnormality was found.

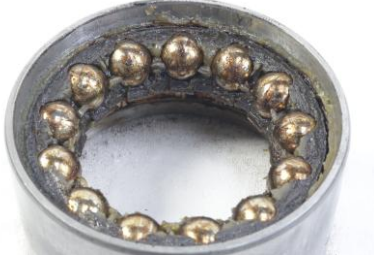
**Condition as received : Inboard**  
Bearing was returned in complete condition.  
Rough hand rotating feeling was found.

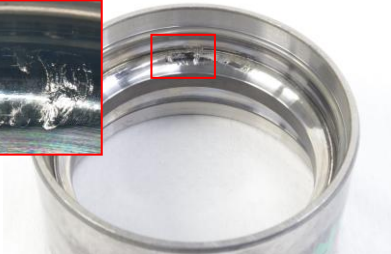
**Outer ring condition : Inboard**  
Flaking was found on raceway.

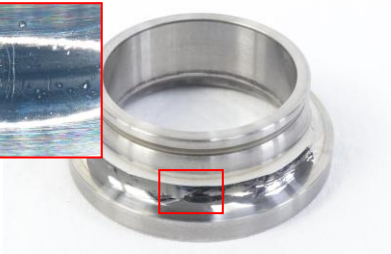
**Inner ring condition : Inboard**  
Flaking was found on raceway.

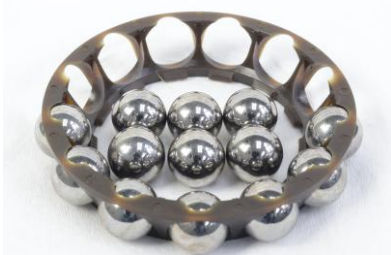
**Balls and cage condition : Inboard**  
Indentation was found on balls surface.  
No abnormality was found on cage.

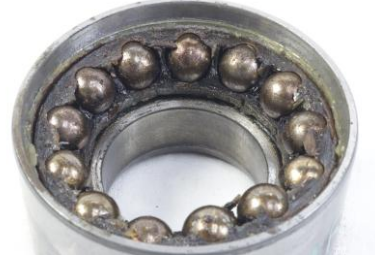
**Condition as received : Outboard**  
Bearing was returned in complete condition.  
Rough hand rotating feeling was found.

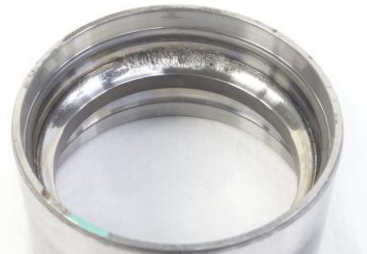
**Outer ring condition : Outboard**  
Flaking was found on raceway.

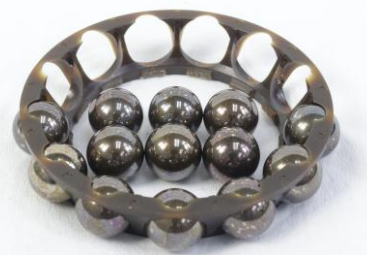
**Balls and cage condition : Outboard**  
Indentation was found on balls surface.  
No abnormality was found on cage.

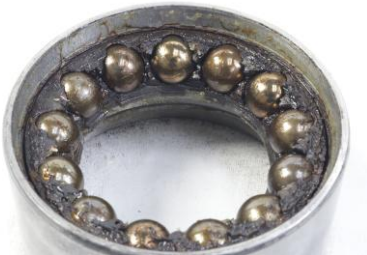
**Condition as received : Outboard**  
Bearing was returned in complete condition.  
Seal out of position from dismounting process was found since received.  
Smooth hand rotating feeling was found.

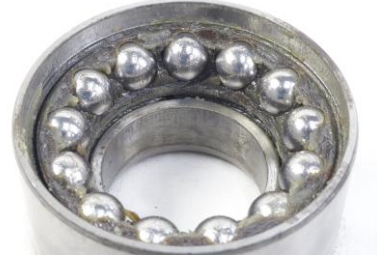
**Internal condition : Inboard**  
Grease color had changed but base oil remained enough.

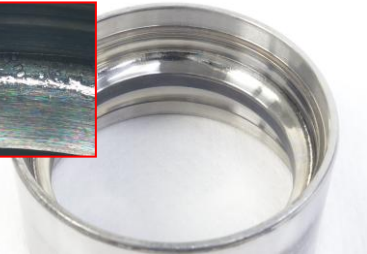
**Outer ring condition : Inboard**  
Indentation was found on raceway.

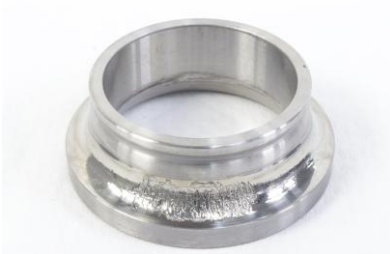
**Inner ring condition : Inboard**  
Flaking was found on raceway.

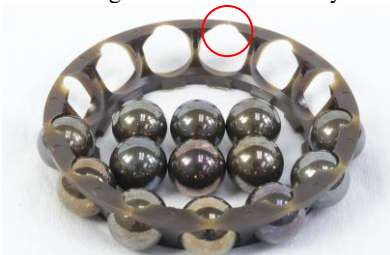
**Balls and cage condition : Inboard**  
Indentation was found on balls surface.  
Breakage was found on cage.

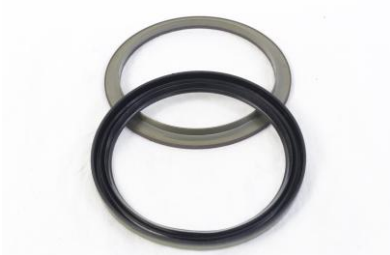
**Balls and cage condition : Outboard**  
No abnormality was found.

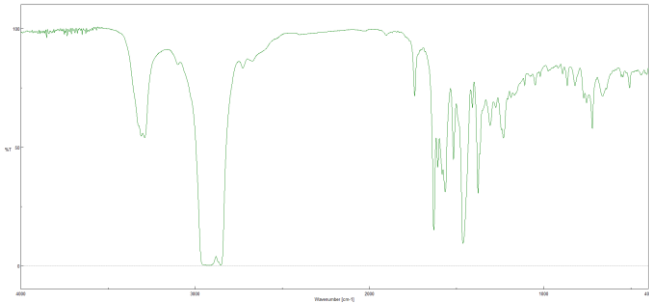
### Bearing No. 1L

Spectrum of grease sample from inboard side.

- No abnormality was found.

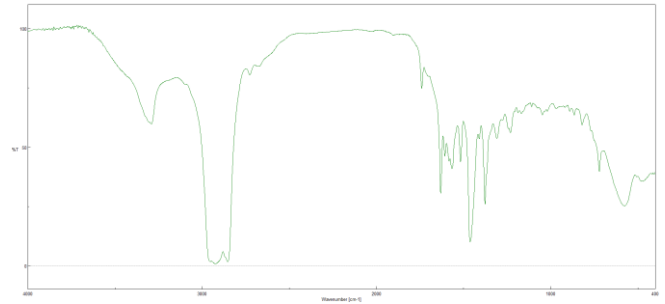
Spectrum of grease sample from outboard side.

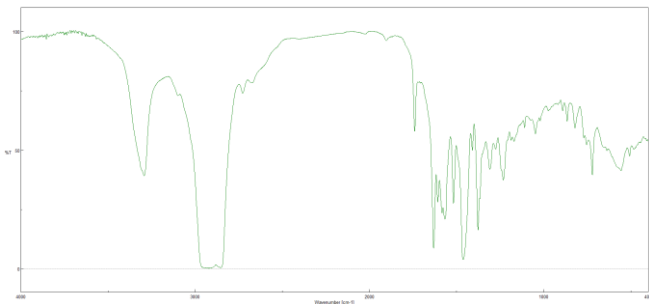
### Bearing No. 3L

Spectrum of grease sample from inboard side.

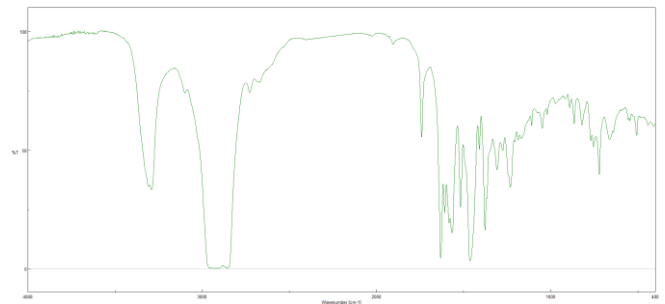
Spectrum of grease sample from outboard side.

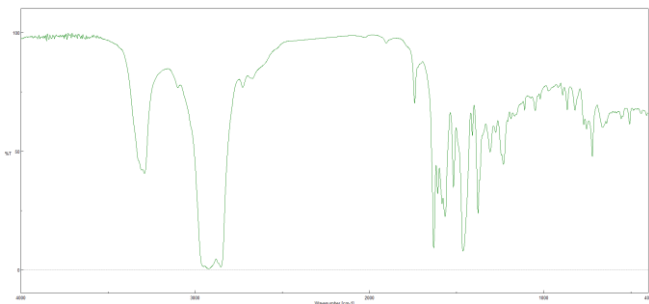
### Bearing No. 4R

Spectrum of grease sample from inboard side.

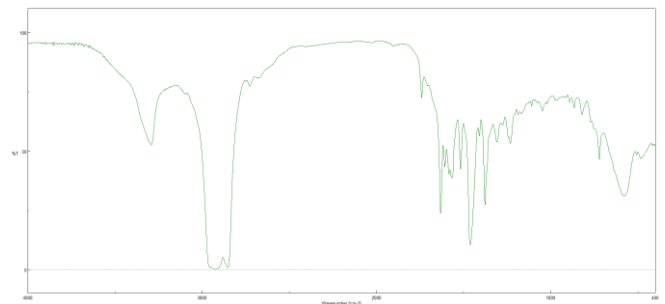
Spectrum of grease sample from outboard side.

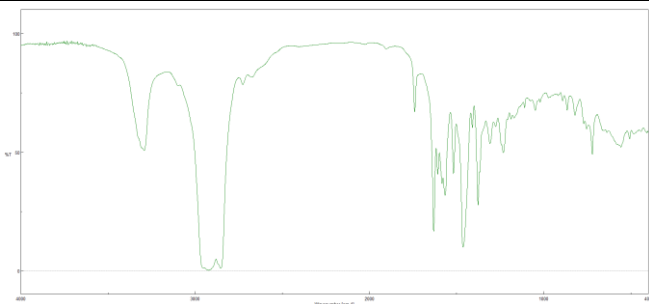
### Bearing No. 5R

Spectrum of grease sample from inboard side.

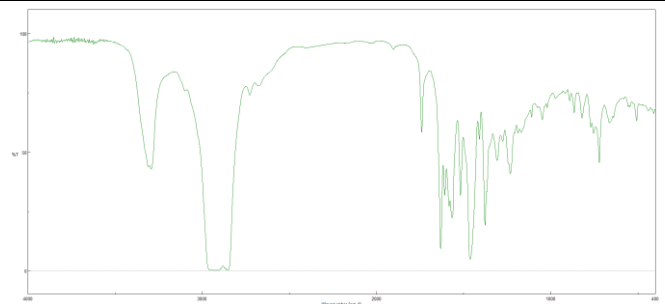
Spectrum of grease sample from outboard side.
