To : P.T. Honda Prospect Motor

Report No. : APTX26124  
 Issued date : 21 May 2026  
 NSK Asia Pacific Technology  
 Centre (Thailand) Co., Ltd.  
 Approved by : T. Ikeda  
 Checked by : E. Watanabe  
 : C. Pastraporn  
 Prepared by : T. Theera

## Investigation Report of Returned Front Wheel Bearing from Indonesia

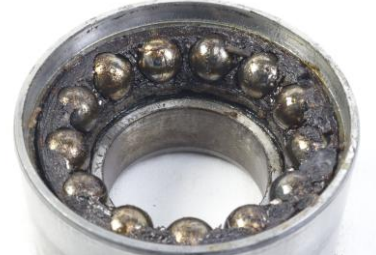
**Internal condition : Inboard**  
Grease color had changed but base oil remained enough.

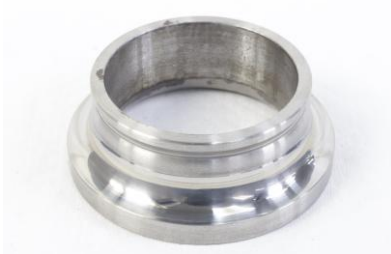
**Outer ring condition : Outboard**  
Indentation was found on raceway.

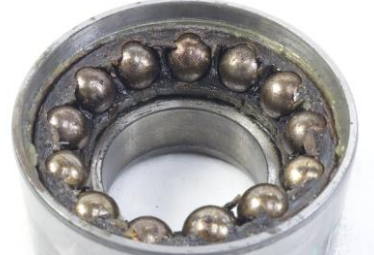
**Internal condition : Inboard**  
Grease color had changed but base oil remained enough.

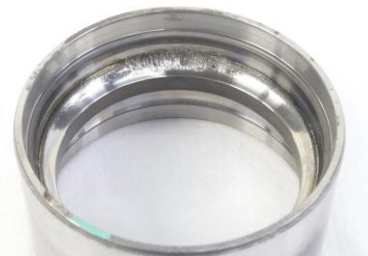
**Outer ring condition : Inboard**  
Flaking was found on raceway.

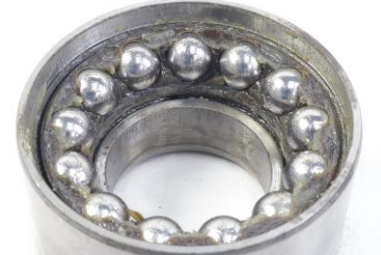
**Internal condition : Inboard**  
Grease color had changed but base oil remained enough.

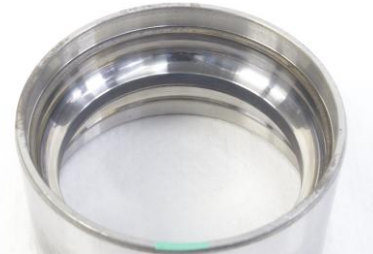
**Outer ring condition : Inboard**  
Indentation was found on raceway.

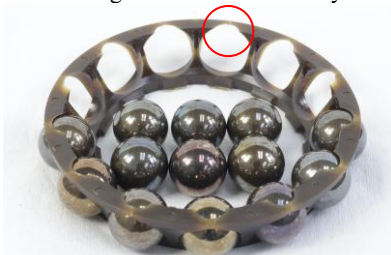
**Inner ring condition : Outboard**  
No abnormality was found.

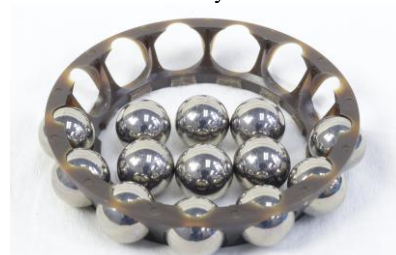
**Balls and cage condition : Inboard**  
Indentation was found on balls surface.  
Breakage was found on cage.
