# (Post-construction)

## Envelope Leakage Test

Project ID: 25-0305 - Robert Morrison - 358  
High St  
Address: 356 High St  
Belfast, ME 04915  
Year Built: 1994  
Geo-Tag Latitude:  
Data: Longitude:  
Timestamp:

# (Pre-construction, Baseline)

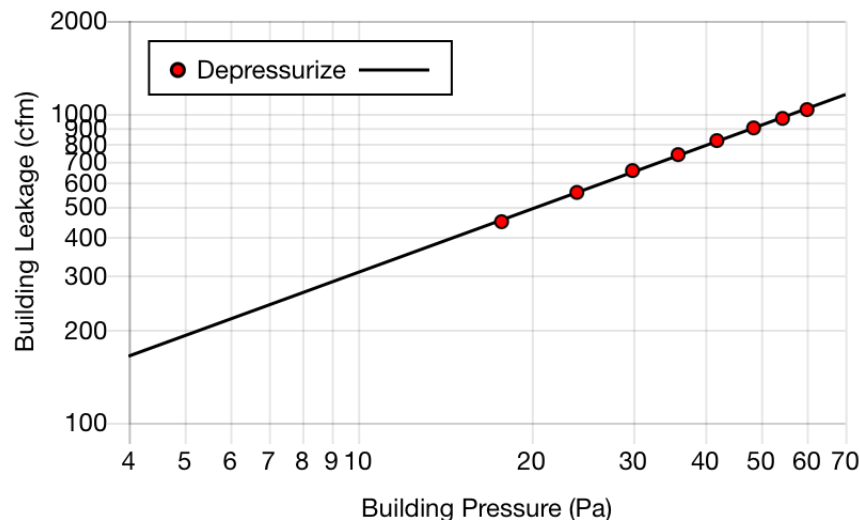
**Measured Leakage: 1.74 ACH50**  
**Leakage Target: 3.00 ACH50**  
**Compliance with Leakage Target: Pass**

| Measured CFM50: | 917.9 (+/- 1.0%) | Effective Leakage Area: 46.6 in <sup>2</sup> |
| Coefficient (C): | 63.9 (+/- 7.3%) | Exponent (n): 0.681 (+/- 0.020) |

Test Conditions: Volume includes crawlspace and attic. Tested both units at once from mechanical access area which at this time of the test was well connected to both units. Interior doors open, windows closed and locked. ERV and plumbing traps taped off, except for one sink which we missed.

Comments: Great job! A big improvement from the original building envelope.

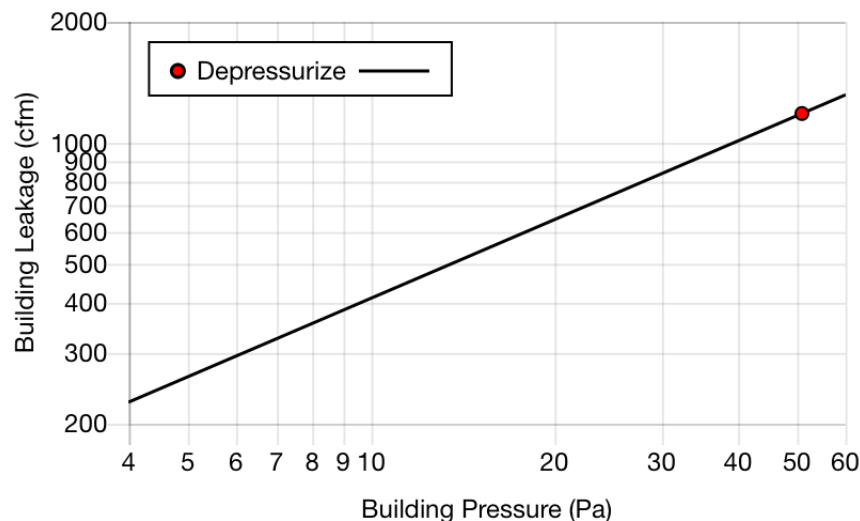
### Measured Leakage: 3.68 ACH50

| Measured CFM50: | 1,168.7 | Effective Leakage Area: 64.3 in <sup>2</sup> |

Test Conditions: Tested house as-is. Volume includes crawlspace. Tested both units at once with all interior doors open. Nothing taped off.
