ROSEN	CAT.:	REPORT	Nº DOC.:	I-RL-3100-970-ROS-007
	ÁREA DE ATIVIDADE:	TRANSP. BRAS. GASODUTO BOLÍVIA-BRASIL	FOLHA:	1 de 96
	INSTALAÇÃO:	TRECHO CORUMBÁ - PAULÍNIA		
	SERVIÇO:	INSPEÇÃO, MANUTENÇÃO E TESTES		
TÍTULO:		FFP ASSESSMENT REPORT – PENÁPOLIS TO SÃO CARLOS

FFP ASSESSMENT REPORT

32" NATURAL GAS PIPELINE

PENÁPOLIS – SÃO CARLOS

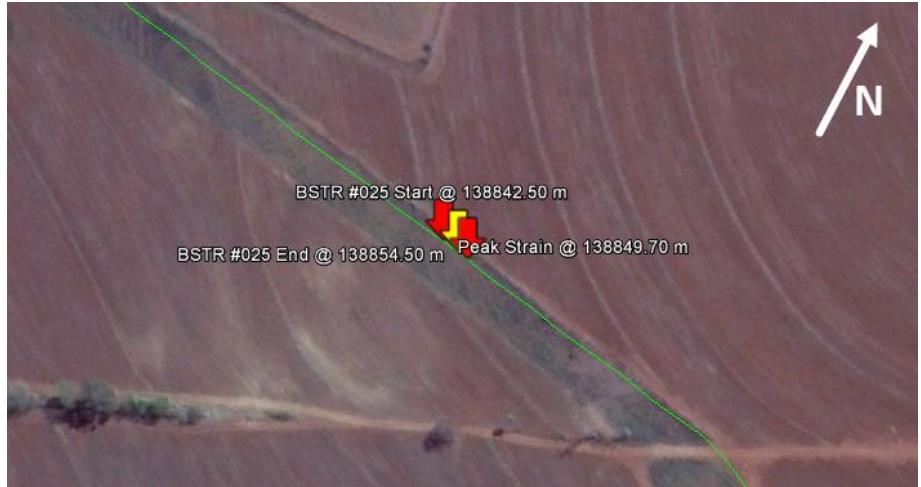
<h3 style="text-align: center;">Bending Strain Area #025</h3>

Orientation	Vertical	Maximum Strain	0.42%
Topography and Bending Strain Description	<p>The pipeline is routed through flat agricultural land adjacent to multiple fields.</p> <p>The maximum point of strain is located at log distance 138849.7 m and is attributable to vertical over bending adjacent to a girth weld located approximately 1.5 m downstream (log distance 138851.560 m). The bending strain appears to be related to a fabricated over bend at the location of the weld, on this basis the area is considered to be a construction irregularity.</p> <p>There is no evidence of external loading at this location and it is considered the vertical bending strain is derived from the pipeline construction.</p>		
Conclusions	<p>The bending strain appears to be related to a fabricated over bend at the location of a weld (construction irregularity). There is no evidence of external loading at this location and it is considered the bending strain is derived from the pipeline construction. Area to be reviewed following next inspection.</p>

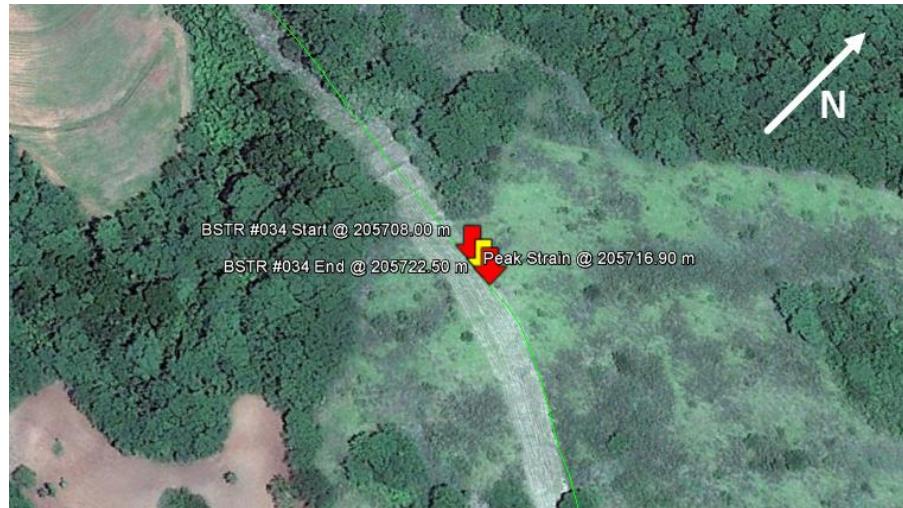
Bending Strain Area #034

Orientation	Vertical	Maximum Strain	0.49%
Topography and Bending Strain Description	<p>The pipeline crosses a shallow ridge between agricultural fields.</p> <p>The maximum point of strain is located at log distance 205716.9 m and is attributable to an over bend adjacent to a weld at log distance 205717.047 m. The bending strain appears to be related to a fabricated over bend at the location of the weld, on this basis the area is considered to be a construction irregularity.</p> <p>There is no evidence of external loading at this location and it is considered the vertical bending strain is derived from the pipeline construction.</p>		
Conclusions	<p>The bending strain appears to be related to a fabricated over bend at the location of a weld (construction irregularity). There is no evidence of external loading at this location and it is considered the bending strain is derived from the pipeline construction. Area to be reviewed following next inspection.</p>
