**ROADWAY ASSESSMENT REPORT  
FOR THE  
VILLAGE OF IRVINGTON  
PUBLIC WORKS DEPARTMENT**

**JAMES J. HAHN ENGINEERING, P.C.  
PUTNAM BUSINESS PARK  
1689 ROUTE 22  
BREWSTER, NEW YORK 10509**

**May, 2019**

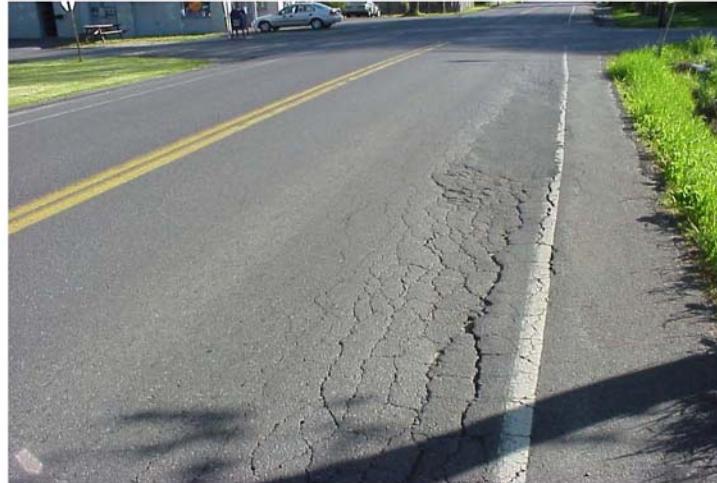
## Alligator Cracking

Typical alligator cracking is composed of frequent interconnected cracks. The distress is load-related, so it is identified only when present in the wheelpath of a full-depth asphalt pavement.

The longitudinal crack in this photo qualifies as alligator cracking even though it lacks the interconnected cracking. The crack is in the early stages of development, but still represents a load-related distress because it occurs in the wheelpath.

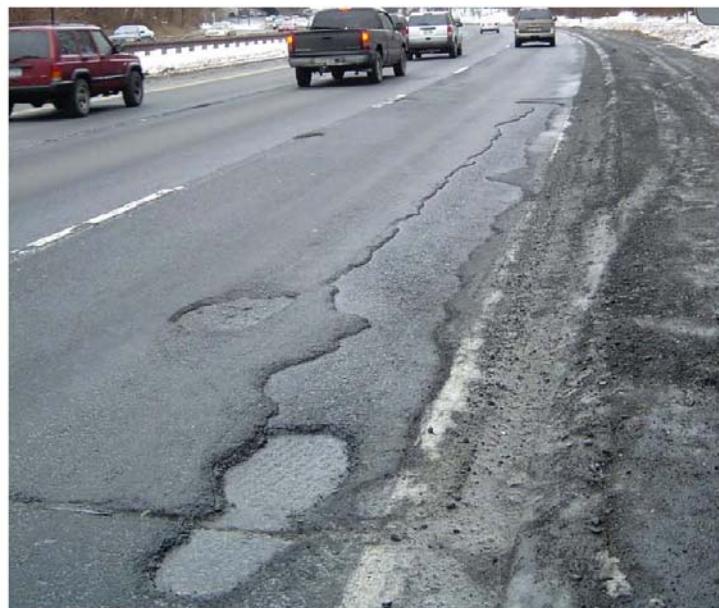
## **Delamination**

Delamination occurs when an overlaid pavement loses the bond to the underlying layers and becomes dislodged. This distress is not identified directly in the NYSDOT survey, so when it is observed, the delaminated areas should be considered the same as cracking distress.

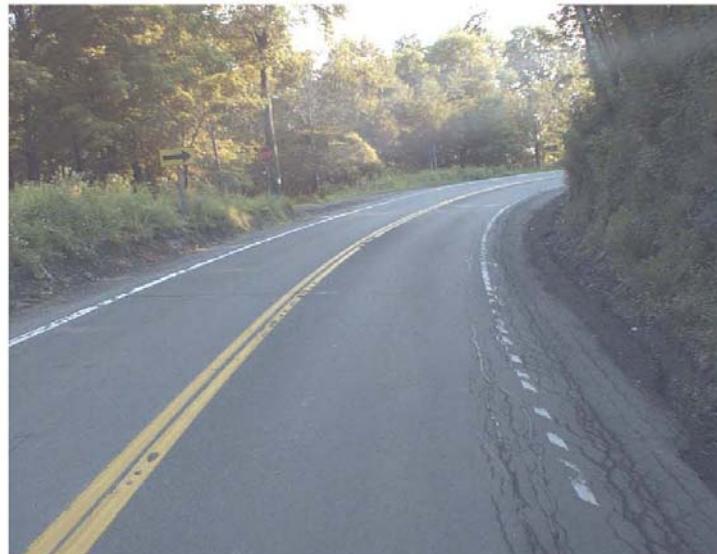
Widening dropoff occurs when an old concrete pavement is widened with an asphalt overlay. The dissimilar base materials settle relative to each other, causing a dropoff at the edge of the underlying slab.

The widening dropoff dominant distress is identified as "low" severity (photo at right) when the cracking at the drop becomes well developed.

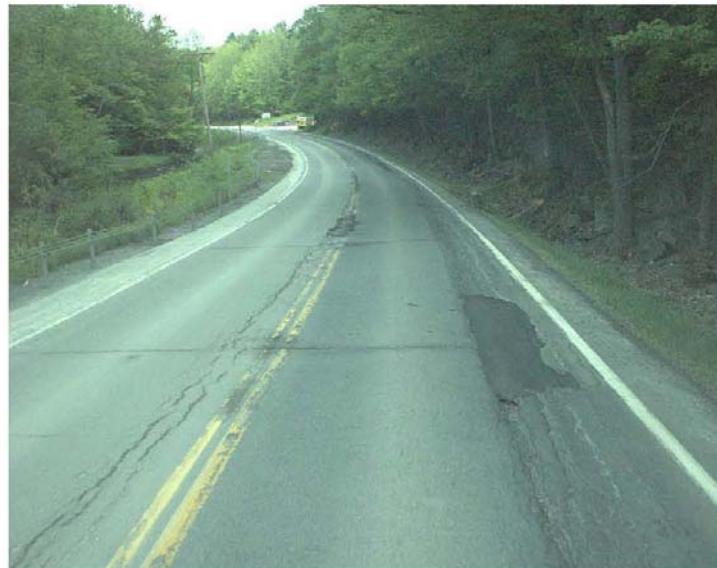
The distress is identified as "high" severity (photo at right) when the effect of the height difference can be detected when driving across the drop, or has the potential to influence the track of a vehicle.

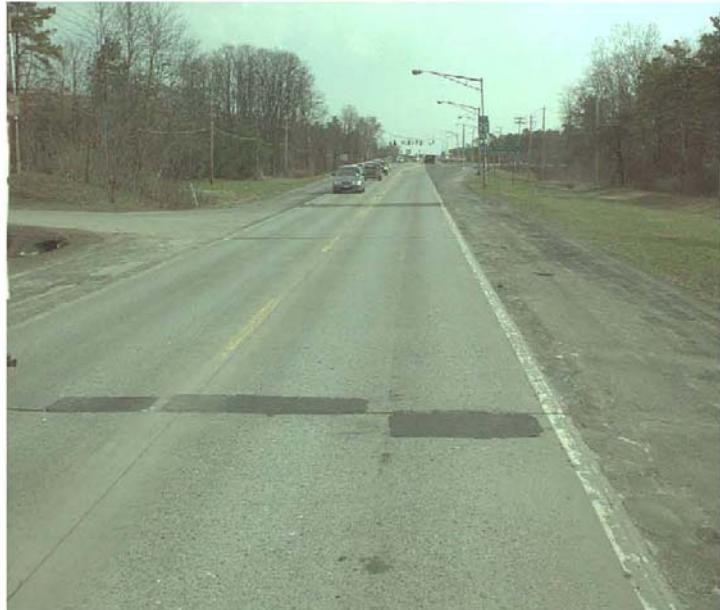
## **Temporary Patching**

Temporary patching, such as "throw and go" patches, do not repair the structural damage in the pavement and therefore are counted as distress. These patches can be identified by their rounded, random shapes.

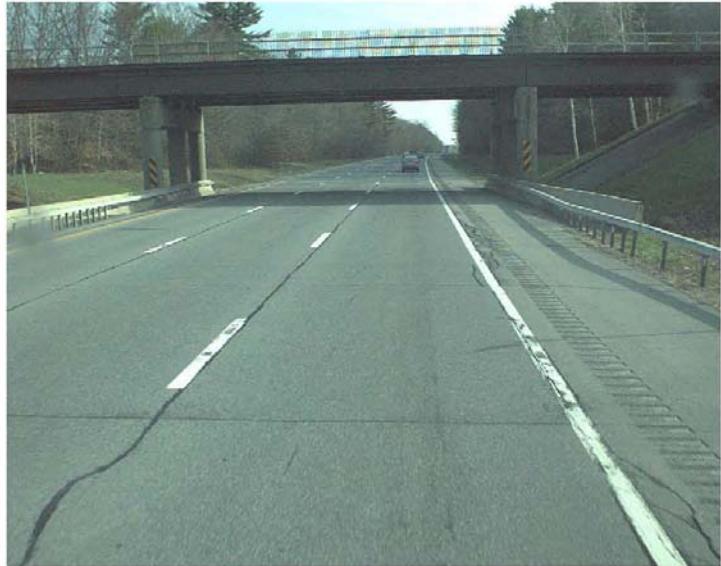
## **Crack Seal**

Crack seal is an effective preventive maintenance activity that helps keep water out of the pavement structure. When a pavement is crack sealed, the sealant tends to highlight the cracks, which could make the pavement look worse and cause a decrease in the rating. Roads that are crack sealed should be given the same rating as the prior year until the continued development of the cracking extends beyond the sealed areas.

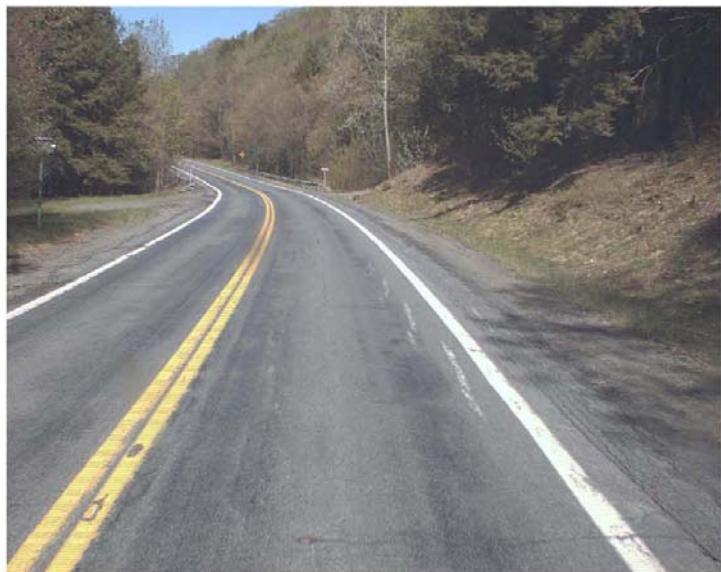
## **Flushing**

Flushing occurs when excess liquid asphalt material rises to the surface of the pavement. This distress is not identified directly in the NYSDOT survey, but should be reported separately to the Resident Engineer and/or the Regional Materials Engineer, as it may present an urgent safety condition.

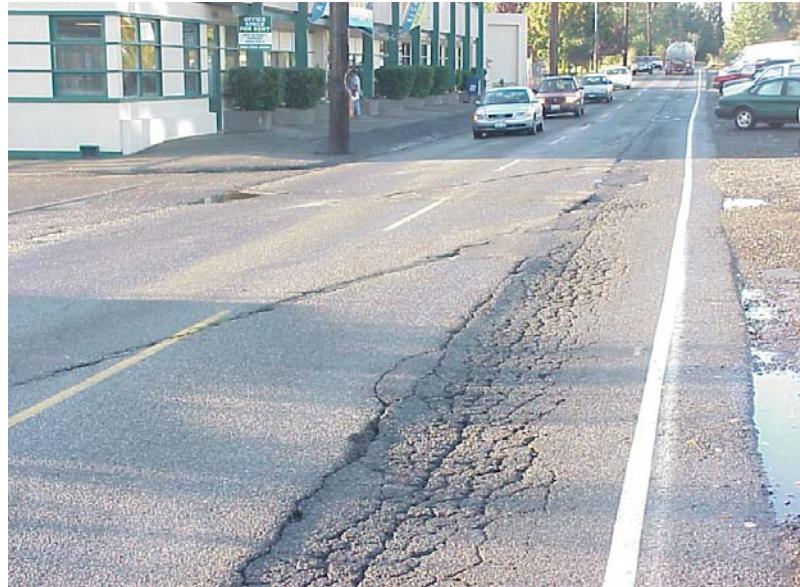
## Wheel Path Rutting

Wheel path rutting is caused by Heavy trucks, slow traffic, stopping and standing traffic and poor aggregate. This causes permanent deformations of the pavement (indentations) in the wheel paths, which can lead to cracking and further deterioration. Most common in intersections, where there is braking and stopping traffic.

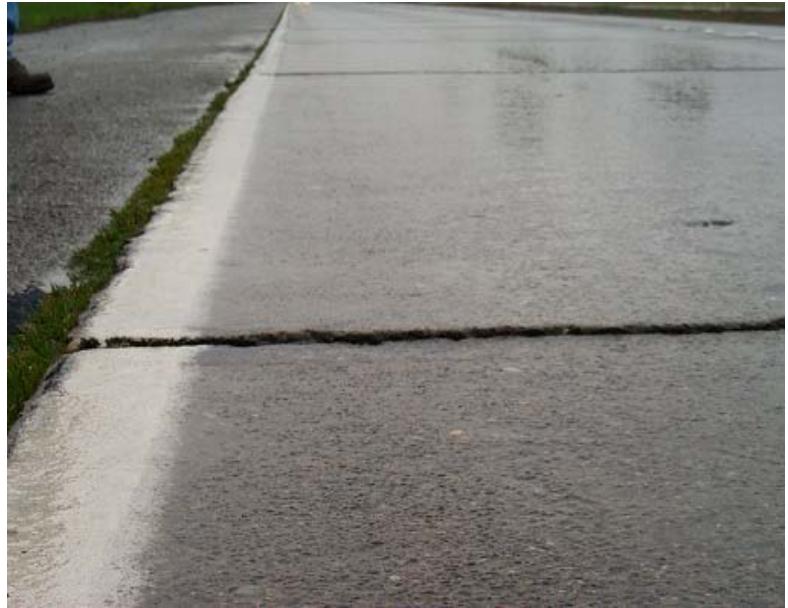
## **Settlements and Heaves**

This is described as localized pavement surface areas having elevations slightly lower than surrounding pavement or localized upward displacements of the pavement surface. Settlements are caused by failure in the lower pavement layers while heaving is caused by expansive soils, typically from water freezing within the soils during winter months.

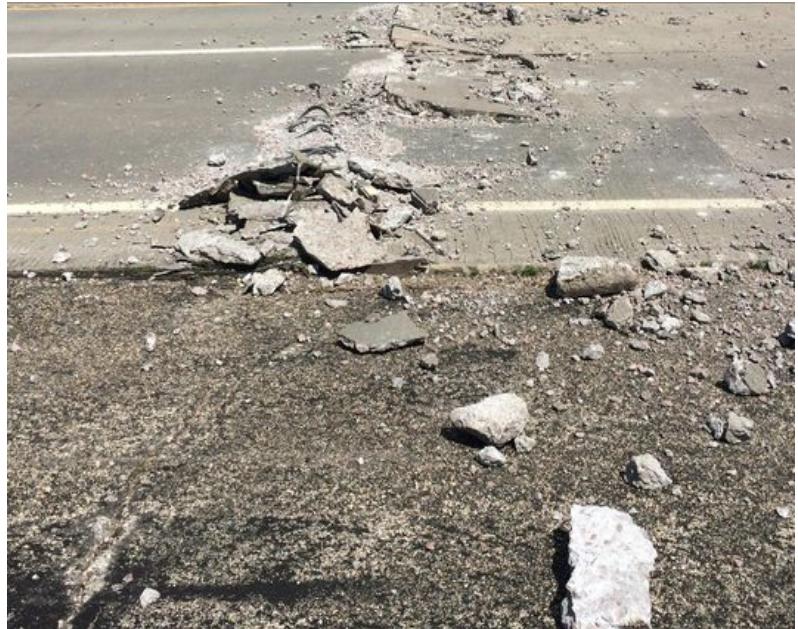
## **Blowups**

Blowups are caused by compression stresses resulting from heat and water, and they generally occur at a joint or crack. It is known that intrusion of foreign material, water, and chemical deicing solution into joints and cracks causes extensive damage to rigid pavements. The intrusion of incompressible soils into the joint space causes even greater problems.

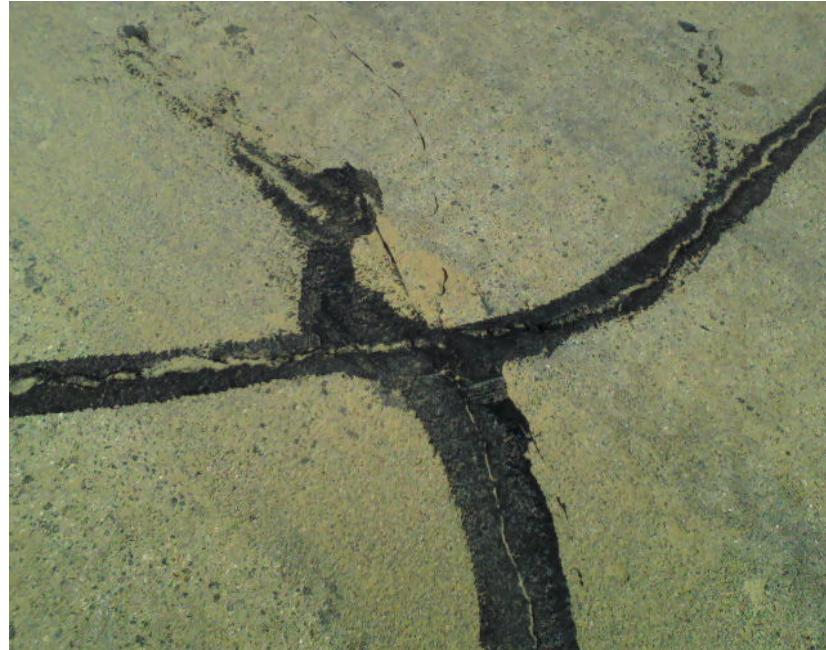
## **Joint Sealer Failure**

Liquid sealer failure is characterized by loss of bond between the sealer and the joint faces, internal tearing within the sealer itself and /or entrapment of incompressibles within the sealer matrix and/or loss of sealer from the joint. Preformed neoprene sealer failure is characterized by loss of recovery from a compressed state and/or internal web sticking allowing the infiltration of water or incompressibles into the joint.

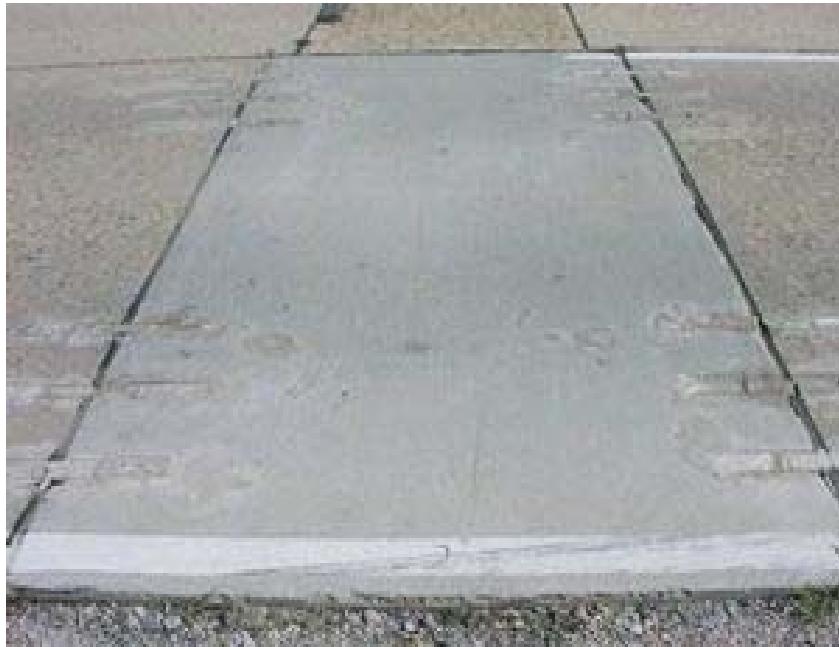
## **Transverse/ Logitudinal Joint Faulting/ Separation/ Distress**

Transverse joint faulting is caused by a differential vertical displacement of abutting slabs at joints or slab cracks creating a step deformation on the pavement surface. Faulting is caused by the loss of fine material under a slab and the increase in fine material under nearby slabs. This flow of fine material is called pumping, and is caused by the presence of high levels of free moisture under a slab carrying heavy traffic loading

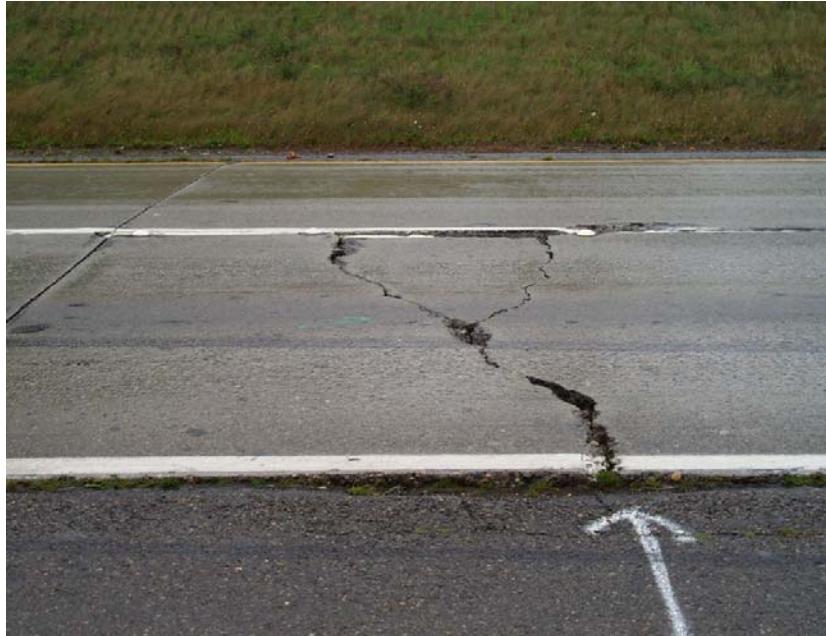
## **Slab Cracking**

A crack or cracks within a pavement slab that propagate in any direction. Cracks may vary from hairline to more than one inch in width. Slab cracks are caused by shrinkage or curing stresses early on in the life of the slab. Cracks later in the slabs life can be caused by environmental and load bearing stresses. The loss of the sub base support along with excessive loading can cause slab cracking.

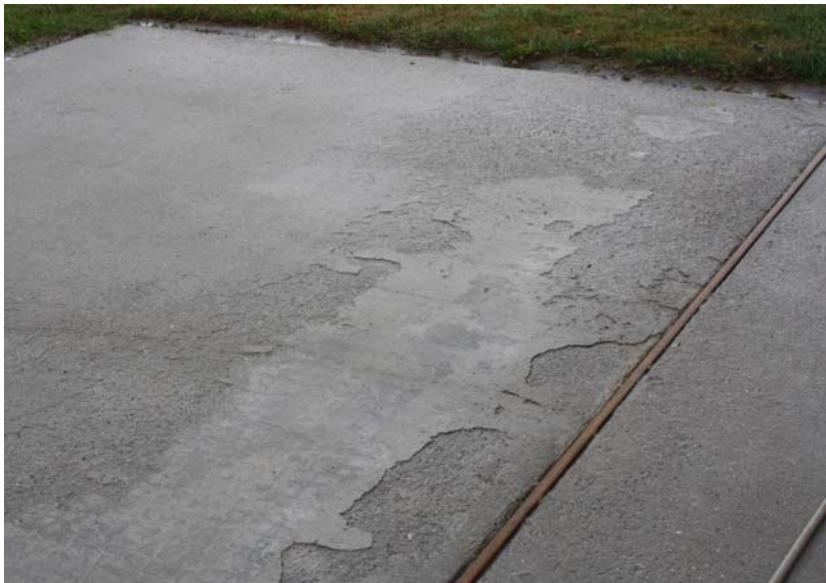
## **Scaling non-Joint Spalling**

Scaling are irregularities in the pavement slab surface other than those occurring at joints and characterized by popouts and/or spalling. These distress types may be patched with asphalt. Scaling is caused by excessive water used in finishing the concretes surface or lack of proper amount of entrained air, in combination with freezing and thawing.

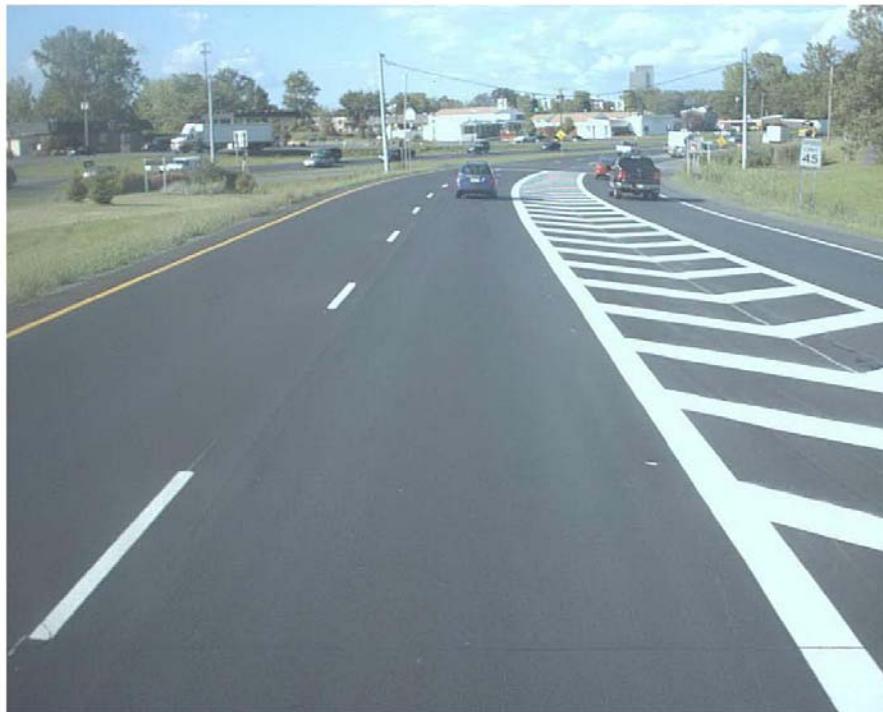
**9**  
Excellent

No  
Distress

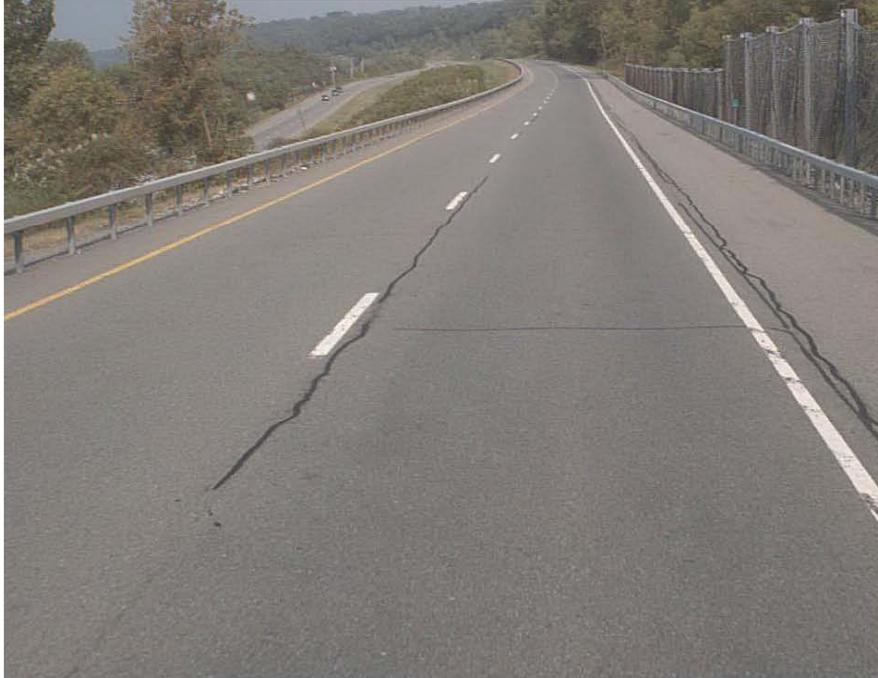
**8**  
**Good**

Infrequent

Slight

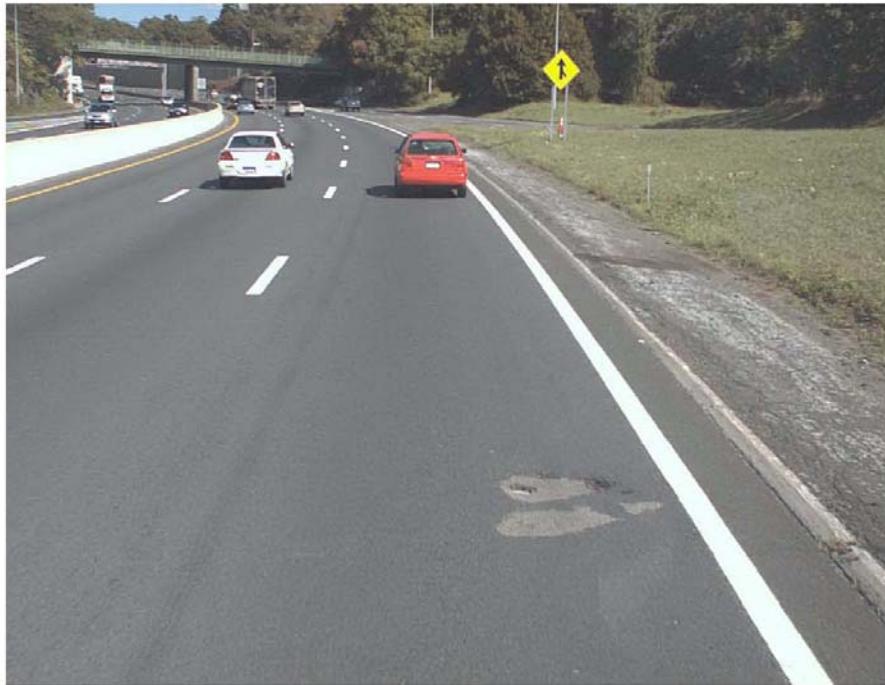
**8**  
Good

Infrequent  
to  
Occasional

Slight

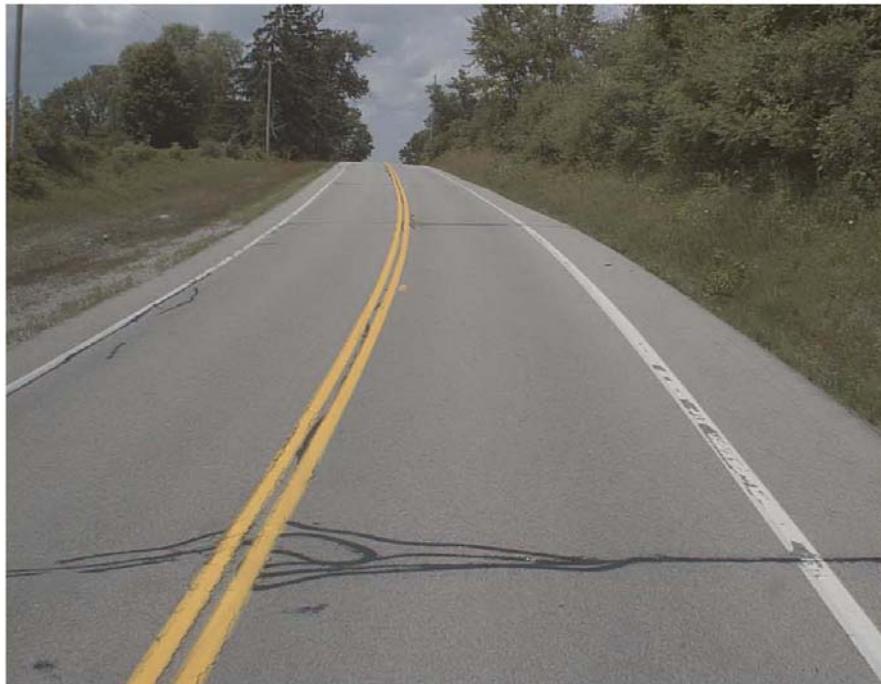
**7**  
**Good**

Infrequent  
to  
Occasional

Minor

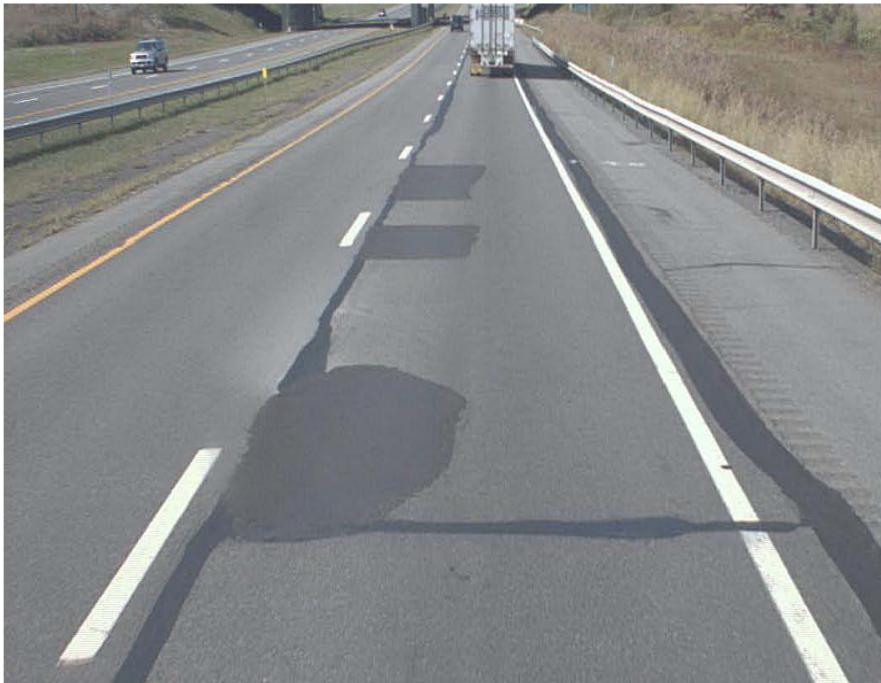
**7**  
Good

Infrequent

Severe

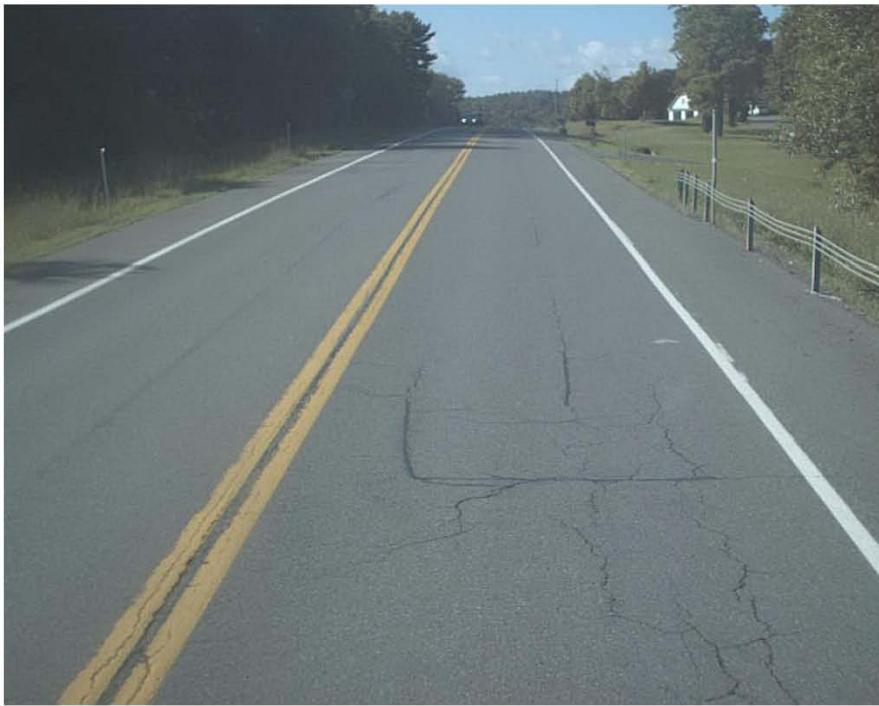
**7**  
**Good**

Infrequent  
to  
Occasional

Moderate

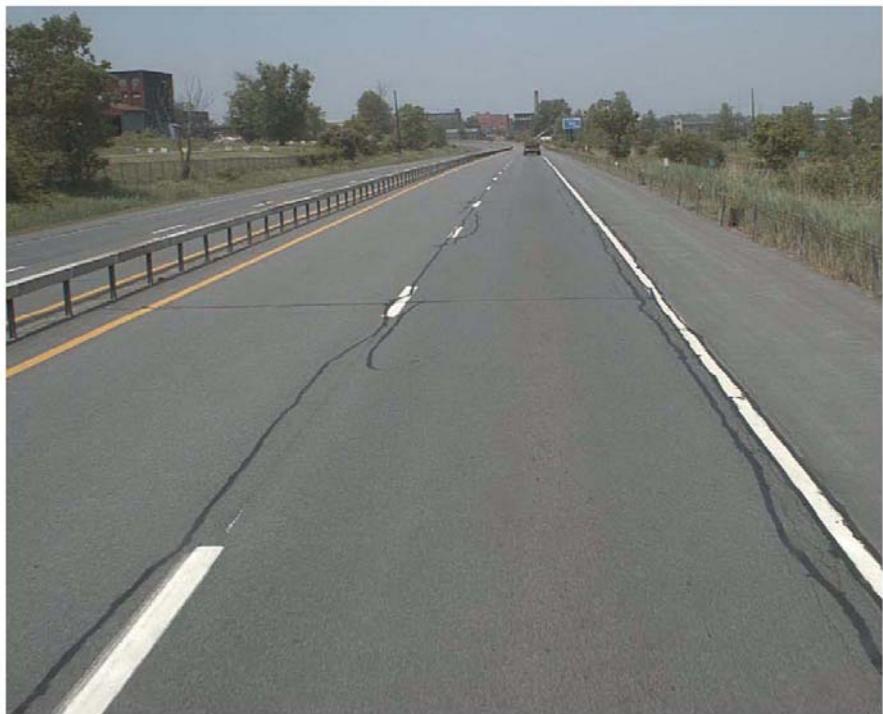
**7**  
**Good**

Occasional  
to  
Frequent

Minor

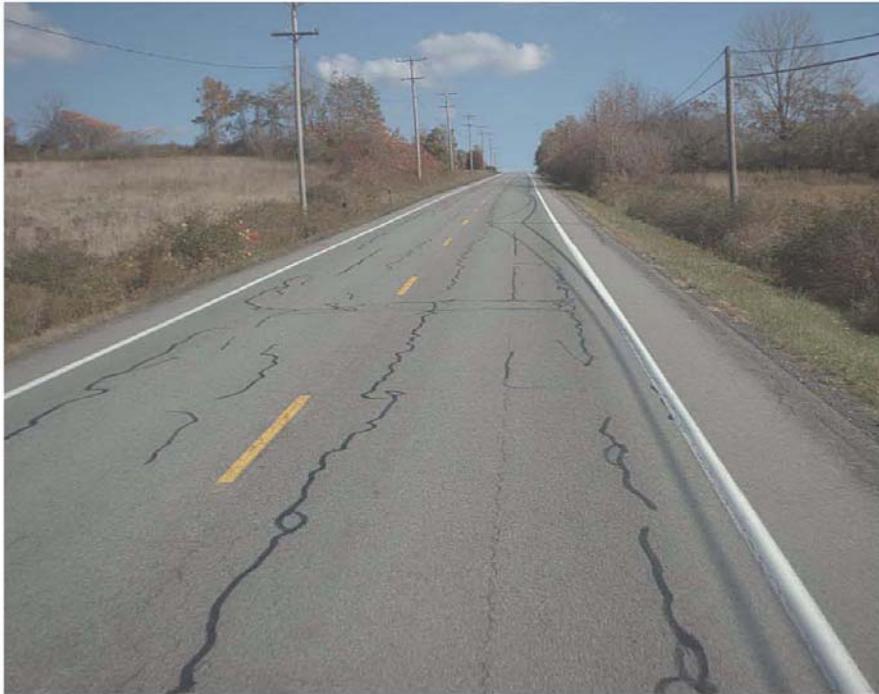
**6**

Fair

Frequent

Minor

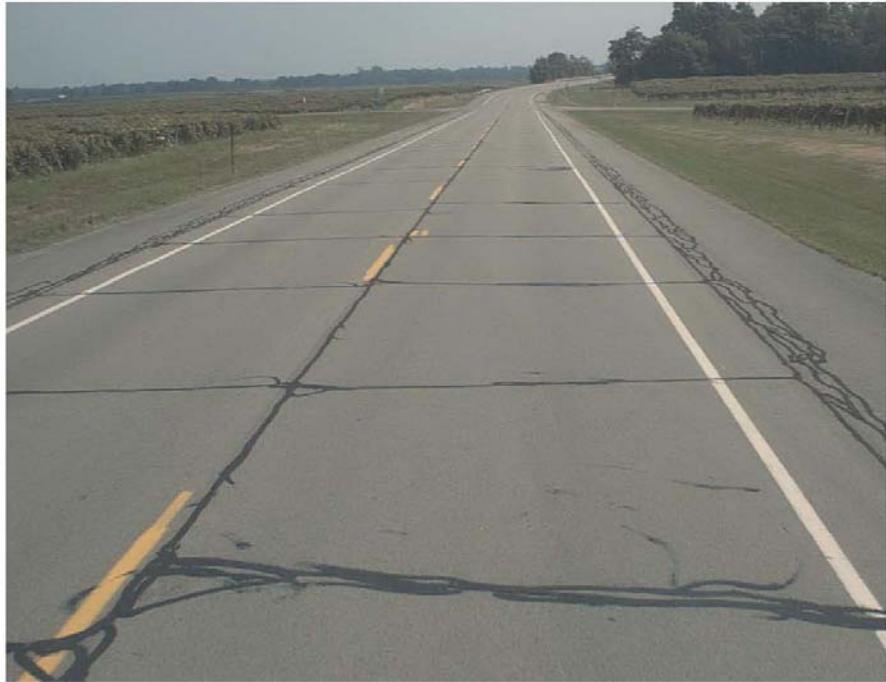
**6**

Fair

Very  
Frequent

Slight

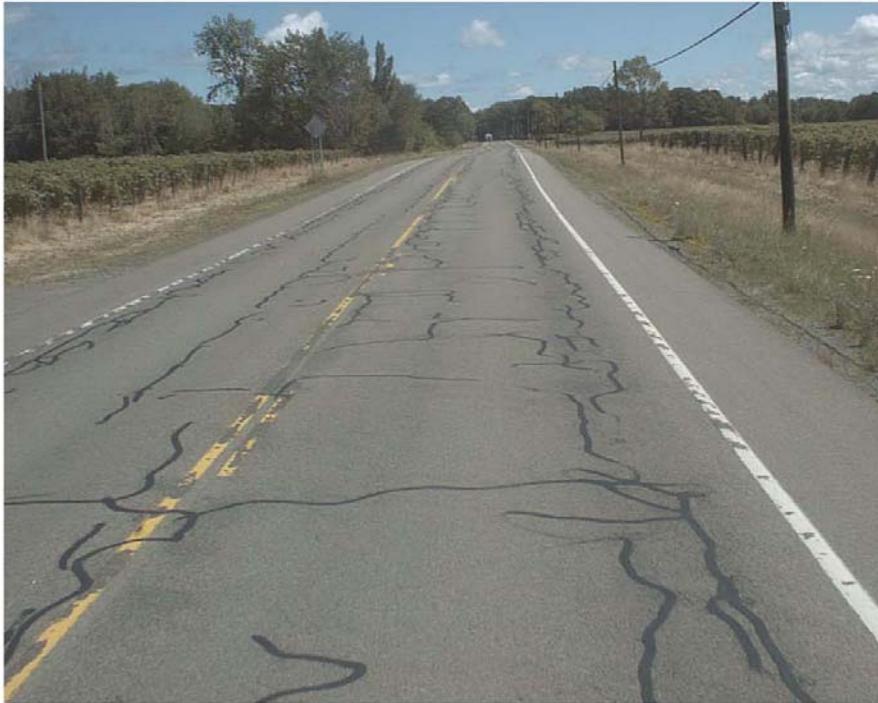
**6**

Fair

Very  
Frequent

Minor

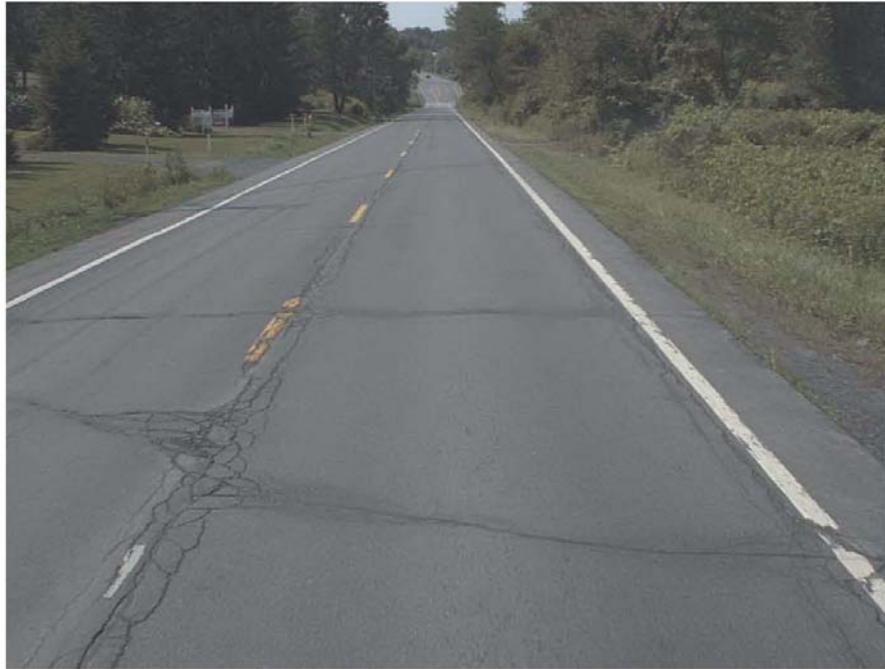
**6**

Fair

Infrequent  
to  
Occasional

Severe

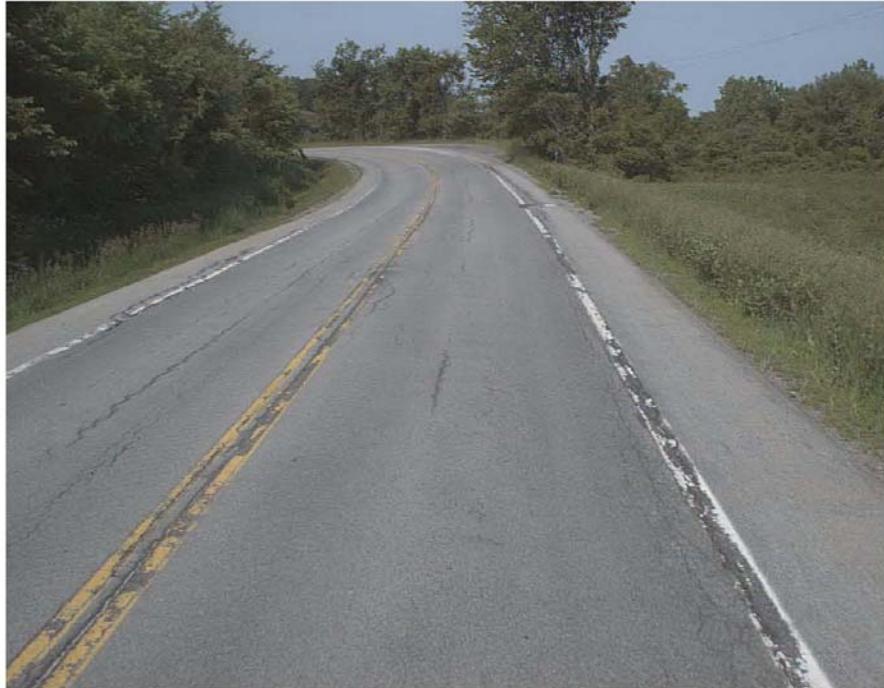
**6**  
Fair

Frequent

Moderate

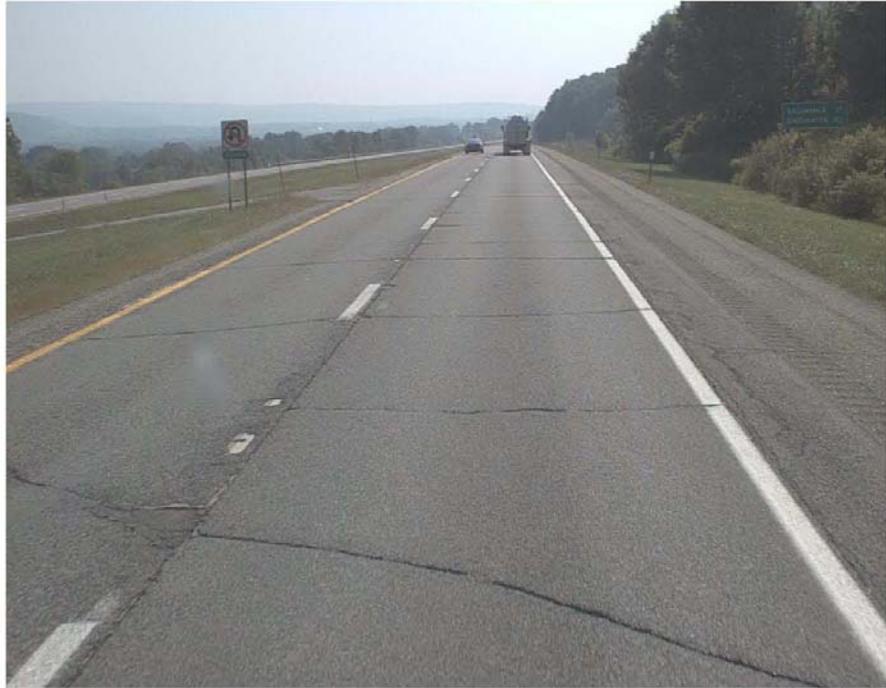
**6**

Fair

Frequent

Moderate

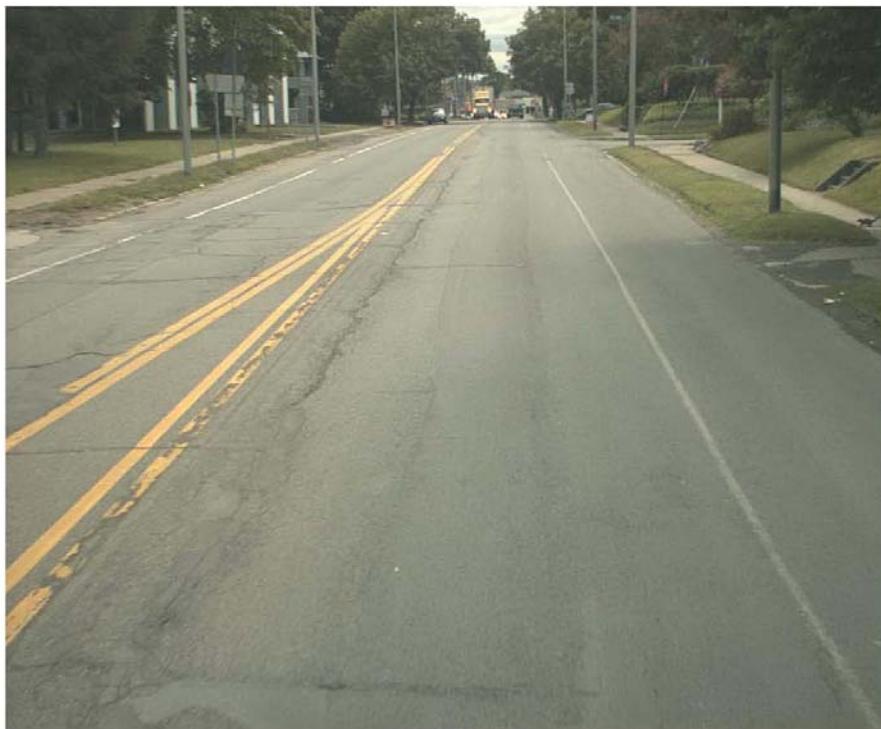
**5**  
Poor

Frequent

Moderate  
to  
Severe

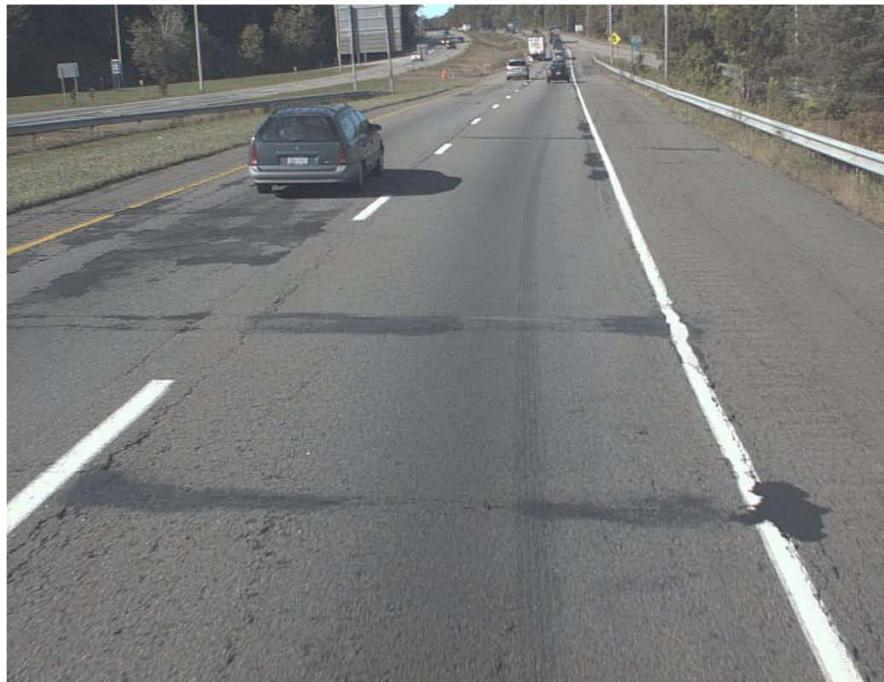
**5**

Poor

Very  
Frequent

Moderate

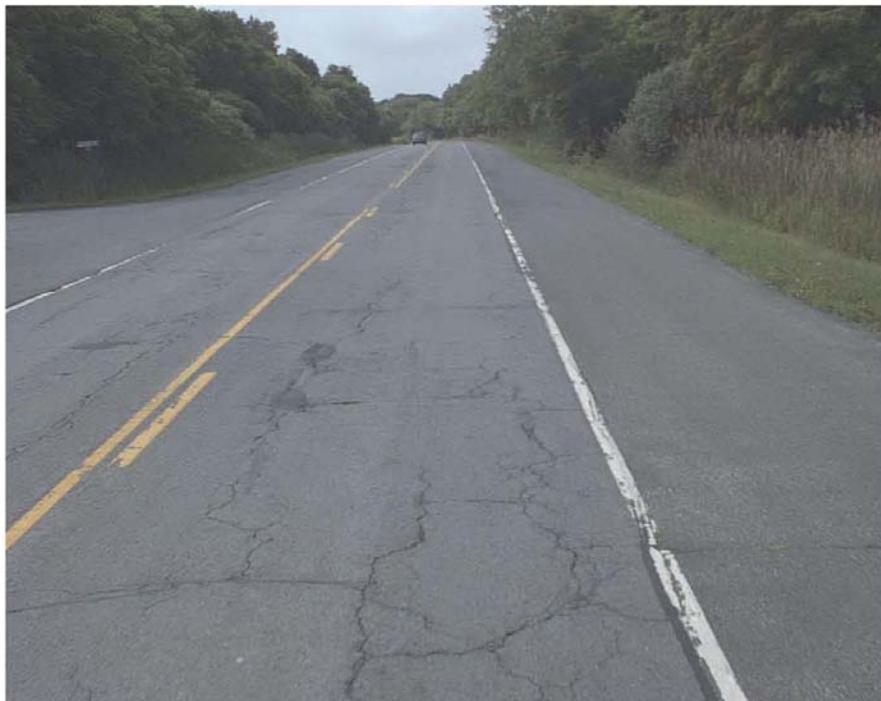
**5**  
**Poor**

Very  
Frequent

Moderate  
to  
Severe

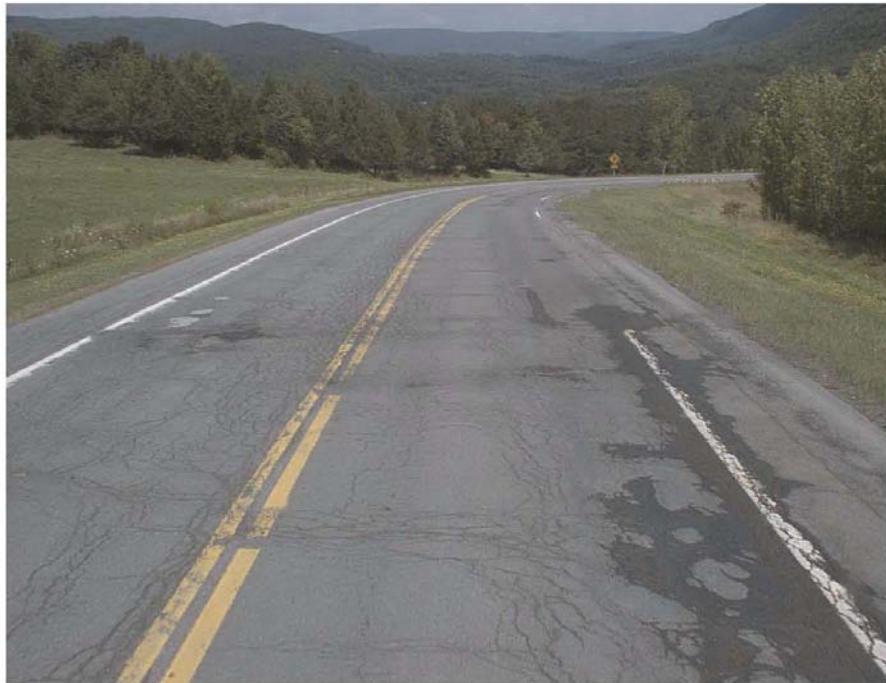
**3**

Very Poor

Very  
Frequent

Very  
Severe

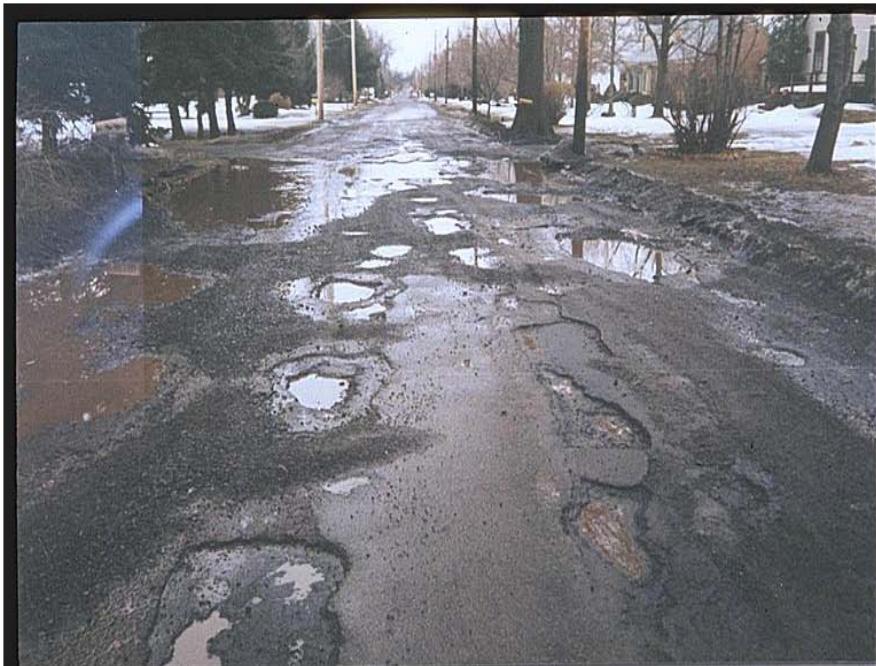
**2**  
**Very Poor**

Very  
Frequent
