Ublox Flash Upgrade

Using Galileo with a cheap Ublox NEO M8N

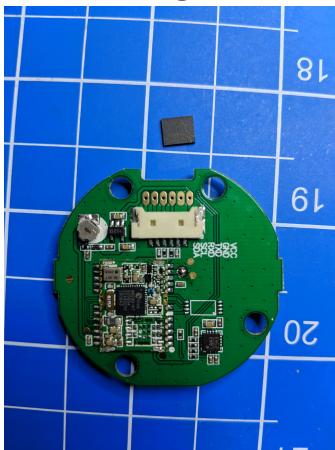
After removing the flash chip you should clean the PCB.

Adding the new flash chip is tricky, you have to add as much heat as needed and as less as possible. If the air stream is to strong you can easily blow away the components! You may use some polyimide soldering masking tape with silicone adhesive.
