# **Property Condition Assessment**

8330 Power Inn Road, Sacramento, CA 95826

Site visit: 2026-06-18

Delta Building Consultants, Inc.

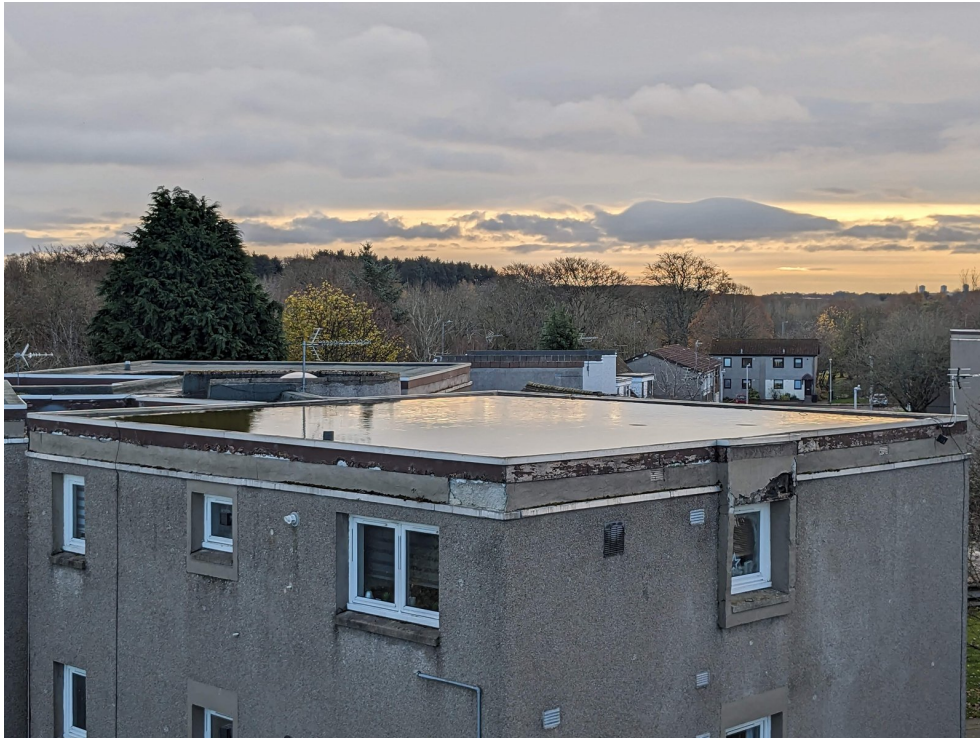
The roof is a low-slope built-up roof (BUR) membrane, gravel-surfaced, covering the full building footprint. Roofing permit and vendor records on file with the owner indicate the membrane is original to the building's 2001 construction; no documented replacement, recover, or full re-roof has occurred since that date. The membrane is well past its typical 20-year service life for this roof type.

Ponding water was observed at the northeast corner of the roof during the site visit, consistent with a drainage deficiency in that area. Ponding accelerates membrane deterioration and should be corrected as part of any re-roofing scope.

*Photo 1: ponding water, NE corner, approx. 1/2 inch after 48 dry hours*

Given the roof's age (original to 2001, no documented replacement), the observed ponding, and the membrane blistering and open seam, we recommend full roof replacement within 12 to 24 months. Budget \$85,000 to \$95,000 for a like-for-like built-up or single-ply replacement, including correction of the NE corner drainage deficiency.

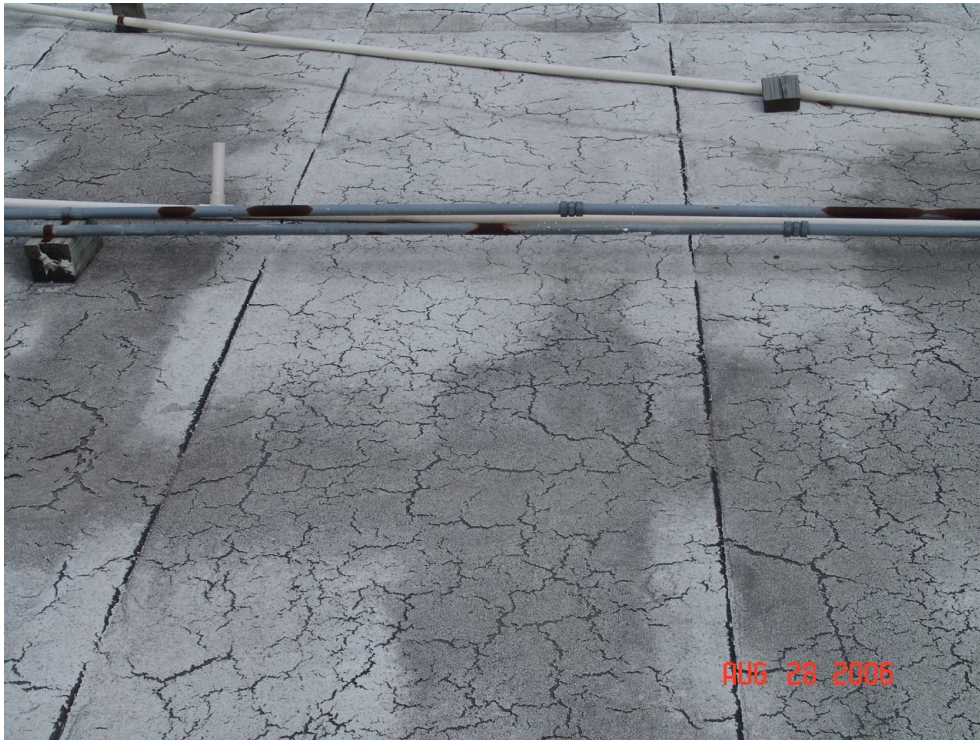
In addition to the ponding condition, the membrane surface shows widespread blistering and at least one open seam, observed near the suite 105 HVAC curb. Blistering indicates trapped moisture beneath the membrane and, combined with an open seam, creates an active leak risk at that location.

*Photo 2: membrane blistering and open seam near suite 105 HVAC curb*

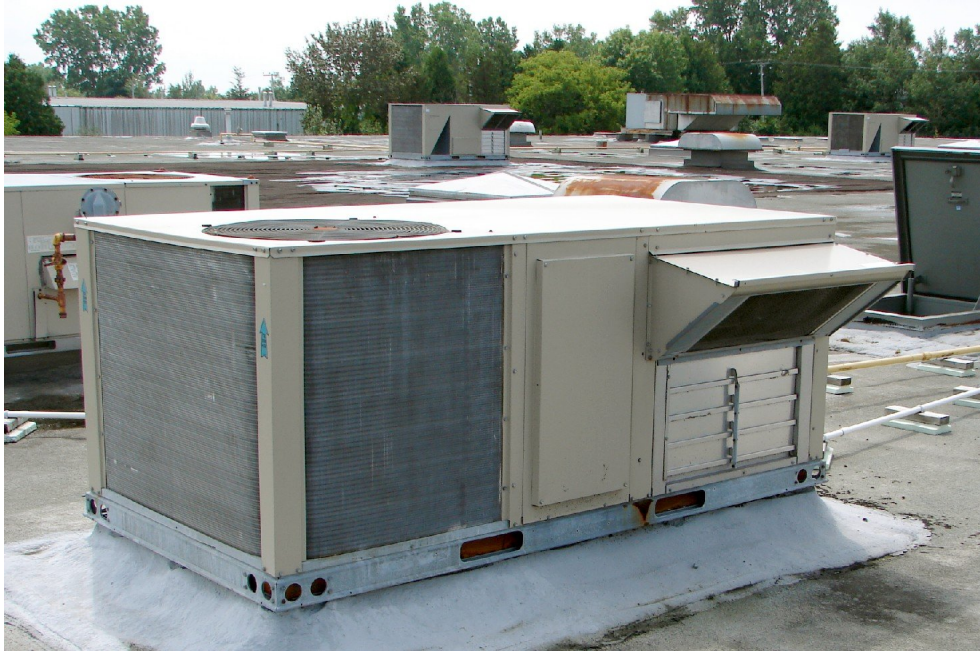
Photo 3: rooftop packaged HVAC units

The units serving suites 103 and 106 are original 1998 packaged units and are beyond typical service life (typical service life for packaged rooftop units is 15 to 20 years). Both units were operational at the time of inspection with no immediate signs of failure. Budget replacement of these two units within 3 to 5 years, at \$14,000 to \$18,000 each.
