# The Crumbling Wonder: A damage- and risk-assessment of sandstone monuments and natural features in the Petra Archaeological Park (Jordan)

VALLETTA ARETTI MARIA VEREZEN \*

Graduate Archaeologist, Leiden University

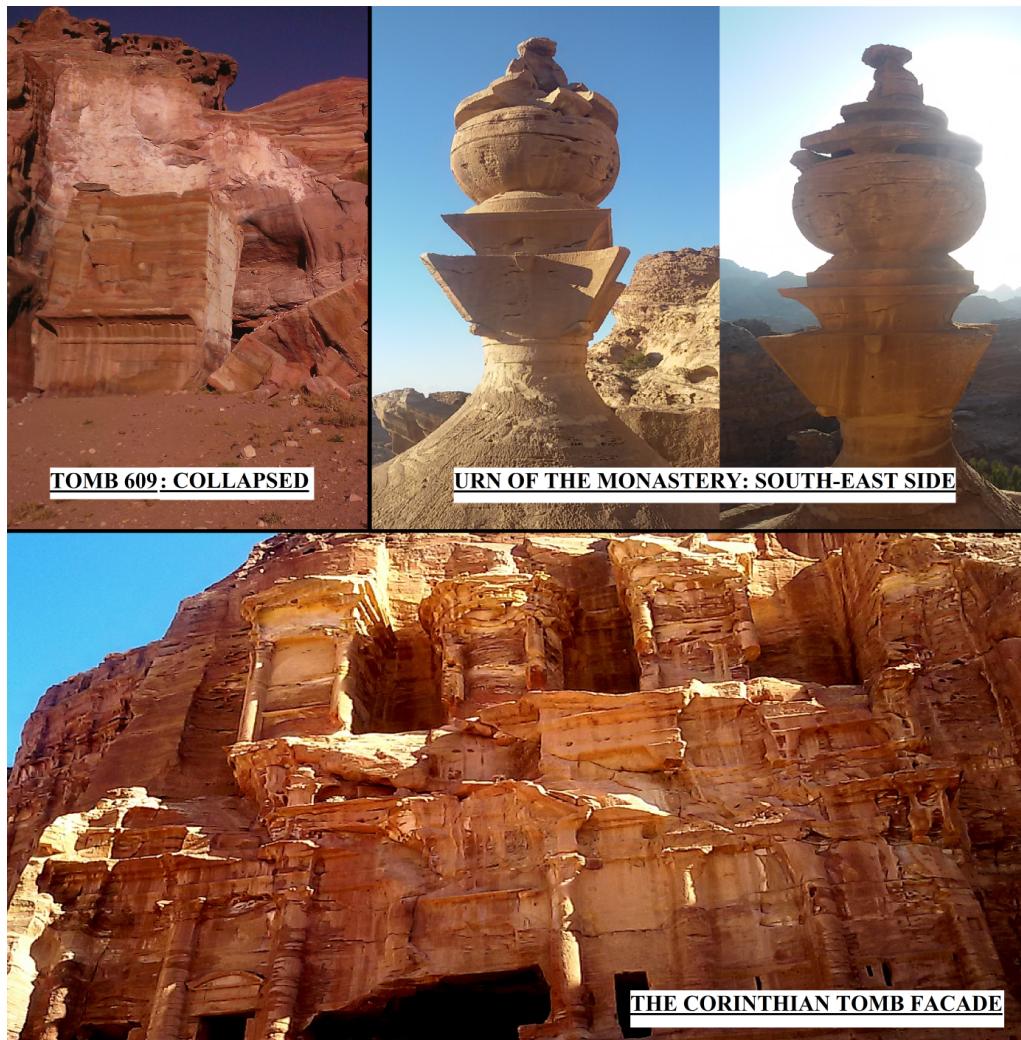
**Figure 1:** *The monuments assessed in this research*

Various collapsed monuments in Petra are the greatest examples and silent witnesses of the continuous forces of weathering and degradation. The most recent example is Tomb 609 with the collapse of its façade (fig. 1) after heavy rainfall in March 2010, known as the Mu'Eissa collapse (Heinrichs and Azzam, 2013a:583). Tomb 609 followed a lengthy process of weathering through natural agents such as: water erosion, seasonal and daily temperature fluctuations, salt-wedging and wind ablation, which caused physical stress and rock failure. The rainfall was likely the last of a series of natural events causing its façade to collapse.

This monument has the largest façade<sup>4</sup> in Petra and is known as the Monastery (Maqsood, 1994:117–121). The focus, regarding degradation, for this case-study was on the sculpted urn, which tops the monument. Not observable from the front-view, is the severe deterioration of its South-East side (fig. 1). This side of the Urn has been eroded through natural weathering and anthropogenic activity. During the field-surveys in Petra, locals and tourists were observed performing unauthorized climbing activities on this monument. These illicit activities and irresponsible behaviours, occurring throughout the Petra Archaeological Park, has created enhanced degradation (Paolini et al., 2012:86). The natural agents most affecting the Monastery itself are wind ablation, surface run-off water, salt-crystallization, and vegetation (Alshawabkeh and Bala'awi, 2010:126–130; Doehne, 2002:1–2). These are the same factors damaging its Urn's surface and structure. Without intervention, the Urn will further deteriorate and this could lead to destabilisation and eventual collapse. The latter will pose a threat to visitors of the Monastery.

Another affected monument is part of the Royal Tombs, which are carved out of the Al-Khubta mountain. The chosen monument is known as the Corinthian Tomb, the façade is extremely weathered and resembles a water-damaged painting (Sachet, 2010:257). Various processes are responsible for the degradation of the Royal Tombs, such as: salt-wedging, surface run-off water, vegetation, wind ablation, and tectonic movements (Balaáwi et al., 2011:267–284; Doehne, 2002:1–3; Nichols, 2009:90); icosmos2005). In the case of the Corinthian Tomb, surface run-off water and consequential salt-crystallization are the main contributors to its façade's decay and destabilization. The latter could result in collapse; this is a threat to the integrity and safety of the souvenir shops, people, and archaeology in its proximity. Vegetation is another factor contributing to the deterioration of archaeological monuments (Balaáwi et al., 2011:267–284). Likewise, vegetation is observed on the façade of the Corinthian Tomb

and indicates that plant removal is necessary. If degradation and the absence of protection continues, its façade might be unrecognizably weathered or collapsed in the future.

The condition of the Monastery's Urn and the Corinthian Tomb both indicate the urgent need for attention and protection. Additionally, the collapsed Tomb 609 makes clear that continuous damage-assessments throughout Petra are required in order to safe-

Concluding from the information gained throughout this research, direct attention is required for the selected monuments and natural features. Previous studies have not highlighted architectural features of the monuments that were degraded and of potential safety risk. This indicates the need for thorough damage-assessments of all and entire monuments including architectural features, such as the Urn of the Monastery.

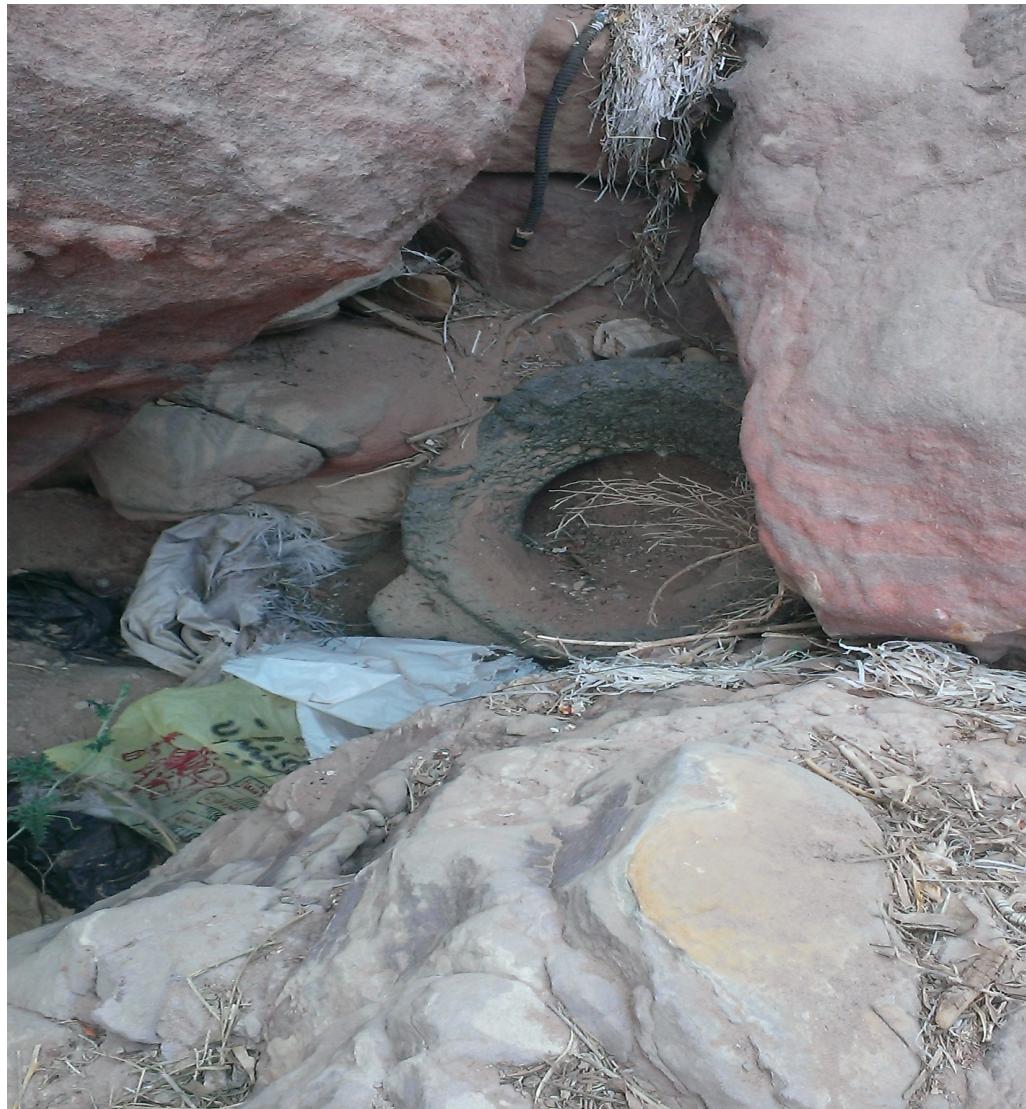
Throughout time, flash-floods are natural hazards occurring inside Petra and are known for their destructive force and capability of removing significant amounts of debris (Franchi et al., 2009:78–84; Ortloff, 2005:104). The debris-filled floods will affect any archaeological and natural sandstone in its path. This force was observed during a field survey in the winter of 2014, when a rapidly formed flash-flood transported and deposited an ancient basalt grinder (fig. 3) and various large boulders. The force and volume of the flash-flood depends on the amount of rainfall and surface run-off water supplied through nine catchment areas located in the Petra area (Al-Weshah and El-Khoury, 1999:171–172; Nichols, 2009:130). Flash-floods pose a major threat to people inside Petra; this was proven by the flash-flood of 1963, which killed more than 20 French tourists (Comer, 2012:55–57; Lingis, 2002:55).

**Figure 3:** An ancient basalt grinder transported and deposited by a flash-flood
