The Crumbling Wonder: A damage- and risk-assessment of sandstone monuments and natural features in the Petra Archaeological Park (Jordan)

VALLETTA ARETTI MARIA VEREZEN*

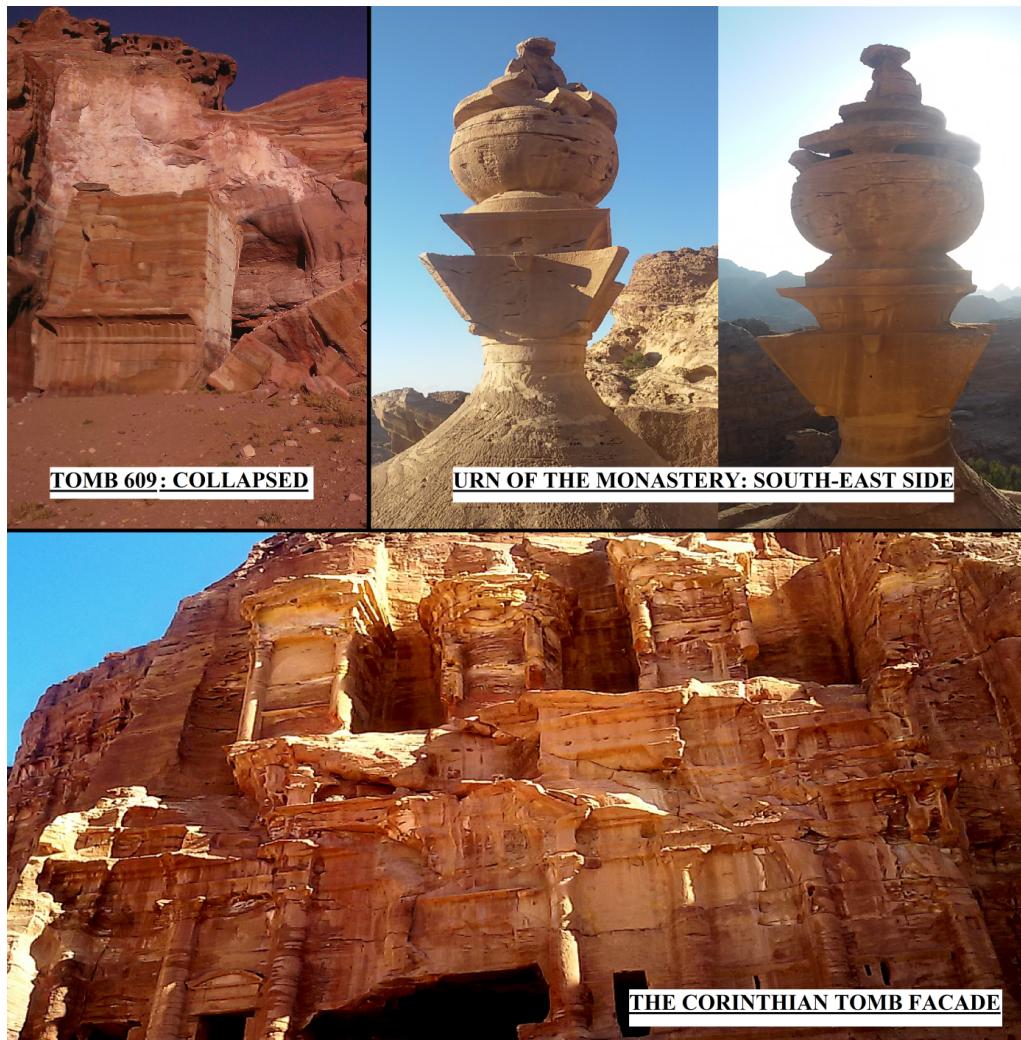
Figure 1: *The monuments assessed in this research.*

- Tomb 609** Various collapsed monuments in Petra are the greatest examples and silent witnesses of the continuous forces of weathering and degradation. The most recent example is Tomb 609 with the collapse of its façade (fig. 1) after heavy rainfall in March 2010, known as the Mu'Eissra collapse (Heinrichs and Azzam, 2013a:583). Tomb 609 followed a lengthy process of weathering through natural agents such as: water erosion, seasonal and daily temperature fluctuations, salt-wedging and wind ablation, which caused physical stress and rock failure. The rainfall was likely the last of a series of natural events causing its façade to collapse.

This monument has the largest façade⁴ in Petra and is known as the Monastery (Maqsood, 1994:117–121). The focus, regarding degradation, for this case-study was on the sculpted urn, which tops the monument. Not observable from the front-view, is the severe deterioration of its South-East side (fig. 1). This side of the Urn has been eroded through natural weathering and anthropogenic activity. During the field-surveys in Petra, locals and tourists were observed performing unauthorized climbing activities on this monument. These illicit activities and irresponsible behaviours, occurring throughout the Petra Archaeological Park, has created enhanced degradation (Paolini et al., 2012:86). The natural agents most affecting the Monastery itself are wind ablation, surface runoff water, salt-crystallization, and vegetation (Alshawabkeh and Bala’awi, 2010:126–

130; Doehne, 2002:1–2). These are the same factors damaging its Urn's surface and structure. Without intervention, the Urn will further deteriorate and this could lead to destabilisation and eventual collapse. The latter will pose a threat to visitors of the Monastery.

Another affected monument is part of the Royal Tombs, which are carved out of the Al-Khubta mountain. The chosen monument is known as the Corinthian Tomb, the façade is extremely weathered and resembles a water-damaged painting (Sachet, 2010:257). Various processes are responsible for the degradation of the Royal Tombs, such as: salt-wedging, surface run-off water, vegetation, wind ablation, and tectonic movements (Balaáwi et al., 2011:267–284; Doehne, 2002:1–3; Nichols, 2009:90); icomos2005). In the case of the Corinthian Tomb, surface run-off water and consequential salt-crystallization are the main contributors to its façade's decay and destabilization. The latter could result in collapse; this is a threat to the integrity and safety of the souvenir shops, people, and archaeology in its proximity. Vegetation is another factor contributing to the deterioration of archaeological monuments (Balaáwi et al., 2011:267–284). Likewise, vegetation is observed on the façade of the Corinthian Tomb and indicates that plant removal is necessary. If degradation and the absence of protection continues, its façade might be unrecognizably weathered or collapsed in the future.

The condition of the Monastery's Urn and the Corinthian Tomb both indicate the urgent need for attention and protection. Additionally, the collapsed Tomb 609 makes clear that continuous damage-assessments throughout Petra are required in order to safeguard Petra's archaeology (Heinrichs, 2008:672). Several conservation works have been fulfilled in Petra however, not all are successful. One unsuccessful attempt occurred at the Qasr-al Bint where structural parts were impregnated with an incorrect mortar-type causing further damage. This partially was due to the lack of a single conservation-policy in Jordan's heritage sector which then led to various unaligned conservation interventions. Various mortar-types have negative and positive merits that should be kept in mind during conservation works in Petra (Al-Saad and Abdel-Halim, 2001:926–932). Desalination techniques are available, which reduce salt-crystallization; however, this needs improvement since some techniques increase decay (Matyšcák, Ottosen, and Rörig-Dalgaard, 2014:561–563; Rörig-Dalgaard, 2015:1915–1916; Young, Urquhart, and Laing, 2003:1125–1129). Furthermore, the process of salt-weathering remains poorly understood and requires further research. Currently, the 'petraSalt' research-project is aimed at gaining a better understanding of salt-weathering that may lead to improved methods that reduce the impact of salt-weathering (Heinrichs and Azzam, 2013b:347–348).

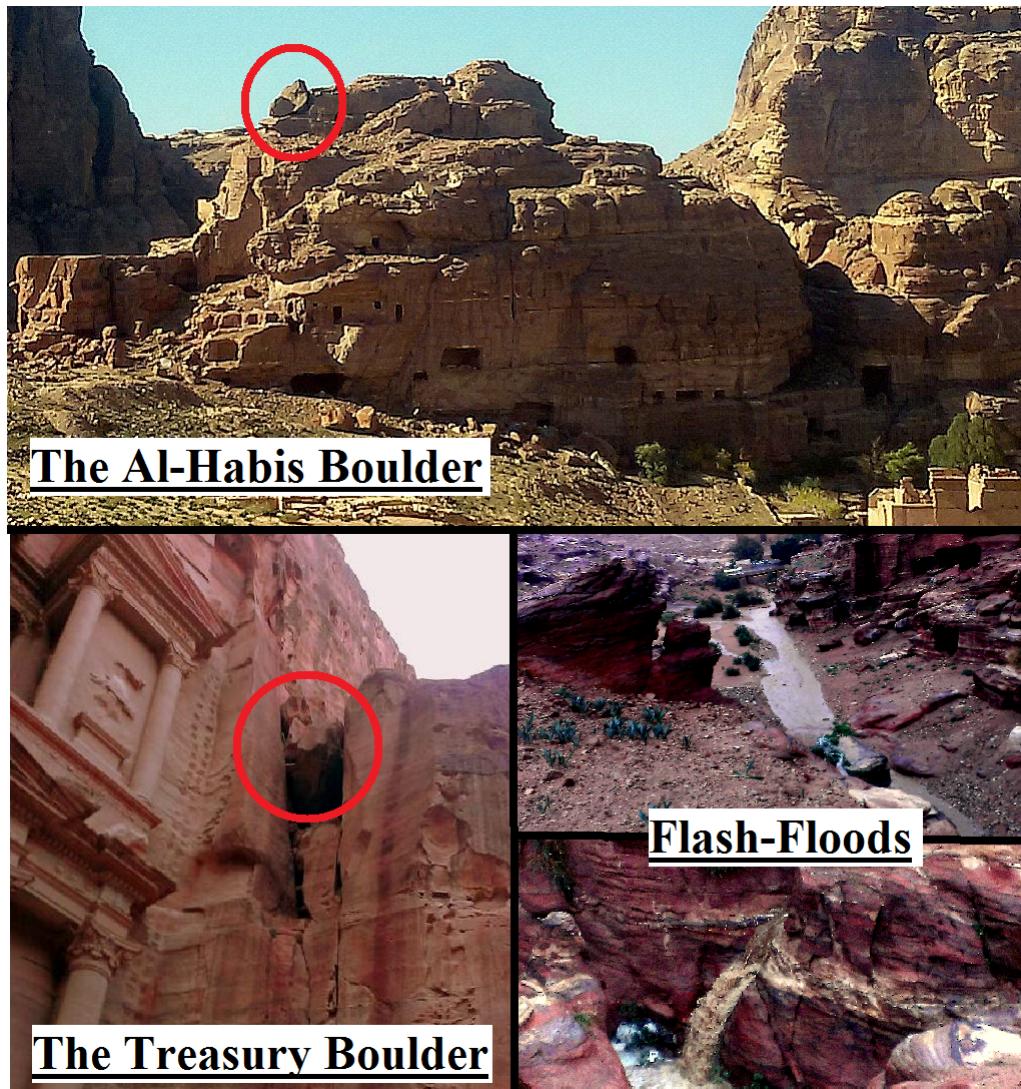
Figure 2: *The three natural and potential hazardous features.*

The first selection was a significant sandstone boulder stuck between a wedge-shaped fissure located to the upper-right side of the Treasury (fig. 2). The boulder is trapped in a rock-fissure; however, it could yet pose a safety-risk upon movement resulting from significant surface run-off water or earthquakes. Steel safety nets could be installed to catch falling debris upon collapse, because ignoring this risk could otherwise threaten the park's safety and the Treasury's façade (Volkwein et al., 2011:2617–2639).

The second natural feature is the boulder topping the Al-Habis mountain. If this boulder falls downward in the East direction, it could tumble down the adjacent hill into archaeological structures and tourist facilities. This indicates a safety-risk in the case of dislocation caused by substantial forces such as earthquakes, which are not uncommon in this region. Petra has witnessed powerful earthquakes in the past, which inflicted great damage to its archaeology⁵ (Alshawabkeh and Bala'awi, 2010:126; Heinrichs, 2008:644). Due to the Habis boulder's unconsolidated state and the possibility of an earthquake, it should be subjected to further risk-assessment and safety procedures.

Continuous risk-assessments of unconsolidated natural features, such as the Al-Habis and Treasury boulder, should be conducted. Rock-fissures, which could lead to collapse, should be monitored and filled with the correct mortar which should first be technically evaluated (Al-Saad and Abdel-Halim, 2001:926–932). Strict regulations regarding the allowance of visitors during significant rain- or snowfall should be applied to prevent dangerous situations. As well, installing steel-safety nets (fig. 4) will contribute to the park's safety in case of rock-falls (Volkwein et al., 2011:2617–2639). Through the enforcement of safety regulations, protection measures, extensive risk- and damage-assessments and mapping affected monuments, damage can be reduced and prevented (Alshawabkeh and Bala'awi, 2010:127; Delmonaco, Margottini, and Spizzichino, 2013:441–446). If implemented, these options will contribute to the protection of Petra's archaeology,

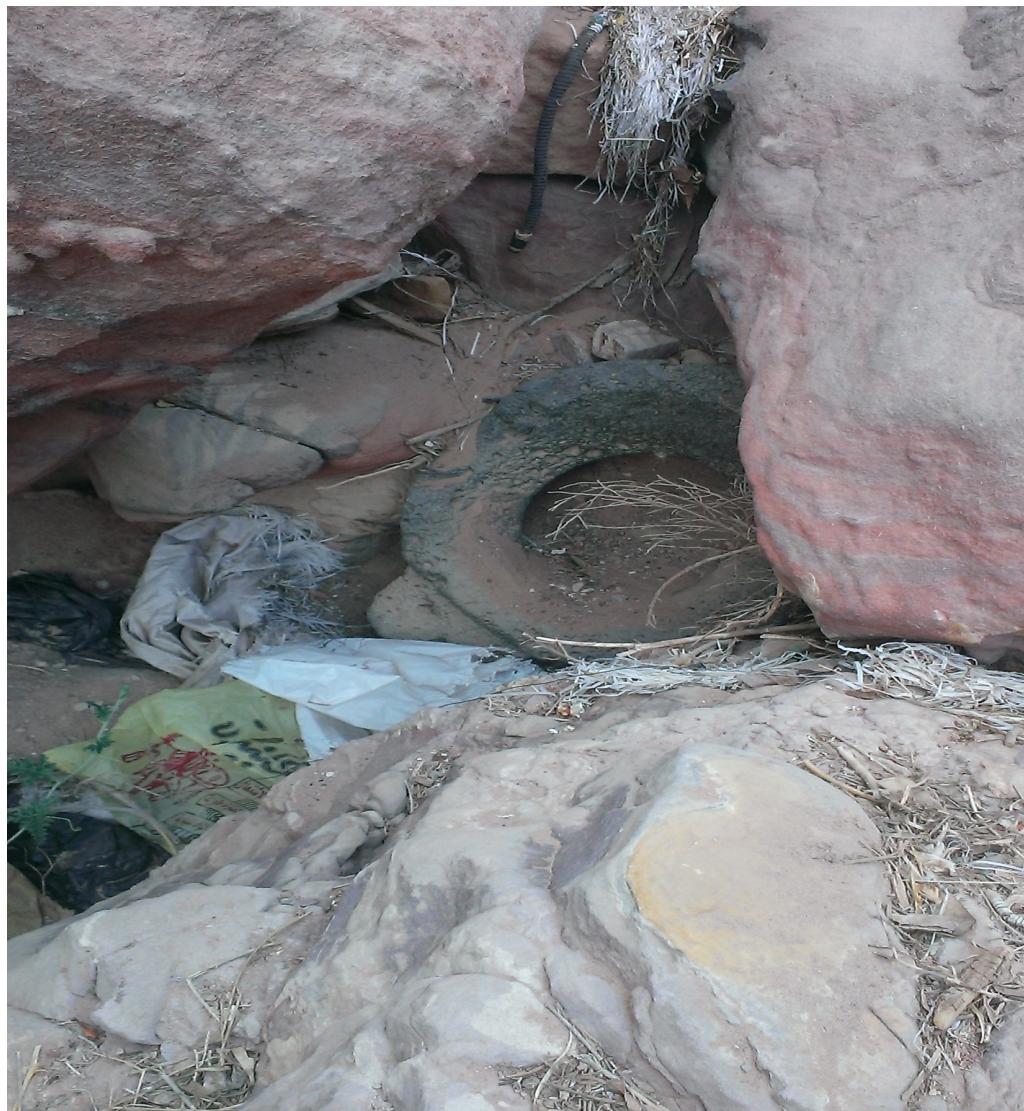
field survey in the winter of 2014, when a rapidly formed flash-flood transported and deposited an ancient basalt grinder (fig. 3) and various large boulders. The force and volume of the flash-flood depends on the amount of rainfall and surface run-off water supplied through nine catchment areas located in the Petra area (Al-Weshah and El-Khoury, 1999:171–172; Nichols, 2009:130). Flash-floods pose a major threat to people inside Petra; this was proven by the flash-flood of 1963, which killed more than 20 French tourists (Comer, 2012:55–57; Lingis, 2002:55).

Figure 3: An ancient basalt grinder transported and deposited by a flash-flood.
