The Crumbling Wonder: A damage- and risk-assessment of sandstone monuments and natural features in the Petra Archaeological Park (Jordan)

VALLETTA ARETTI MARIA VEREZEN*

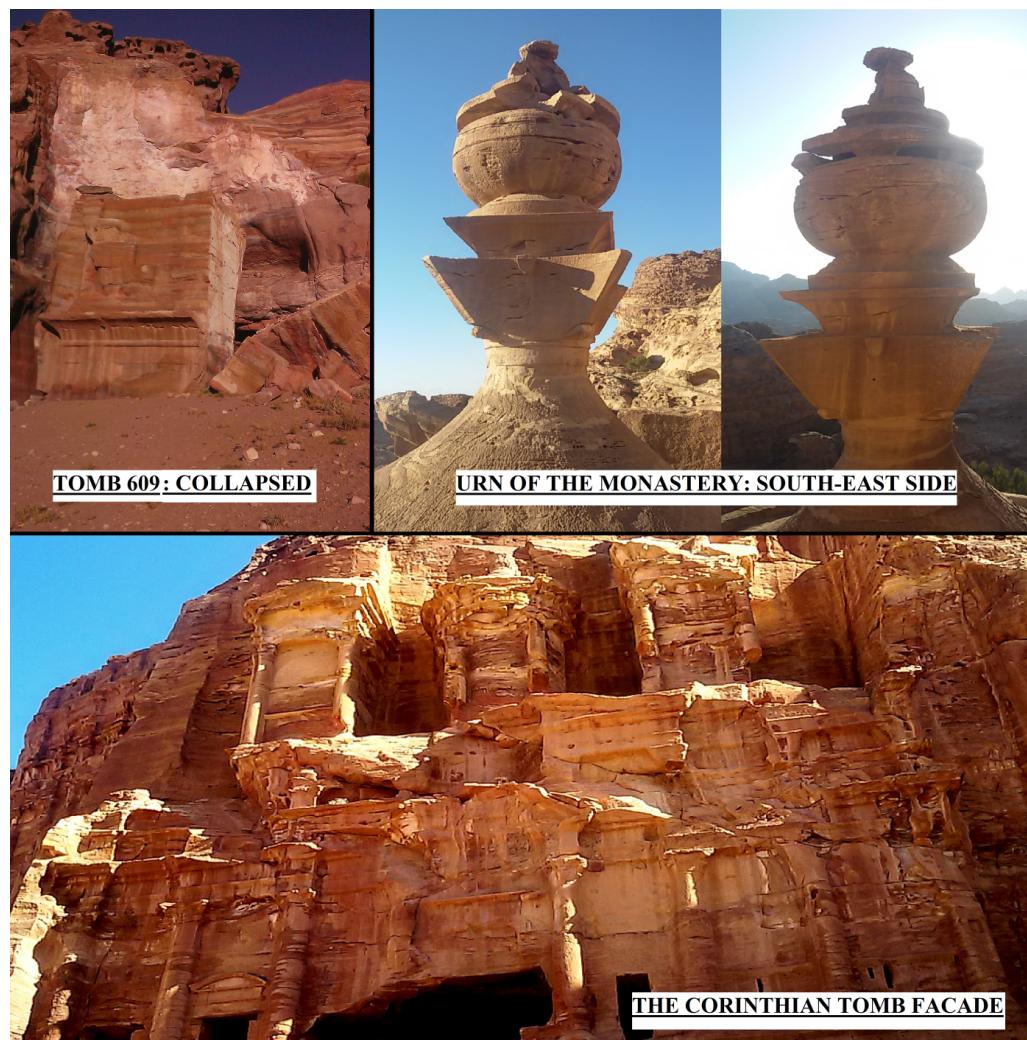
Various collapsed monuments in Petra are the greatest examples and silent witnesses of the continuous forces of weathering and degradation. The most recent example is Tomb 609 with the collapse of its façade (fig. 1) after heavy rainfall in March 2010, known as the Mu'Eissra collapse (Heinrichs and Azzam, 2013a:583). Tomb 609 followed a lengthy process of weathering through natural agents such as: water erosion, seasonal and daily temperature fluctuations, salt-wedging and wind ablation, which caused physical stress and rock failure. The rainfall was likely the last of a series of natural events causing its façade to collapse.

Figure 1: *The monuments assessed in this research.*

This monument has the largest façade⁴ in Petra and is known as the Monastery (Maqsood, 1994:117–121). The focus, regarding degradation, for this case-study was on the sculpted urn, which tops the monument. Not observable from the front-view, is the severe deterioration of its South-East side (fig. 1). This side of the Urn has been eroded through natural weathering and anthropogenic activity. During the field-surveys in Petra, locals and tourists were observed performing unauthorized climbing activities on this monument. These illicit activities and irresponsible behaviours, occurring throughout the Petra Archaeological Park, has created enhanced degradation (Paolini et al., 2012:86). The natural agents most affecting the Monastery itself are wind ablation, surface run-off water, salt-crystallization, and vegetation (Alshawabkeh and Bala’awi, 2010:126–

130; Doehne, 2002:1–2). These are the same factors damaging its Urn's surface and structure. Without intervention, the Urn will further deteriorate and this could lead to destabilisation and eventual collapse. The latter will pose a threat to visitors of the Monastery.

Another affected monument is part of the Royal Tombs, which are carved out of the Al-Khubta mountain. The chosen monument is known as the Corinthian Tomb, the façade is extremely weathered and resembles a water-damaged painting (Sachet, 2010:257). Various processes are responsible for the degradation of the Royal Tombs, such as: salt-wedging, surface run-off water, vegetation, wind ablation, and tectonic movements (Balaáwi et al., 2011:267–284; Doehne, 2002:1–3; Nichols, 2009:90; icomos2005). In the case of the Corinthian Tomb, surface run-off water and consequential salt-crystallization are the main contributors to its façade's decay and destabilization. The latter could result in collapse; this is a threat to the integrity and safety of the souvenir shops, people, and archaeology in its proximity. Vegetation is another factor contributing to the deterioration of archaeological monuments (Balaáwi et al., 2011:267–284). Likewise, vegetation is observed on the façade of the Corinthian Tomb and indicates that plant removal is necessary. If degradation and the absence of protection continues, its façade might be unrecognizably weathered or collapsed in the future.

The condition of the Monastery's Urn and the Corinthian Tomb both indicate the urgent need for attention and protection. Additionally, the collapsed Tomb 609 makes clear that continuous damage-assessments throughout Petra are required in order to safeguard Petra's archaeology (Heinrichs, 2008:672). Several conservation works have been fulfilled in Petra however, not all are successful. One unsuccessful attempt occurred at the Qasr-al Bint where structural parts were impregnated with an incorrect mortar-type causing further damage. This partially was due to the lack of a single conservation-policy in Jordan's heritage sector which then led to various unaligned conservation interventions. Various mortar-types have negative and positive merits that should be kept in mind during conservation works in Petra (Al-Saad and Abdel-Halim, 2001:926–932). Desalination techniques are available, which reduce salt-crystallization; however, this needs improvement since some techniques increase decay (Matyšcák, Ottosen, and Rörig-Dalgaard, 2014:561–563; Rörig-Dalgaard, 2015:1915–1916; Young, Urquhart, and Laing, 2003:1125–1129). Furthermore, the process of salt-weathering remains poorly understood and requires further research. Currently, the 'petraSalt' research-project is aimed at gaining a better understanding of salt-weathering that may lead to improved methods that reduce the impact of salt-weathering (Heinrichs and Azzam, 2013b:347–348).
