The Crumbling Wonder: A damage- and risk-assessment of sandstone monuments and natural features in the Petra Archaeological Park (Jordan)

Keywords: Archaeology, Heritage Preservation, Safety-Risks, Nabataean, Weathering, Monuments

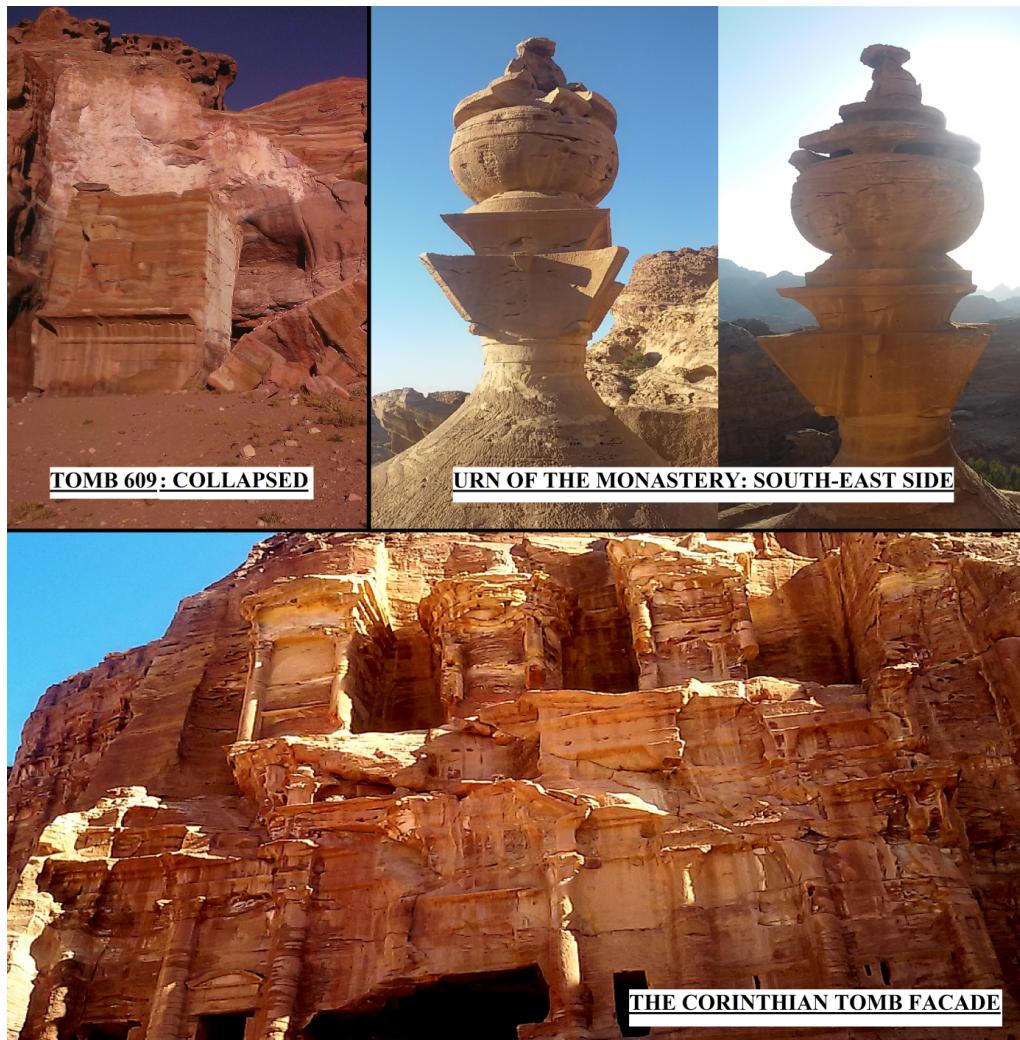
Tomb 609 Various collapsed monuments in Petra are the greatest examples and silent witnesses of the continuous forces of weathering and degradation. The most recent example is Tomb 609 with the collapse of its façade fig. 1 after heavy rainfall in March 2010, known as the Mu'Eissra collapse (Heinrichs and Azzam, 2013a:583). Tomb 609 followed a lengthy process of weathering through natural agents such as: water erosion, seasonal and daily temperature fluctuations, salt-wedging and wind ablation, which caused physical stress and rock failure. The rainfall was likely the last of a series of natural events causing its façade to collapse.

The Monastery's Urn This monument has the largest façade⁴ in Petra and is known as the Monastery (Maqsood, 1994:117–121). The focus, regarding degradation, for this case-study was on the sculpted urn, which tops the monument. Not observable from the front-view, is the severe deterioration of its South-East side fig. 1. This side of the Urn has been eroded through natural weathering and anthropogenic activity. During the field-surveys in Petra, locals and tourists were observed performing unauthorized climbing activities on this monument. These illicit activities and irresponsible behaviours, occurring throughout the Petra Archaeological Park, has created enhanced degradation (Paolini et al., 2012:86). The natural agents most affecting the Monastery itself are wind ablation, surface run-off water, salt-crystallization, and vegetation (Alshawabkeh and Bala'awi, 2010:126–130; Doehne, 2002:1–2). These are the same factors damaging its Urn's surface and structure. Without intervention, the Urn will further deteriorate and this could lead to destabilisation and eventual collapse. The latter will pose a threat to visitors of the Monastery.

The Corinthian Tomb Another affected monument is part of the Royal Tombs, which are carved out of the Al-Khubta mountain. The chosen monument is known as the Corinthian Tomb, the façade is extremely weathered and resembles a water-damaged painting (Sachet, 2010:257). Various processes are responsible for the degradation of the Royal Tombs, such as: salt-wedging, surface run-off water, vegetation, wind ablation, and tectonic movements (Balaáwi et al., 2011:267–284; Doehne, 2002:1–3; Nichols, 2009:90); icomos2005). In the case of the Corinthian Tomb, surface run-off water and consequential salt-crystallization are the main contributors to its façade's decay and destabilization. The latter could result in collapse; this is a threat to the integrity and safety of the souvenir shops,

Figure 1: The monuments assessed in this research

people, and archaeology in its proximity. Vegetation is another factor contributing to the deterioration of archaeological monuments (Balaáwi et al., 2011:267–284). Likewise, vegetation is observed on the façade of the Corinthian Tomb and indicates that plant removal is necessary. If degradation and the absence of protection continues, its façade might be unrecognizably weathered or collapsed in the future.

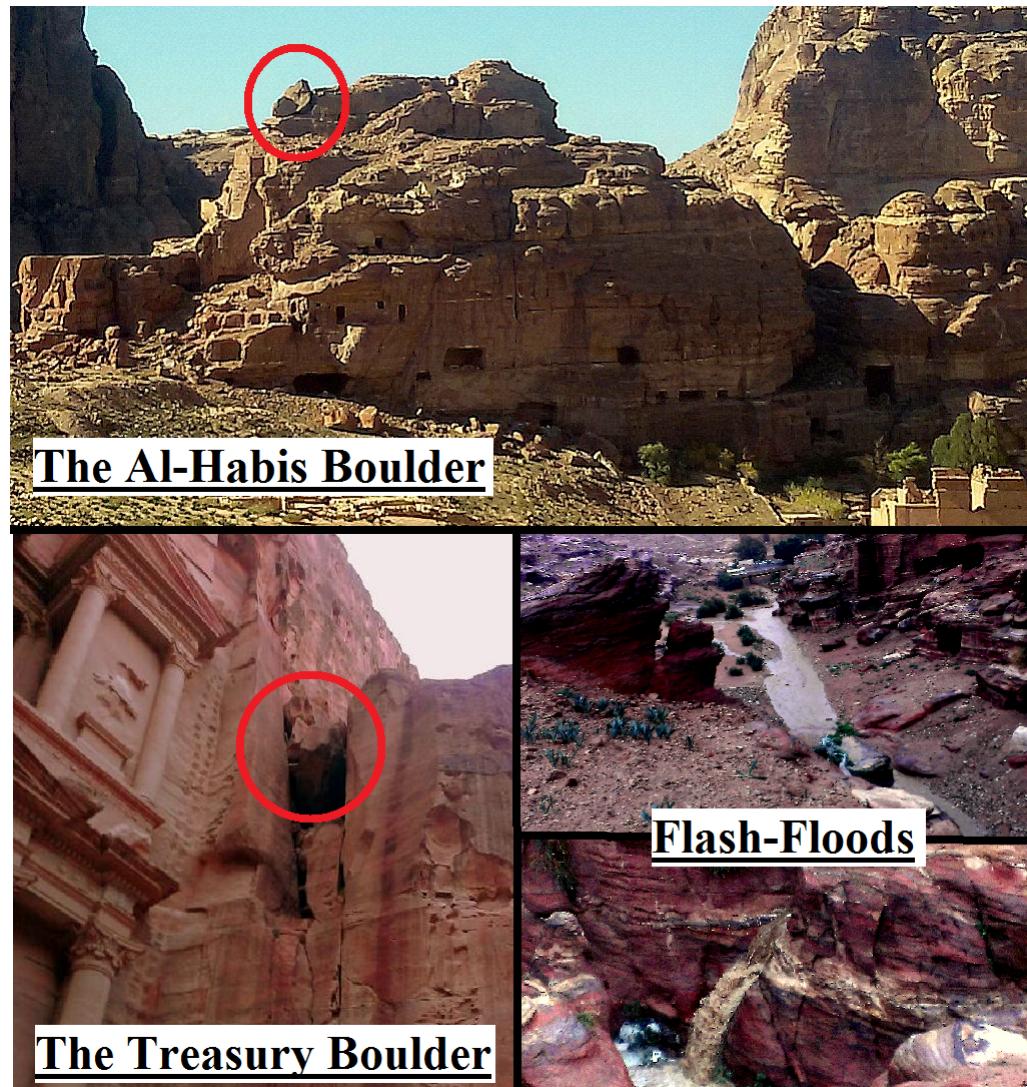
The first selection was a significant sandstone boulder stuck between a wedge-shaped fissure located to the upper-right side of the Treasury fig. 2. The boulder is trapped in a rock-fissure; however, it could yet pose a safety-risk upon movement resulting from

significant surface run-off water or earthquakes. Steel safety nets could be installed to catch falling debris upon collapse, because ignoring this risk could otherwise threaten the park's safety and the Treasury's façade (**volkwein2010**).

Figure 2: *The three natural and potential hazardous features*

The second natural feature is the boulder topping the Al-Habis mountain. If this boulder falls downward in the East direction, it could tumble down the adjacent hill into archaeological structures and tourist facilities. This indicates a safety-risk in the case of dislocation caused by substantial forces such as earthquakes, which are not uncommon in this region. Petra has witnessed powerful earthquakes in the past, which inflicted

great damage to its archaeology⁵ (Alshawabkeh and Bala'awi, 2010:126; Heinrichs, 2008:644). Due to the Habis boulder's unconsolidated state and the possibility of an earthquake, it should be subjected to further risk-assessment and safety procedures.

In regards to the chosen natural features, various options could contribute to maintain the safety for Petra’s archaeology and visitors, such as steel-nets fig. 4, which retain falling debris during rock-falls (Volkwein et al., 2011:2638). The Al-Habis boulder and the Treasury’s boulder fig. 2 are proofs of the silent, and often unnoticed, presence of safety-risks and are just a glimpse of the collective amount of hazards in the park. This suggests that extensive and continuous risk-assessments should be enforced in order to maintain a safe environment. The rapid formation of flash-floods, after a rain- or snow-fall, likewise point to the need of the continuous monitoring of weather patterns and its effect on Petra’s archaeological and natural features.

Continuous risk-assessments of unconsolidated natural features, such as the Al-Habis and Treasury boulder, should be conducted. Rock-fissures, which could lead to collapse, should be monitored and filled with the correct mortar which should first be technically evaluated (Al-Saad and Abdel-Halim, 2001:926–932). Strict regulations regarding the allowance of visitors during significant rain- or snowfall should be applied to prevent dangerous situations. As well, installing steel-safety nets (fig. 4) will contribute to the park’s safety in case of rock-falls (Volkwein et al., 2011:2617–2639). Through the enforcement of safety regulations, protection measures, extensive risk- and damage-assessments and mapping affected monuments, damage can be reduced and prevented (Alshawabkeh and Bala’awi, 2010:127; **Delmonaco et al. in Margottini et al. 2013**). If implemented, these options will contribute to the protection of Petra’s archaeology, visitors, and future; and with that, the protection of irreplaceable and valuable data required to retrieve an understanding of this region’s past.

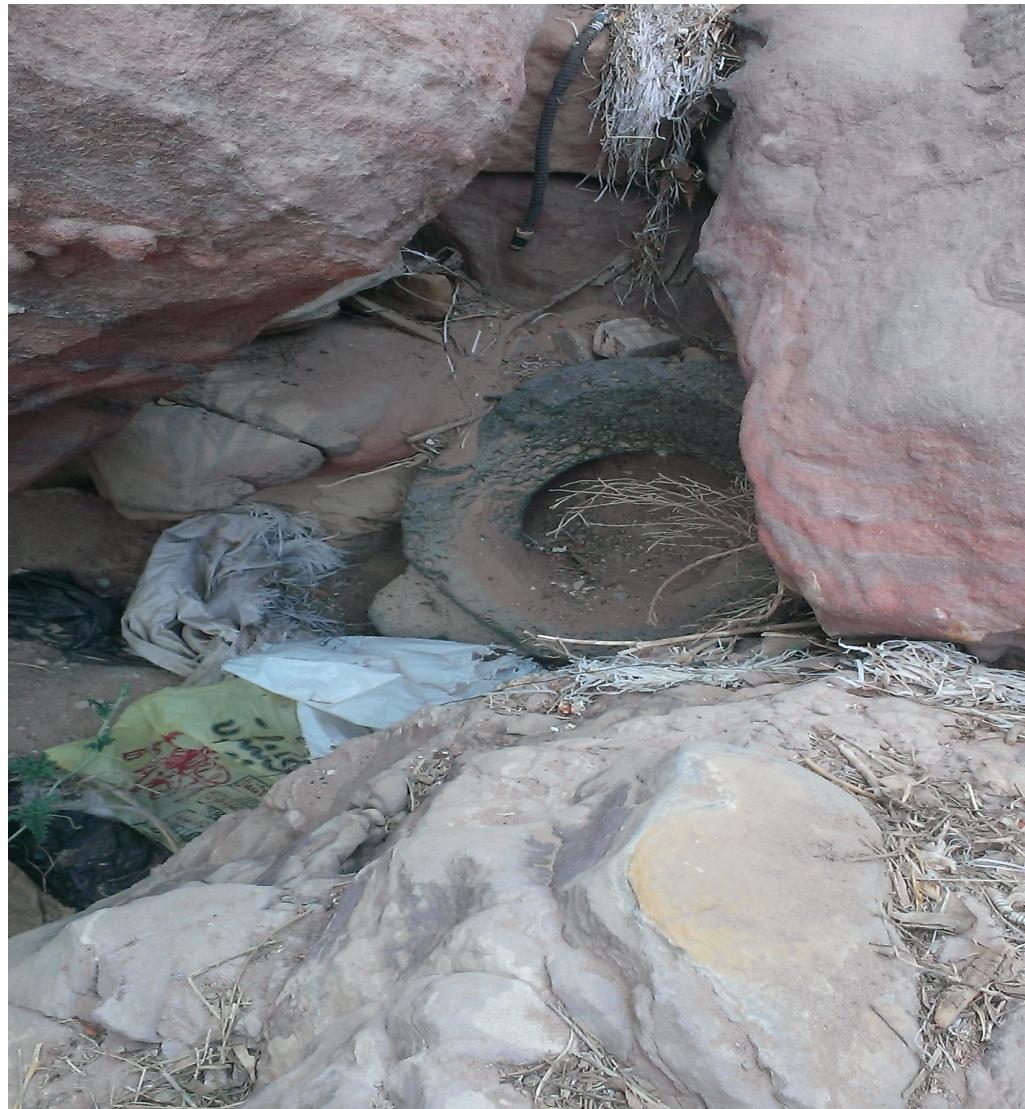
Throughout time, flash-floods are natural hazards occurring inside Petra and are known for their destructive force and capability of removing significant amounts of debris (Franchi et al., 2009:78–84; Ortloff, 2005:104). The debris-filled floods will affect any archaeological and natural sandstone in its path. This force was observed during a field survey in the winter of 2014, when a rapidly formed flash-flood transported and deposited an ancient basalt grinder fig. 3 and various large boulders. The force and volume of the flash-flood depends on the amount of rainfall and surface run-off water supplied through nine catchment areas located in the Petra area (Al-Weshah and El-Khoury, 1999:171–172; Nichols, 2009:130). Flash-floods pose a major threat to people inside Petra; this was proven by the flash-flood of 1963, which killed more than 20 French tourists (Comer, 2012:55–57; Lingis, 2002:55).

Figure 3: An ancient basalt grinder transported and deposited by a flash-flood
