# The Crumbling Wonder: A damage- and risk-assessment of sandstone monuments and natural features in the Petra Archaeological Park (Jordan)

VALLETTA ARETTI MARIA VEREZEN \*

Graduate Archaeologist, Leiden University

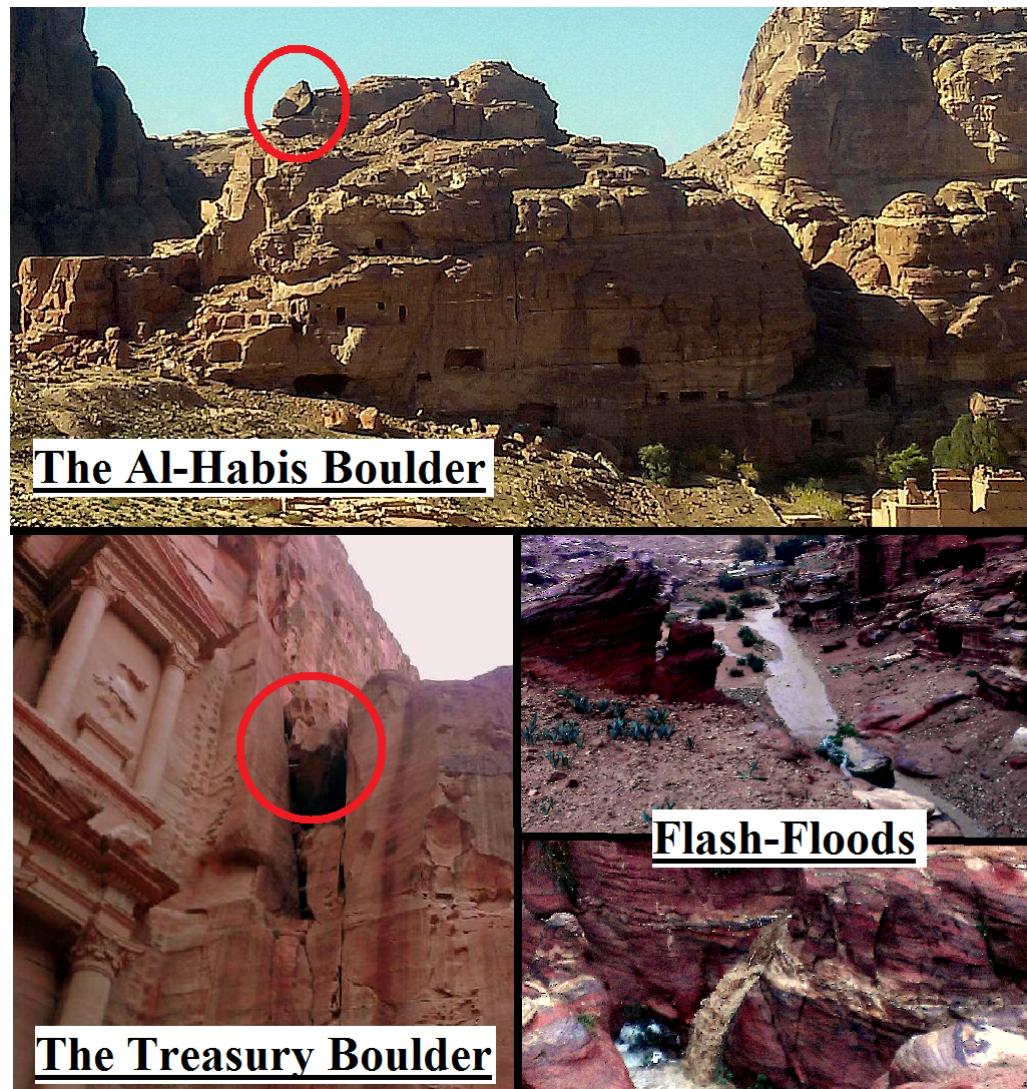
**Figure 2:** «*The three natural and potential hazardous features*»

The 4.1 Treasury's Boulder first selection was a significant sandstone boulder stuck between a wedge-shaped fissure located to the upper-right side of the Treasury fig. 2. The boulder is trapped in a rock-fissure; however, it could yet pose a safety-risk upon move-

ment resulting from significant surface run-off water or earthquakes. Steel safety nets could be installed to catch falling debris upon collapse, because ignoring this risk could otherwise threaten the park's safety and the Treasury's façade (**volkwein2010**).

The 4.2 Al-Habis Boulder second natural feature is the boulder topping the Al-Habis mountain. If this boulder falls downward in the East direction, it could tumble down the adjacent hill into archaeological structures and tourist facilities. This indicates a safety-risk in the case of dislocation caused by substantial forces such as earthquakes, which are not uncommon in this region. Petra has witnessed powerful earthquakes

in the past, which inflicted great damage to its archaeology<sup>5</sup> (**alshawabkeh2010; heinrichs2008**). Due to the Habis boulder's unconsolidated state and the possibility of an earthquake, it should be subjected to further risk-assessment and safety procedures.

In regards to the chosen natural features, various options could contribute to maintain the safety for Petra’s archaeology and visitors, such as steel-nets fig. 4, which retain falling debris during rock-falls (**volkwein2011**). The Al-Habis boulder and the Treasury’s boulder fig. 2 are proofs of the silent, and often unnoticed, presence of safety-risks and are just a glimpse of the collective amount of hazards in the park. This suggests that extensive and continuous risk-assessments should be enforced in order to maintain a safe environment. The rapid formation of flash-floods, after a rain- or snow-fall, likewise point to the need of the continuous monitoring of weather patterns and its effect on Petra’s archaeological and natural features.

Continuous risk-assessments of unconsolidated natural features, such as the Al-Habis and Treasury boulder, should be conducted. Rock-fissures, which could lead to collapse, should be monitored and filled with the correct mortar which should first be technically evaluated (**alsaad2001**). Strict regulations regarding the allowance of visitors during significant rain- or snowfall should be applied to prevent dangerous situations. As well, installing steel-safety nets (fig. 4) will contribute to the park's safety in case of rock-falls (**volkwein2011**). Through the enforcement of safety regulations, protection measures, extensive risk- and damage-assessments and mapping affected monuments, damage can be reduced and prevented (**alshawabkeh2010**; D)elmonaco et al. in Margottini et al. 2013). If implemented, these options will contribute to the protection of Petra's archaeology, visitors, and future; and with that, the protection of irreplaceable and valuable data required to retrieve an understanding of this region's past.

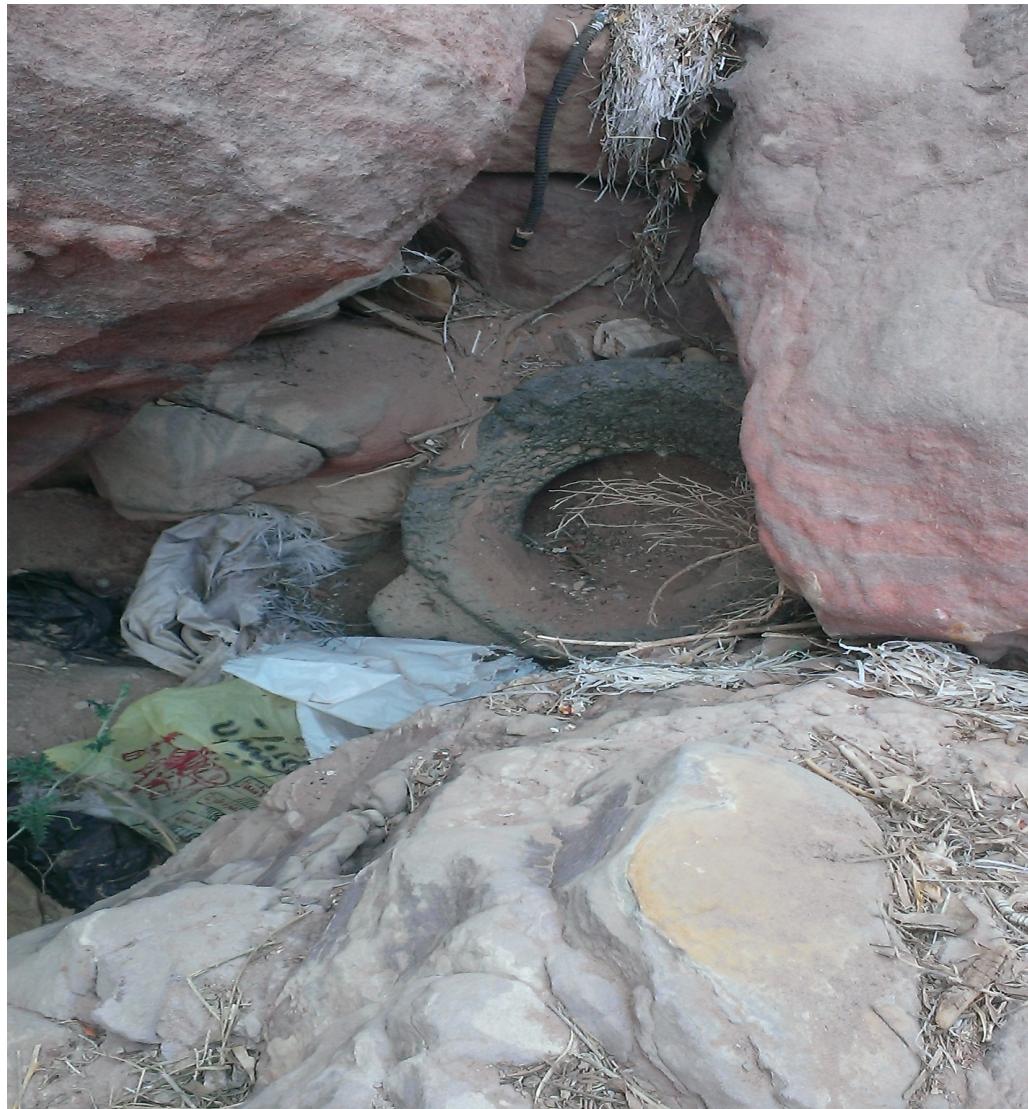
Throughout 4.3 Flash Floods time, flash-floods are natural hazards occurring inside Petra and are known for their destructive force and capability of removing significant amounts of debris (**franchi2009; ortloff2005**). The debris-filled floods will affect any archaeological and natural sandstone in its path. This force was observed during a field survey in the winter of 2014, when a rapidly formed flash-flood transported and deposited an ancient basalt grinder fig. 3 and various large boulders. The force and volume of the flash-flood depends on the amount of rainfall and surface run-off water supplied through nine catchment areas located in the Petra area (**alweshahr1999; nichols2009**). Flash-floods pose a major threat to people inside Petra; this was proven by the flash-flood of 1963, which killed more than 20 French tourists (**comer2012; lingis2002**).

**Figure 3:** «An ancient basalt grinder transported and deposited by a flash-flood»

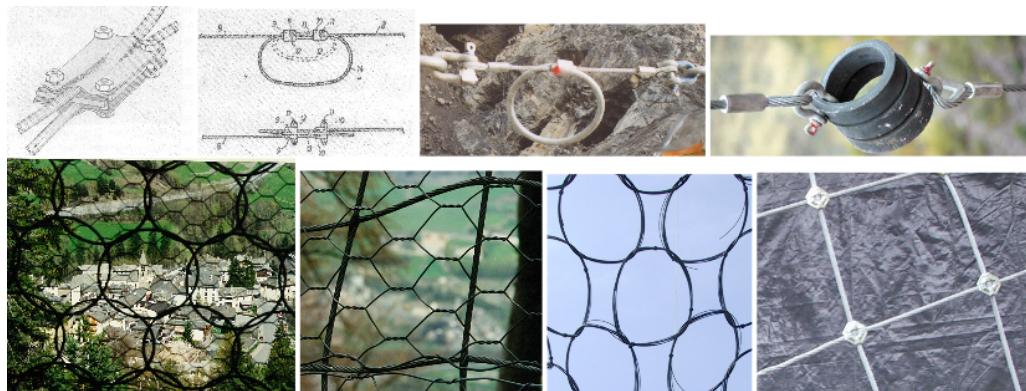
**Figure 4:** «An example of safety-measures»
