# The Crumbling Wonder: A damage- and risk-assessment of sandstone monuments and natural features in the Petra Archaeological Park (Jordan)

VALLETTA ARETTI MARIA VEREZEN\*

Graduate Archaeologist, Leiden University

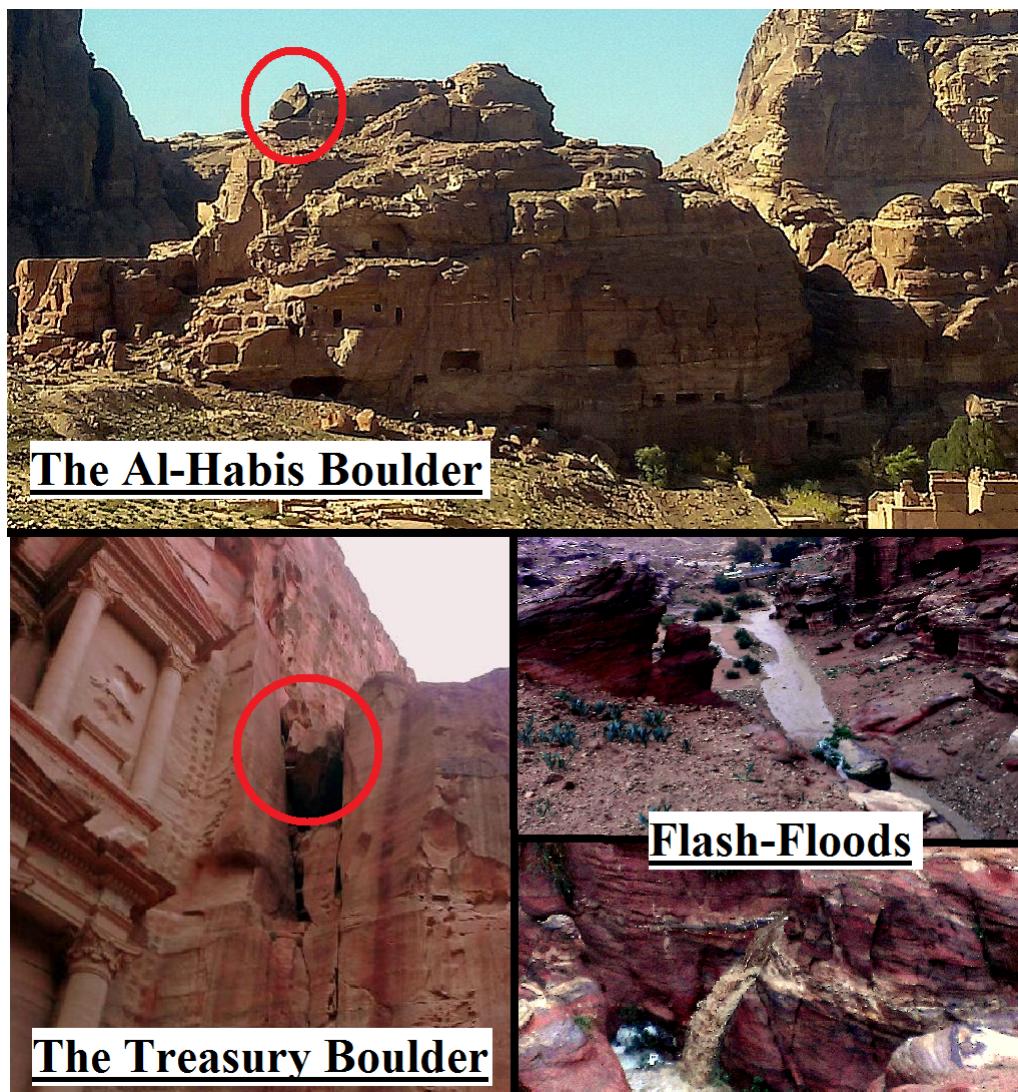
The chosen natural features of Petra shed light on the presence of possible hazards in the archaeological park that might threaten the integrity of the archaeology and the safety of visitors. The first selection was a significant sandstone boulder stuck between a wedge-shaped fissure located to the upper-right side of the Treasury (fig. 2). The boulder is trapped in a rock-fissure; however, it could yet pose a safety-risk upon movement resulting from significant surface run-off water or earthquakes. Steel safety nets could be installed to catch falling debris upon collapse, because ignoring this risk could otherwise threaten the park's safety and the Treasury's façade (Volkwein et al., 2011:2617–2639).

The second natural feature is the boulder topping the Al-Habis mountain. If this boulder falls downward in the East direction, it could tumble down the adjacent hill into archaeological structures and tourist facilities. This indicates a safety-risk in the case of dislocation caused by substantial forces such as earthquakes, which are not uncommon in this region. Petra has witnessed powerful earthquakes in the past, which inflicted great damage to its archaeology<sup>5</sup> (Alshawabkeh and Bala'awi, 2010:126; Heinrichs, 2008:644). Due to the Habis boulder's unconsolidated state and the possibility of an earthquake, it should be subjected to further risk-assessment and safety procedures.

Throughout time, flash-floods are natural hazards occurring inside Petra and are known for their destructive force and capability of removing significant amounts of debris (Franchi et al., 2009:78–84; Ortloff, 2005:104). The debris-filled floods will affect any archaeological and natural sandstone in its path. This force was observed during a field survey in the winter of 2014, when a rapidly formed flash-flood transported and deposited an ancient basalt grinder (fig. 3) and various large boulders. The force and volume of the flash-flood depends on the amount of rainfall and surface run-off water supplied through nine catchment areas located in the Petra area (Al-Weshah and El-Khoury, 1999:171–172; Nichols, 2009:130). Flash-floods pose a major threat to people inside Petra; this was proven by the flash-flood of 1963, which killed more than 20 French tourists (Comer, 2012:55–57; Lingis, 2002:55).

**Figure 2:** *The three natural and potential hazardous features*

In regards to the chosen natural features, various options could contribute to maintain the safety for Petra's archaeology and visitors, such as steel-nets (fig. 4), which retain falling debris during rock-falls (Volkwein et al., 2011:2638). The Al-Habis boulder and the Treasury's boulder (fig. 2) are proofs of the silent, and often unnoticed, presence of safety-risks and are just a glimpse of the collective amount of hazards in the park. This suggests that extensive and continuous risk-assessments should be enforced in order to maintain a safe environment. The rapid formation of flash-floods, after a rain- or snow-fall, likewise point to the need of the continuous monitoring of weather patterns and its effect on Petra's archaeological and natural features.

Continuous risk-assessments of unconsolidated natural features, such as the Al-Habis and Treasury boulder, should be conducted. Rock-fissures, which could lead to collapse, should be monitored and filled with the correct mortar which should first be technically evaluated (Al-Saad and Abdel-Halim, 2001:926–932). Strict regulations regarding the allowance of visitors during significant rain- or snowfall should be applied to prevent dangerous situations. As well, installing steel-safety nets (fig. 4) will contribute to the park's safety in case of rock-falls (Volkwein et al., 2011:2617–2639). Through the enforcement of safety regulations, protection measures, extensive risk- and damage-assessments and mapping affected monuments, damage can be reduced and prevented (Alshawabkeh and Bala'awi, 2010:127; Delmonaco, Margottini, and Spizzichino, 2013:441–446). If implemented, these options will contribute to the protection of Petra's archaeology, visitors, and future; and with that, the protection of irreplaceable and valuable data required to retrieve an understanding of this region's past.

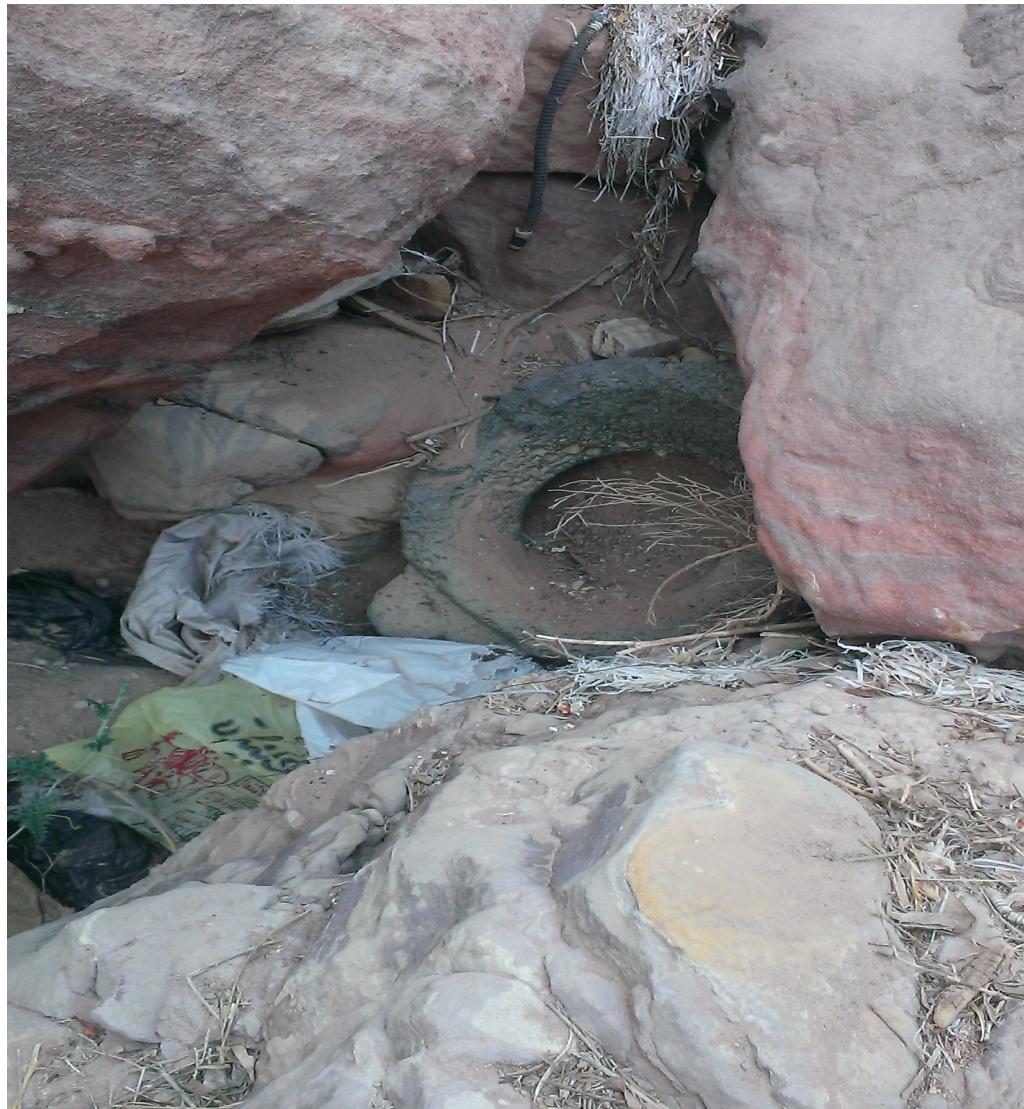
**Figure 3:** An ancient basalt grinder transported and deposited by a flash-flood
