The Crumbling Wonder: A damage- and risk-assessment of sandstone monuments and natural features in the Petra Archaeological Park (Jordan)

Keywords: Archaeology, Heritage Preservation, Safety-Risks, Nabataean, Weathering, Monuments

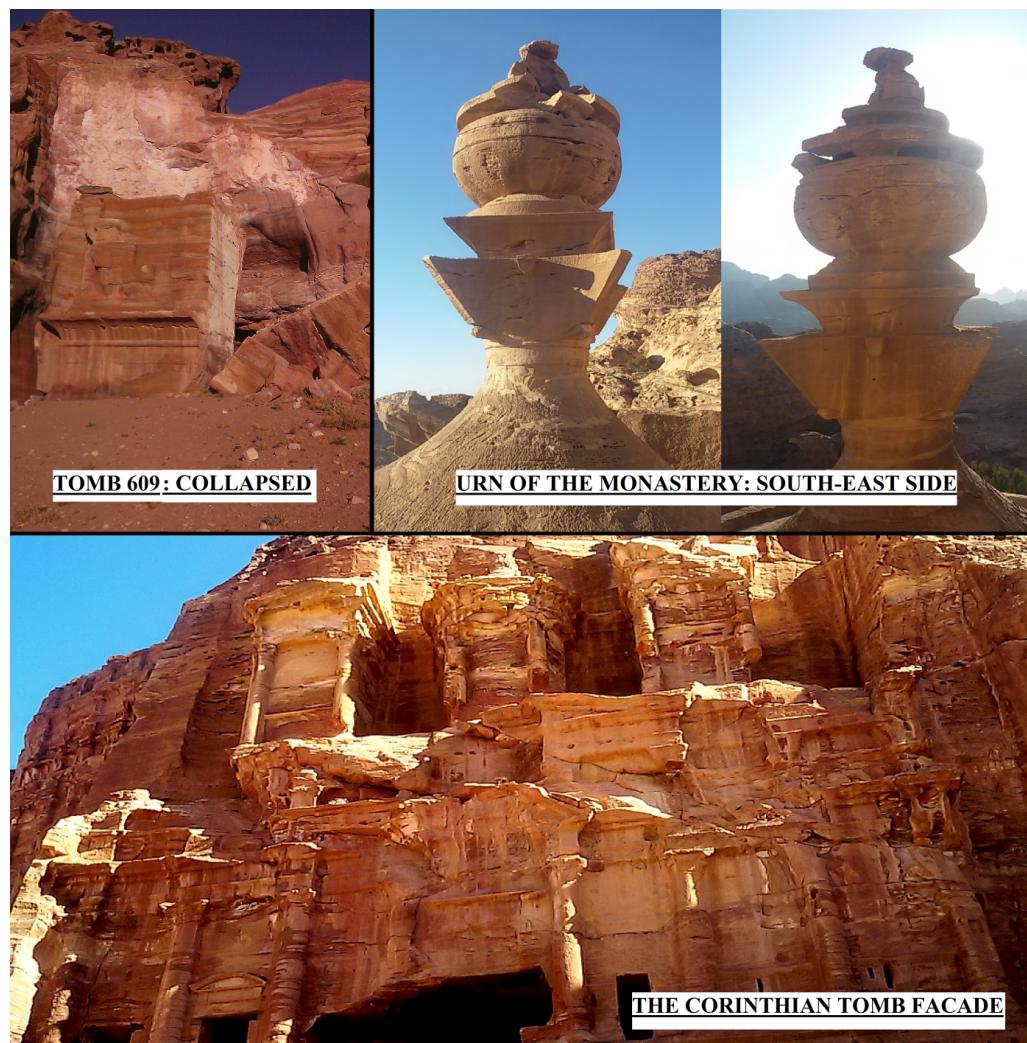
Various collapsed monuments in Petra are the greatest examples and silent witnesses of the continuous forces of weathering and degradation. The most recent example is Tomb 609 with the collapse of its façade (fig. 1) after heavy rainfall in March 2010, known as the Mu'Eissra collapse (Heinrichs and Azzam, 2013a:583). Tomb 609 followed a lengthy process of weathering through natural agents such as: water erosion, seasonal and daily temperature fluctuations, salt-wedging and wind ablation, which caused physical stress and rock failure. The rainfall was likely the last of a series of natural events causing its façade to collapse.

Figure 1: *The monuments assessed in this research.*

This monument has the largest façade⁴ in Petra and is known as the Monastery (Maqsood, 1994:117–121). The focus, regarding degradation, for this case-study was on the sculpted urn, which tops the monument. Not observable from the front-view, is the severe deterioration of its South-East side (fig. 1). This side of the Urn has been eroded through natural weathering and anthropogenic activity. During the field-surveys in Petra, locals and tourists were observed performing unauthorized climbing activities on this monument. These illicit activities and irresponsible behaviours, occurring throughout the Petra Archaeological Park, has created enhanced degradation (Paolini et al., 2012:86). The natural agents most affecting the Monastery itself are wind ablation, surface run-off water, salt-crystallization, and vegetation (Alshawabkeh and Bala’awi, 2010:126–

130; Doehne, 2002:1–2). These are the same factors damaging its Urn's surface and structure. Without intervention, the Urn will further deteriorate and this could lead to destabilisation and eventual collapse. The latter will pose a threat to visitors of the Monastery.

Another affected monument is part of the Royal Tombs, which are carved out of the Al-Khubta mountain. The chosen monument is known as the Corinthian Tomb, the façade is extremely weathered and resembles a water-damaged painting (Sachet, 2010:257). Various processes are responsible for the degradation of the Royal Tombs, such as: salt-wedging, surface run-off water, vegetation, wind ablation, and tectonic movements (Balaáwi et al., 2011:267–284; Doehne, 2002:1–3; Nichols, 2009:90; icomos2005). In the case of the Corinthian Tomb, surface run-off water and consequential salt-crystallization are the main contributors to its façade's decay and destabilization. The latter could result in collapse; this is a threat to the integrity and safety of the souvenir shops, people, and archaeology in its proximity. Vegetation is another factor contributing to the deterioration of archaeological monuments (Balaáwi et al., 2011:267–284). Likewise, vegetation is observed on the façade of the Corinthian Tomb and indicates that plant removal is necessary. If degradation and the absence of protection continues, its façade might be unrecognizably weathered or collapsed in the future.

The condition of the Monastery's Urn and the Corinthian Tomb both indicate the urgent need for attention and protection. Additionally, the collapsed Tomb 609 makes clear that continuous damage-assessments throughout Petra are required in order to safeguard Petra's archaeology (Heinrichs, 2008:672). Several conservation works have been fulfilled in Petra however, not all are successful. One unsuccessful attempt occurred at the Qasr-al Bint where structural parts were impregnated with an incorrect mortar-type causing further damage. This partially was due to the lack of a single conservation-policy in Jordan's heritage sector which then led to various unaligned conservation interventions. Various mortar-types have negative and positive merits that should be kept in mind during conservation works in Petra (Al-Saad and Abdel-Halim, 2001:926–932). Desalination techniques are available, which reduce salt-crystallization; however, this needs improvement since some techniques increase decay (Matyšcák, Ottosen, and Rörig-Dalgaard, 2014:561–563; Rörig-Dalgaard, 2015:1915–1916; Young, Urquhart, and Laing, 2003:1125–1129). Furthermore, the process of salt-weathering remains poorly understood and requires further research. Currently, the 'petraSalt' research-project is aimed at gaining a better understanding of salt-weathering that may lead to improved methods that reduce the impact of salt-weathering (Heinrichs and Azzam, 2013b:347–348).

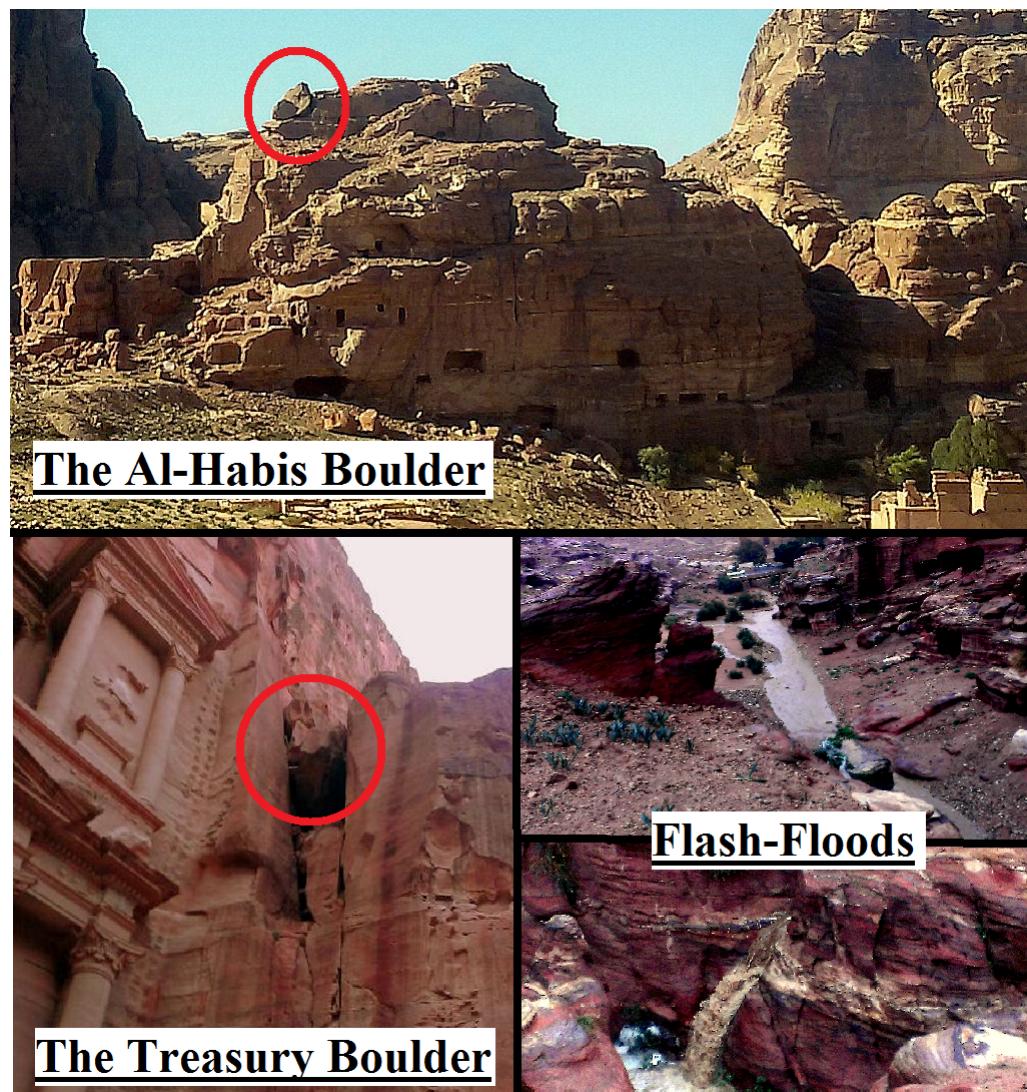
The first selection was a significant sandstone boulder stuck between a wedge-shaped fissure located to the upper-right side of the Treasury (fig. 2). The boulder is trapped in a rock-fissure; however, it could yet pose a safety-risk upon movement resulting from significant surface run-off water or earthquakes. Steel safety nets could be installed to catch falling debris upon collapse, whereas ignoring this risk could otherwise threaten the park's safety and the Treasury's façade (Volkwein et al., 2011:2617–2639).

The second natural feature is the boulder topping the Al-Habis mountain (fig. 2). If this boulder falls downward in the East direction, it could tumble down the adjacent hill into archaeological structures and tourist facilities. This indicates a safety-risk in the case of dislocation caused by substantial forces such as earthquakes, which are not uncommon in this region. Petra has witnessed powerful earthquakes in the past, which inflicted great damage to its archaeology⁵ (Alshawabkeh and Bala'awi, 2010:126; Heinrichs, 2008:644). Due to the Habis boulder's unconsolidated state and the possibility of an earthquake, it should be subjected to further risk-assessment and safety procedures.

Figure 2: *The three natural and potential hazardous features.*

Continuous risk-assessments of unconsolidated natural features, such as the Al-Habis and Treasury boulder, should be conducted. Rock-fissures, which could lead to collapse, should be monitored and filled with the correct mortar which should first be technically evaluated (Al-Saad and Abdel-Halim, 2001:926–932). Strict regulations regarding the allowance of visitors during significant rain- or snowfall should be applied to prevent dangerous situations. As well, installing steel-safety nets (fig. 4) will contribute to the park's safety in case of rock-falls (Volkwein et al., 2011:2617–2639). Through the enforcement of safety regulations, protection measures, extensive risk- and damage-assessments and mapping affected monuments, damage can be reduced and prevented (Alshawabkeh and Bala'awi, 2010:127; Delmonaco, Margottini, and Spizzichino, 2013:441–446). If implemented, these options will contribute to the protection of Petra's archaeology,

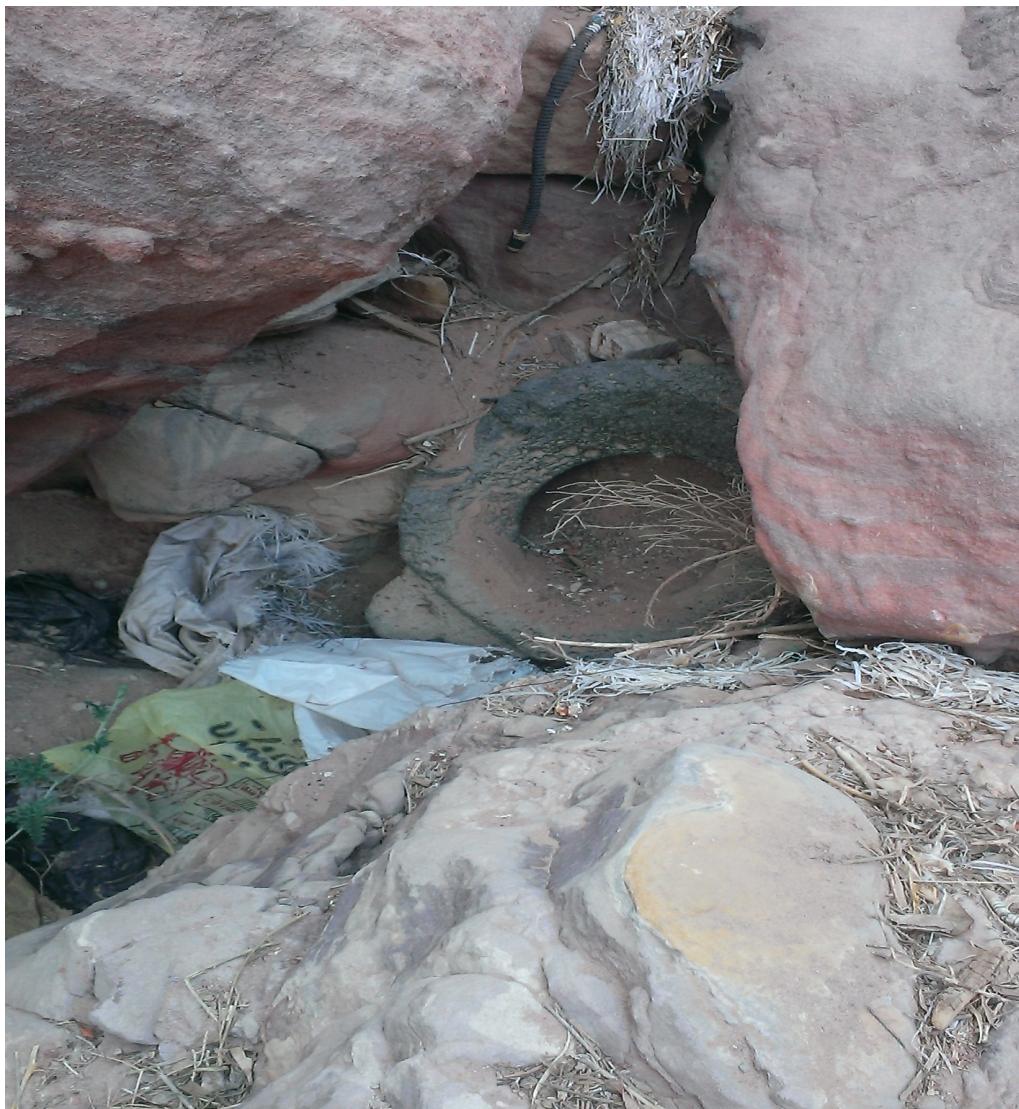
field survey in the winter of 2014, when a rapidly formed flash-flood transported and deposited an ancient basalt grinder (fig. 3) and various large boulders. The force and volume of the flash-flood depends on the amount of rainfall and surface run-off water supplied through nine catchment areas located in the Petra area (Al-Weshah and El-Khoury, 1999:171–172; Nichols, 2009:130). Flash-floods pose a major threat to people inside Petra; this was proven by the flash-flood of 1963, which killed more than 20 French tourists (Comer, 2012:55–57; Lingis, 2002:55).

Figure 3: An ancient basalt grinder transported and deposited by a flash-flood.

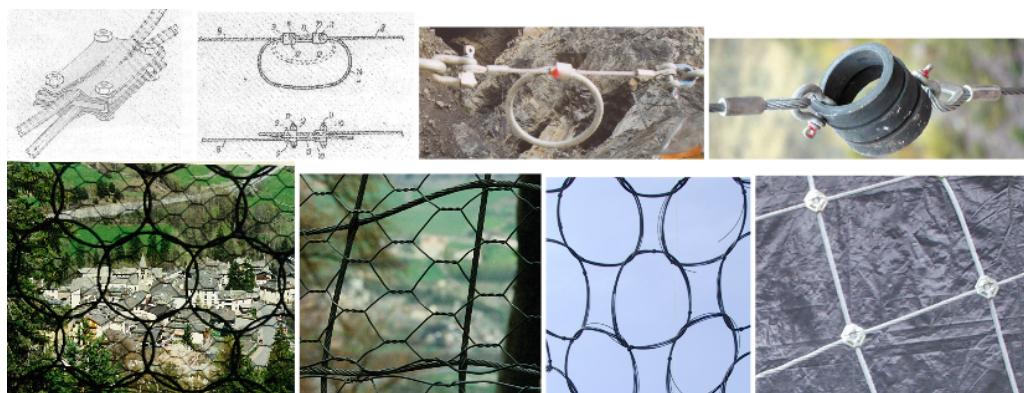
Figure 4: An example of safety-measures.

In regards to the chosen natural features, various options could contribute to maintain the safety for Petra's archaeology and visitors, such as steel-nets (fig. 4), which retain falling debris during rock-falls (Volkwein et al., 2011:2638). The Al-Habis boulder and the Treasury's boulder (fig. 2) are proofs of the silent, and often unnoticed, presence of safety-risks and are just a glimpse of the collective amount of hazards in the park. This suggests that extensive and continuous risk-assessments should be enforced in order to maintain a safe environment. The rapid formation of flash-floods, after a rain- or snow-fall, likewise point to the need of the continuous monitoring of weather patterns and its effect on Petra's archaeological and natural features.
