# The Crumbling Wonder: A damage- and risk-assessment of sandstone monuments and natural features in the Petra Archaeological Park (Jordan)

VALLETTA ARETTI MARIA VEREZEN \*

Graduate Archaeologist, Leiden University

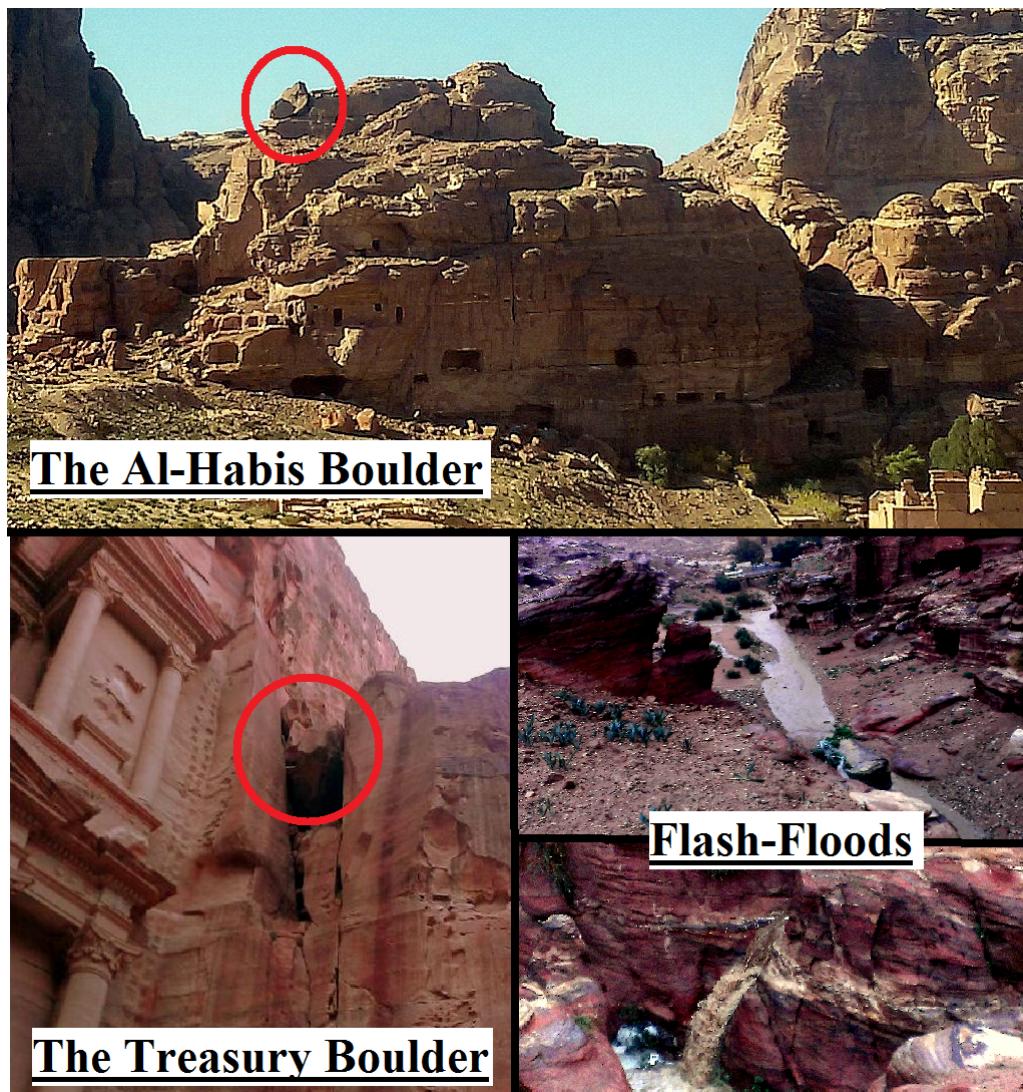
The first selection was a significant sandstone boulder stuck between a wedge-shaped fissure located to the upper-right side of the Treasury (fig. 2). The boulder is trapped in a rock-fissure; however, it could yet pose a safety-risk upon movement resulting from significant surface run-off water or earthquakes. Steel safety nets could be installed to catch falling debris upon collapse, because ignoring this risk could otherwise threaten the park’s safety and the Treasury’s façade (Volkwein et al., 2011:2617–2639).

The second natural feature is the boulder topping the Al-Habis mountain. If this boulder falls downward in the East direction, it could tumble down the adjacent hill into archaeological structures and tourist facilities. This indicates a safety-risk in the case of dislocation caused by substantial forces such as earthquakes, which are not uncommon in this region. Petra has witnessed powerful earthquakes in the past, which inflicted great damage to its archaeology<sup>5</sup> (Alshawabkeh and Bala’awi, 2010:126; Heinrichs, 2008:644). Due to the Habis boulder’s unconsolidated state and the possibility of an earthquake, it should be subjected to further risk-assessment and safety procedures.

Throughout time, flash-floods are natural hazards occurring inside Petra and are known for their destructive force and capability of removing significant amounts of debris

**Figure 2:** *The three natural and potential hazardous features.*

(Franchi et al., 2009:78–84; Ortloff, 2005:104). The debris-filled floods will affect any archaeological and natural sandstone in its path. This force was observed during a field survey in the winter of 2014, when a rapidly formed flash-flood transported and deposited an ancient basalt grinder (fig. 3) and various large boulders. The force and volume of the flash-flood depends on the amount of rainfall and surface run-off water supplied through nine catchment areas located in the Petra area (Al-Weshah and El-Khoury, 1999:171–172; Nichols, 2009:130). Flash-floods pose a major threat to people inside Petra; this was proven by the flash-flood of 1963, which killed more than 20 French tourists (Comer, 2012:55–57; Lingis, 2002:55).

In regards to the chosen natural features, various options could contribute to maintain the safety for Petra's archaeology and visitors, such as steel-nets (fig. 4), which retain falling debris during rock-falls (Volkwein et al., 2011:2638). The Al-Habis boulder and the Treasury's boulder (fig. 2) are proofs of the silent, and often unnoticed, presence of safety-risks and are just a glimpse of the collective amount of hazards in the park. This suggests that extensive and continuous risk-assessments should be enforced in order to maintain a safe environment. The rapid formation of flash-floods, after a rain- or snow-fall, likewise point to the need of the continuous monitoring of weather patterns and its effect on Petra's archaeological and natural features.

Continuous risk-assessments of unconsolidated natural features, such as the Al-Habis and Treasury boulder, should be conducted. Rock-fissures, which could lead to collapse, should be monitored and filled with the correct mortar which should first be technically evaluated (Al-Saad and Abdel-Halim, 2001:926–932). Strict regulations regarding the allowance of visitors during significant rain- or snowfall should be applied to prevent dangerous situations. As well, installing steel-safety nets (fig. 4) will contribute to the park's safety in case of rock-falls (Volkwein et al., 2011:2617–2639). Through the enforcement of safety regulations, protection measures, extensive risk- and damage-

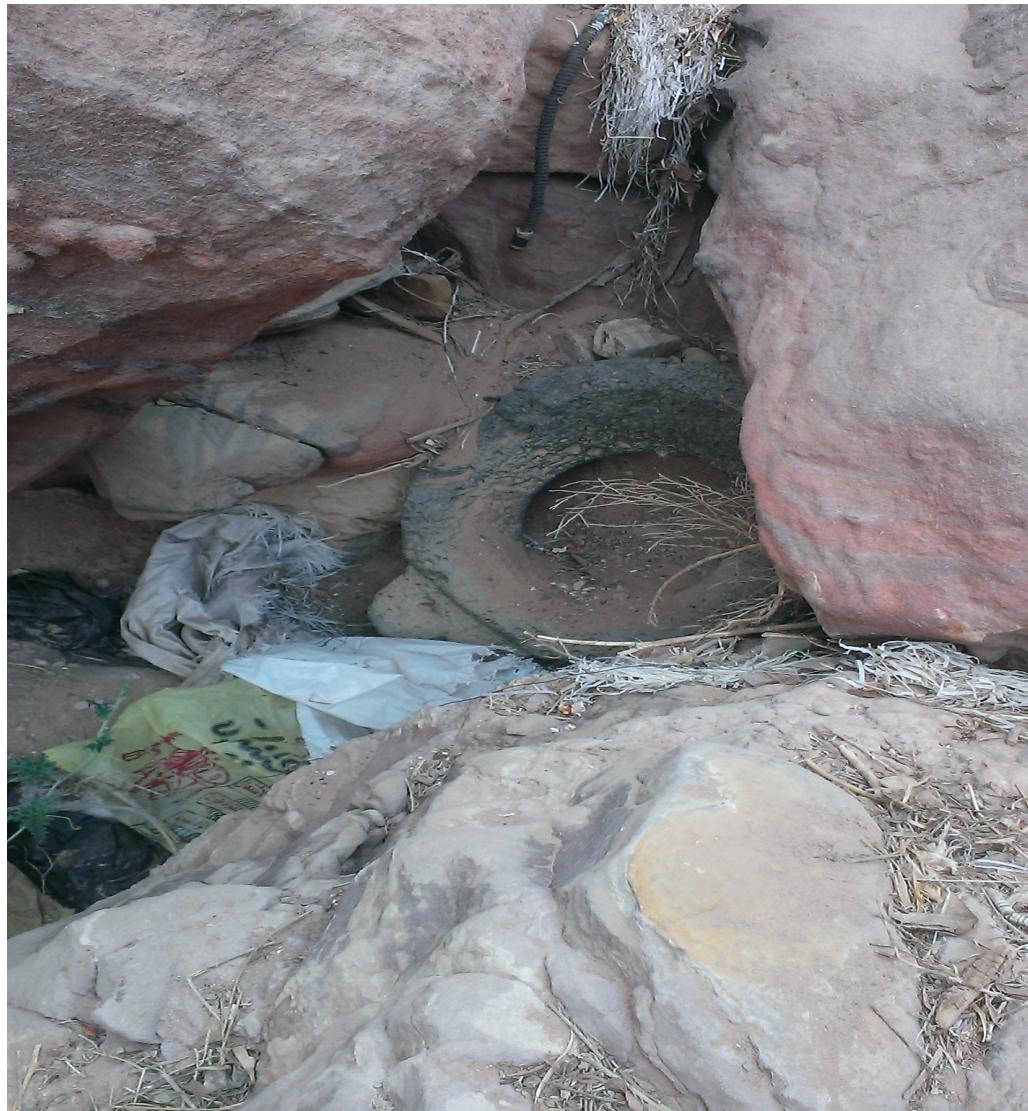
**Figure 3:** An ancient basalt grinder transported and deposited by a flash-flood.
