Unit ID: 5-BM-2

Description: Kiln 1 Ball Mill Gear Box

Sample ID: 25147288013

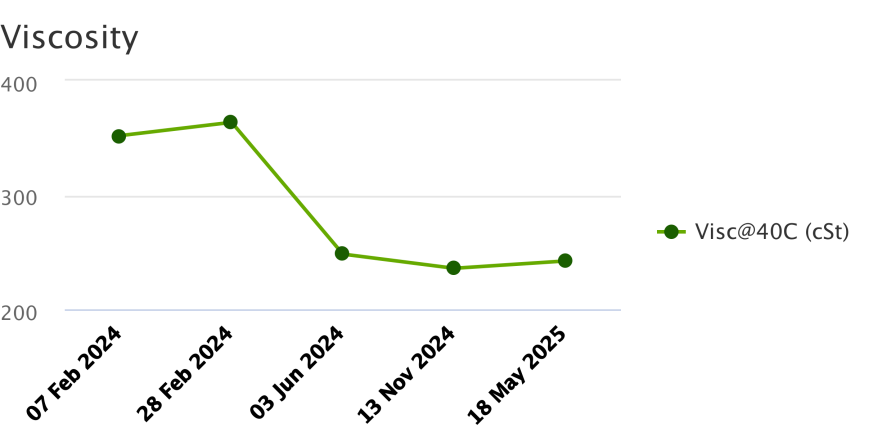
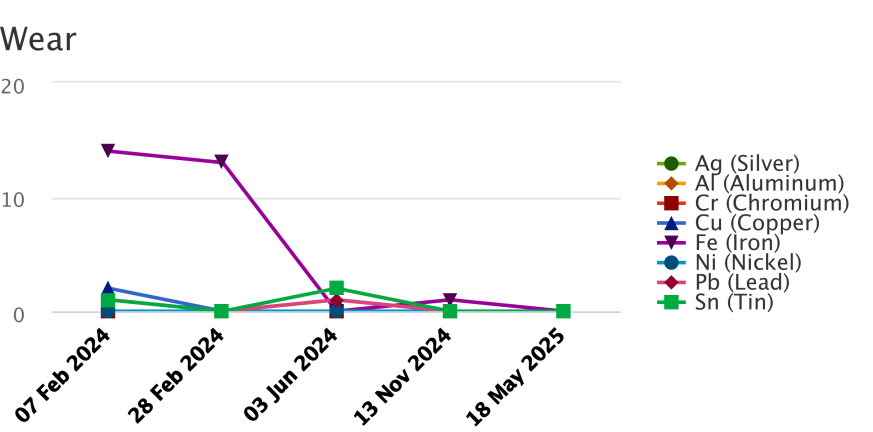
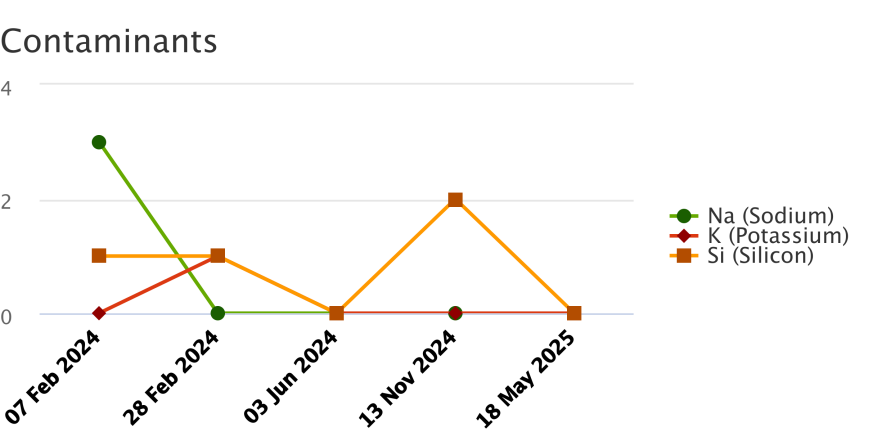
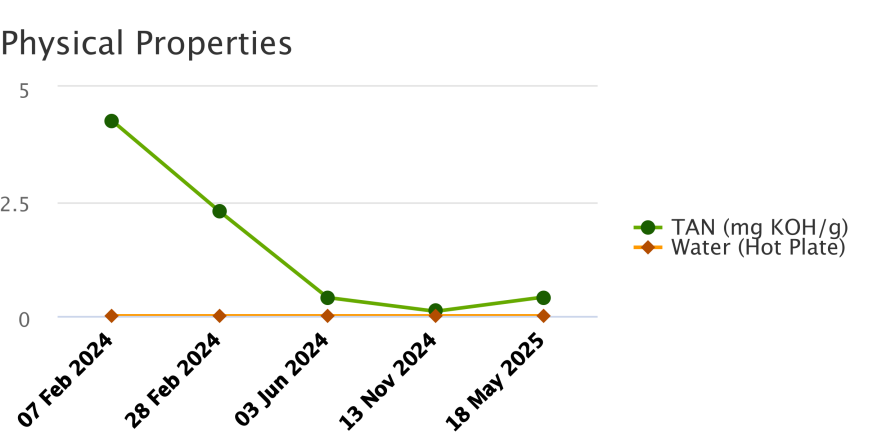
| | Visc@40C (cSt) | 351.9 | 363.5 | 248.2 | 235.8 | 242.2 |

ACTION REQUIRED - ELEVATED OIL VISCOSITY. Determine cause of elevated oil viscosity and take corrective action. Elevated viscosities can interfere with the cooling process of components and restrict oil flow causing oil starvation and component wear. Possible causes of elevated viscosity include: a. Contact with oil that has a higher viscosity; b. High rates of oxidation and oil degradation; c. Excessive sediment; d. Coolant contamination. A partial drain and refill with fresh oil may rejuvenate the oil condition. Change the oil immediately if the condition escalates. Contact your ExxonMobil representative for further assistance if necessary.
