Mobil™

Unit ID: 4-phu-1

Asset ID: 50326099

Description: Hyd pump

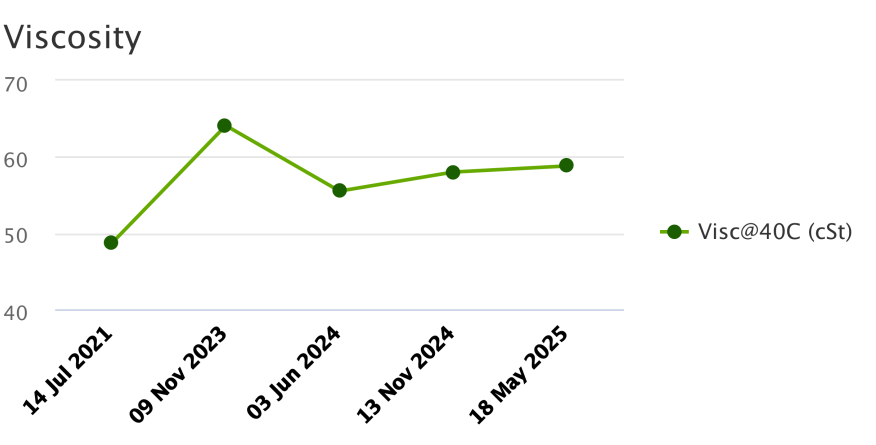
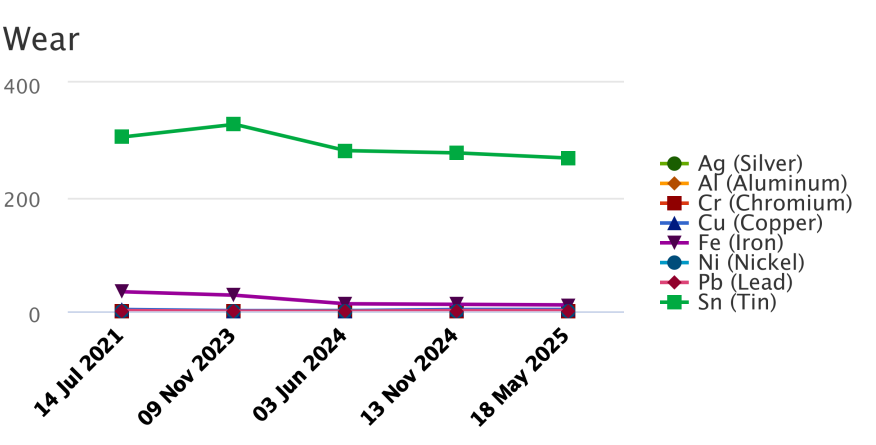
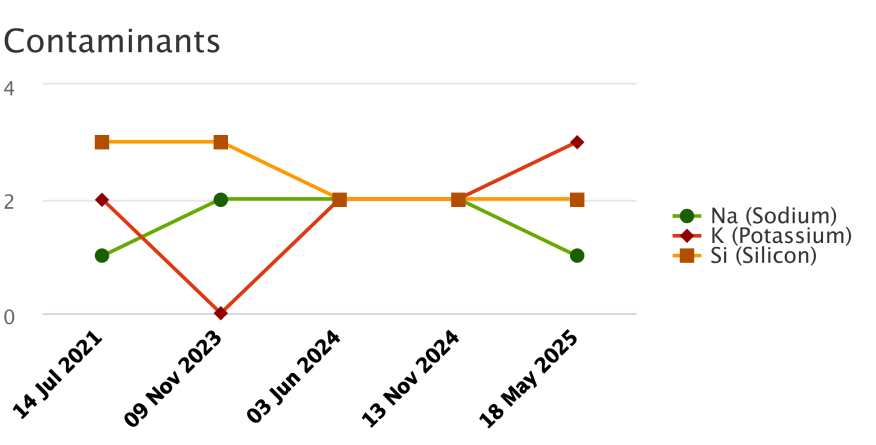
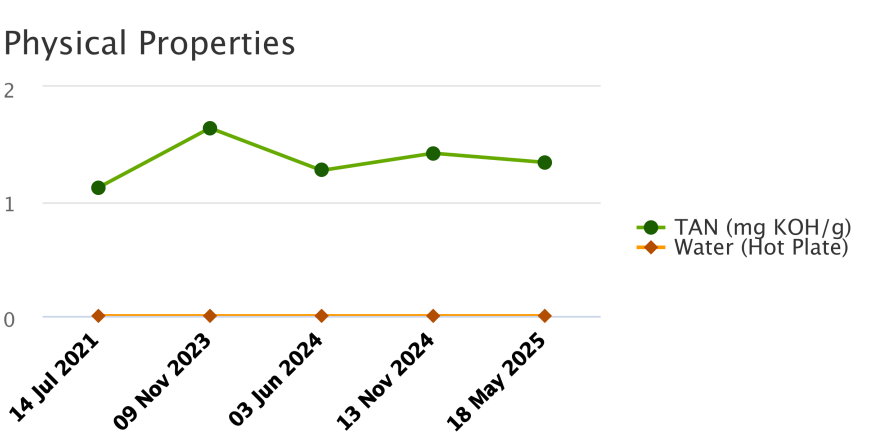
ACTION REQUIRED - ELEVATED OIL VISCOSITY. Determine cause of elevated oil viscosity and take corrective action. Elevated viscosities can interfere with the cooling process of components and restrict oil flow causing oil starvation and component wear. Possible causes of elevated viscosity include: a. Contact with oil that has a higher viscosity; b. High rates of oxidation and oil degradation; c. Excessive sediment; d. Coolant contamination. A partial drain and refill with fresh oil may rejuvenate the oil condition. Change the oil immediately if the condition escalates. Contact your ExxonMobil representative for further assistance if necessary.

ACTION REQUIRED - UNSATISFACTORY OIL CONDITION. Test results indicate that the condition of this oil sample is unsatisfactory. The oil may be unfit for continued use and should be closely monitored further condition regressions. Contact your ExxonMobil representative for further assistance if necessary.
