Mobil™

Unit ID: 1212

Asset ID: 51414377

Description: right rear final drive

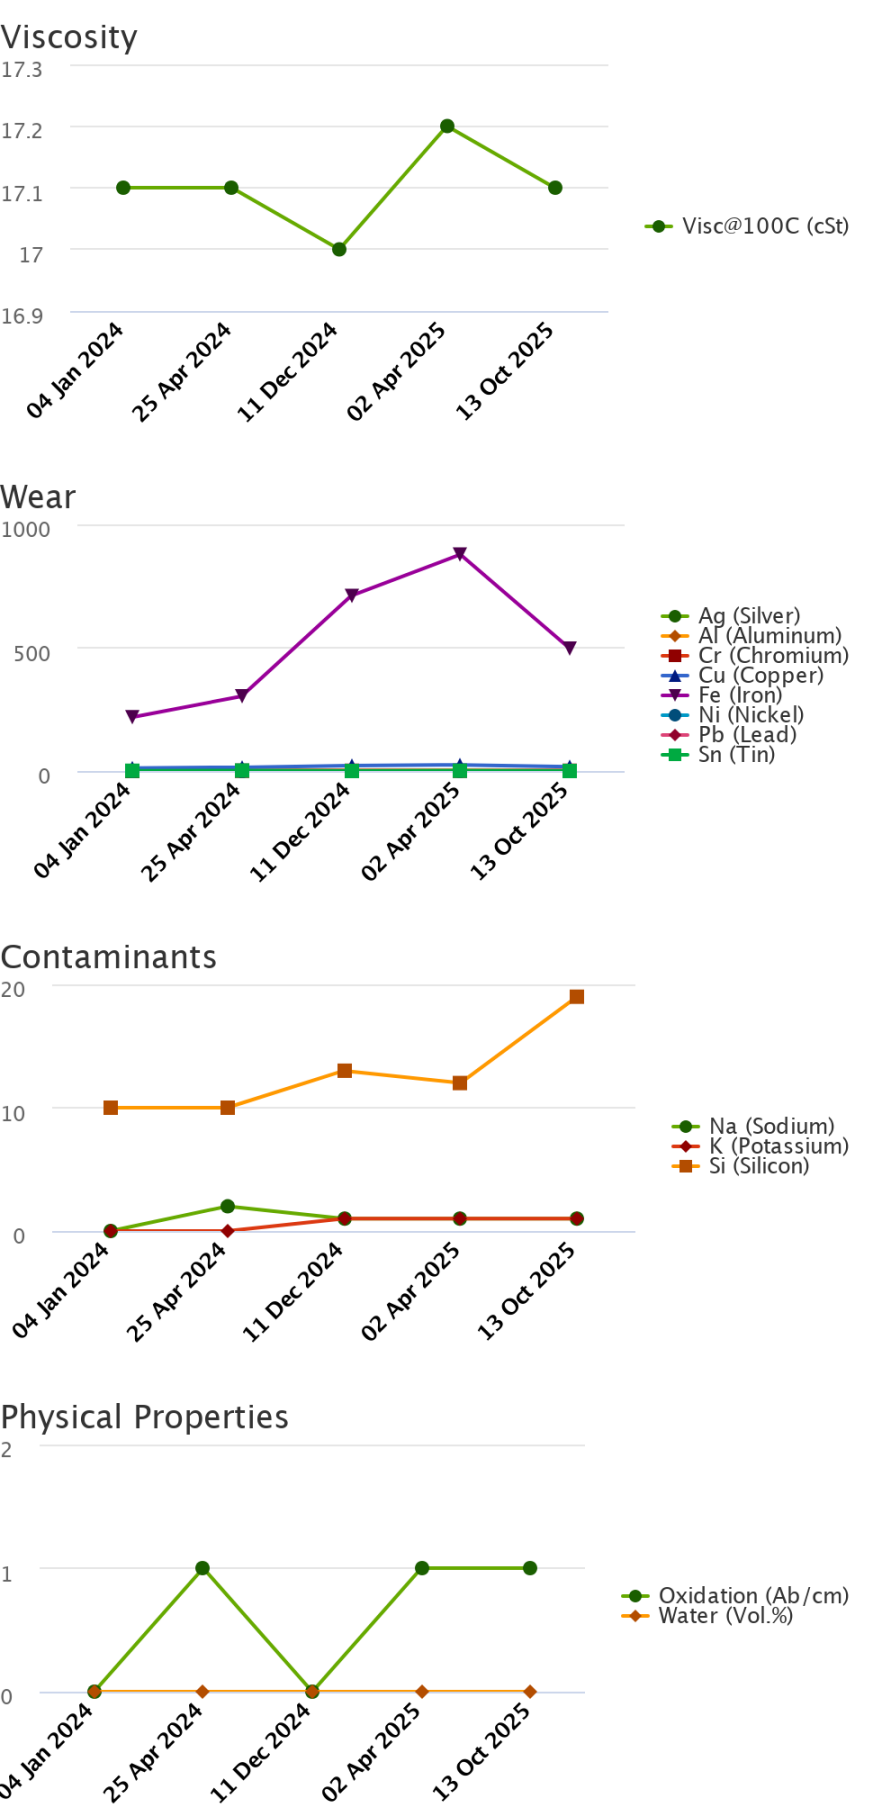
- 13 Oct 2025 3:23 PM UTC - Josh Simmons - In Service Oil Sample    Comments:    Photo:
