Alert

Unit ID: 4-RK-1

Asset ID: 50074758

Description: Kiln 2 Drive Primary Gear Box

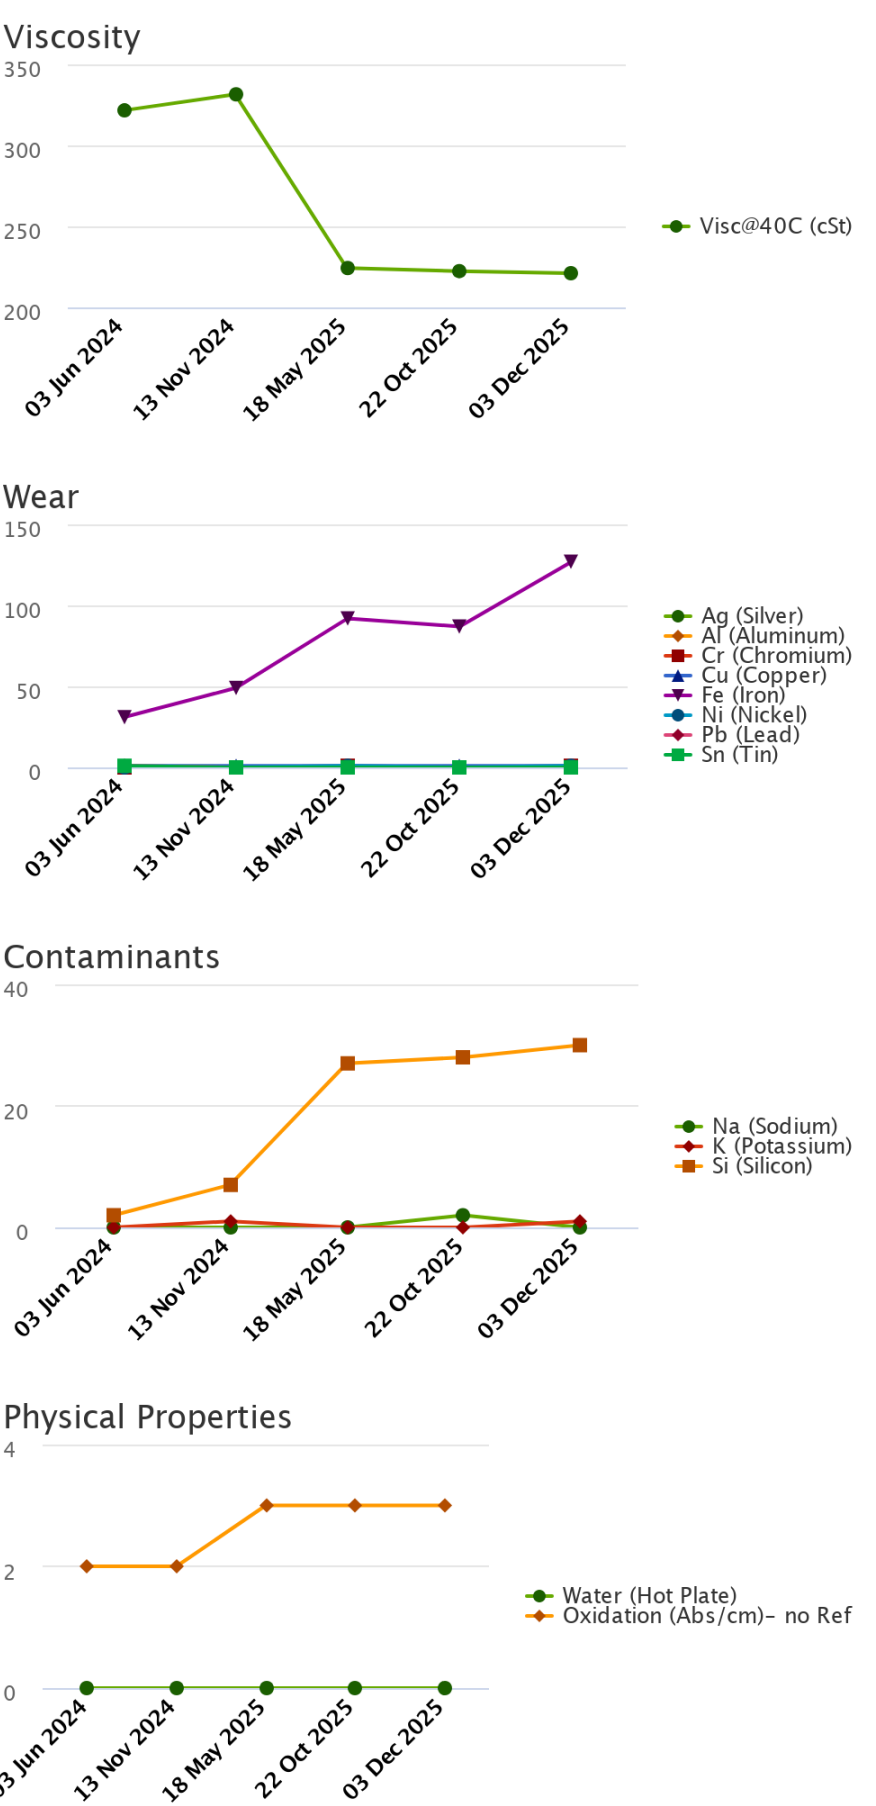
- 03 Dec 2025 10:25 PM UTC - Shawn Turner - In Service Oil Sample    Comments:    Photo:
