Alert

Unit ID: 5-BM-1

Description: Kiln 2 Ball Mill Feed End Bearing

Name: Greer Lime

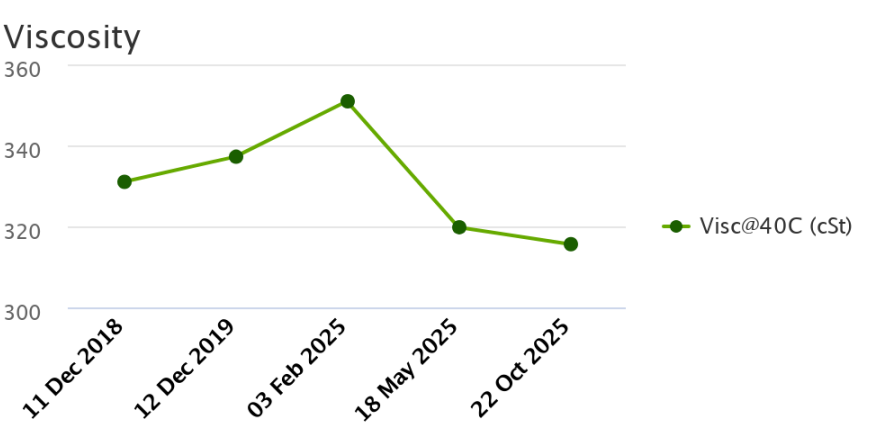
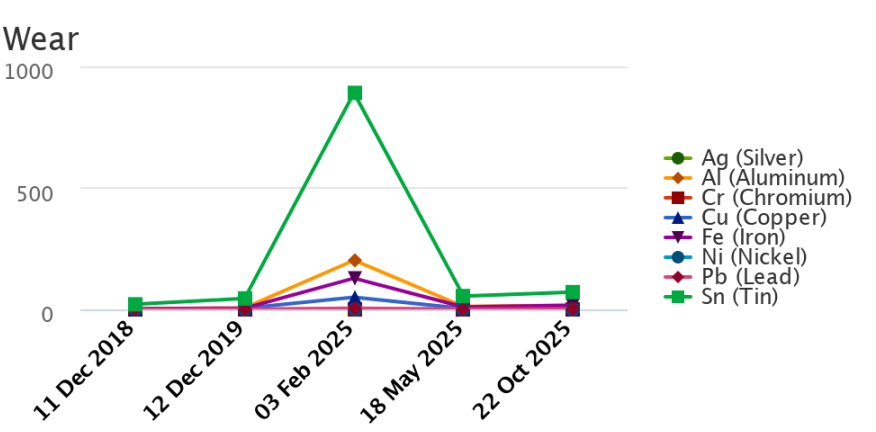
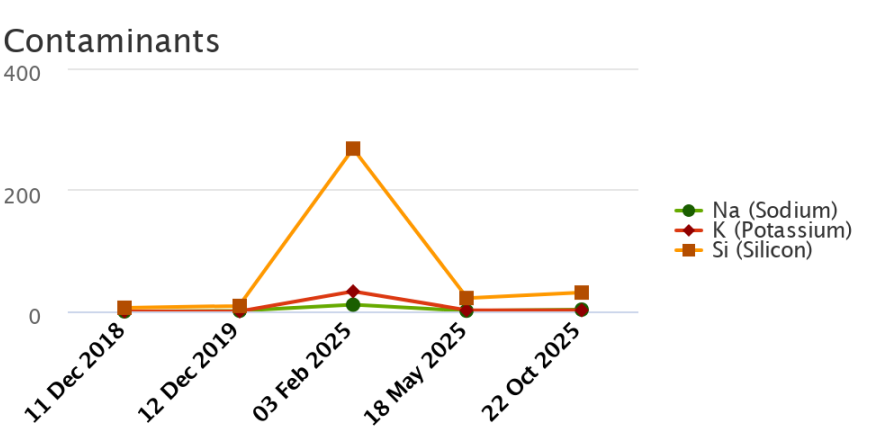
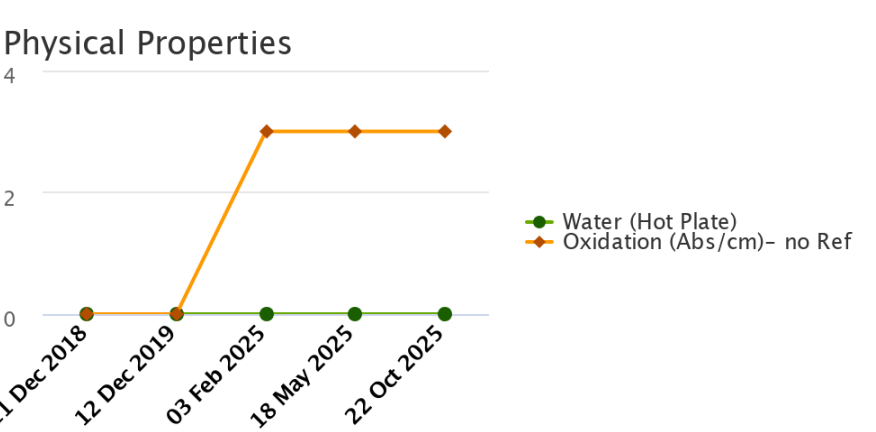
ACTION REQUIRED - ELEVATED SILICON LEVEL. Determine source of Silicon (Si) and take corrective action. If the silicon level is elevated for the first time with no history of an increasing trend, then resample immediately to confirm condition. If the wear metals levels are low, then the silicon likely exists in a non-abrasive form. Possible sources of non-abrasive silicon include: a. Defoamants; b. Sealant compounds. If wear metals levels are elevated, then the silicon likely exists in an abrasive form. Possible sources of abrasive silicon include: a. Abrasive dirt; b. Contamination from environment during an equipment overhaul or shutdown. Other possible sources of silicon include: a. Inefficient or leaking air intake filters; b. Leaking pipes; c. Clogged oil bath air filter; d. Poor oil filtration; e. Dirty sample containers or improper sampling procedures. In landfill gas applications, silicon can enter the engine as a siloxane. This material is a gas and is not normally abrasive; however, siloxanes can easily mask the presence dirt. The oil may be unfit for continued use and should be monitored closely for further condition regressions. Prolonged usage of lubricants with elevated levels of abrasive silicon can cause severe wear and damage to the equipment. Inspect the equipment for signs of excessive wear and change the oil immediately if damage is detected. Contact your ExxonMobil representative for further assistance if necessary.

ACTION REQUIRED - EXCESSIVE WEAR METALS LEVELS. Determine cause of excessive wear metals levels and take corrective action. Possible causes of excessive wear metals levels include: a. Excessively worn bearings, gears, and / or shafts; b. Equipment fatigue; c. Abrasive dirt. The components suffering from excessive wear are unfit for continued use and should be inspected immediately. Change the oil immediately after corrective actions have been implemented. Contact your ExxonMobil representative for further assistance if necessary.

ACTION REQUIRED - UNSATISFACTORY OIL CONDITION. Test results indicate that the condition of this oil sample is unsatisfactory. The oil may be unfit for continued use and should be closely monitored further condition regressions. Contact your ExxonMobil representative for further assistance if necessary.
