Mobil<sup>TM</sup>

Alert

Unit ID: 4-RK-1

Description: Kiln 2 Drive Trunion Bearing 2

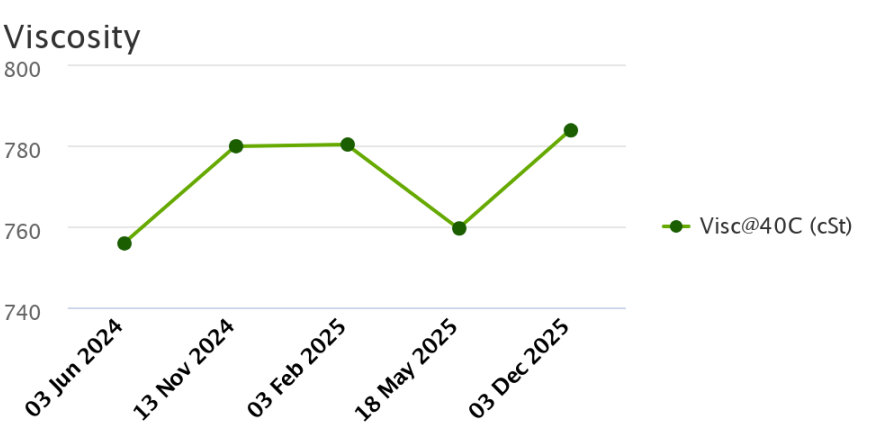
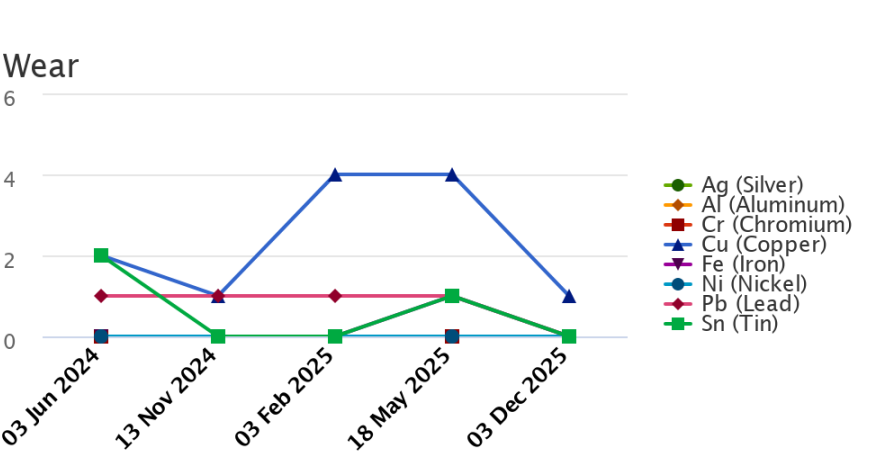
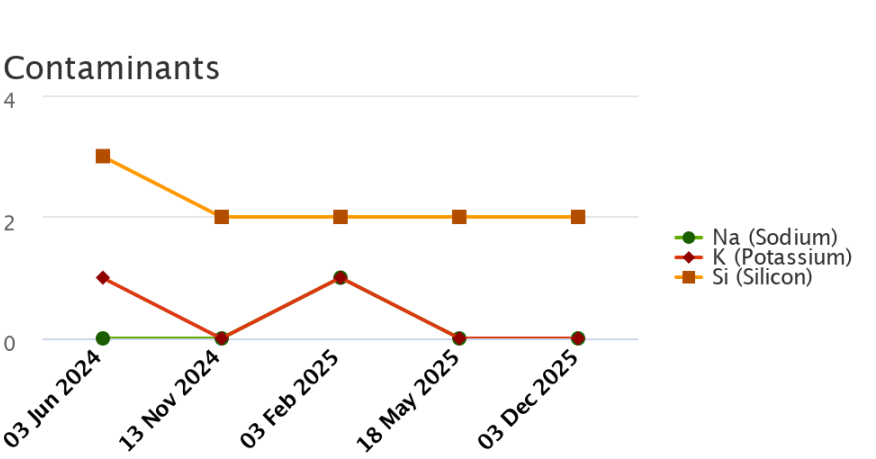
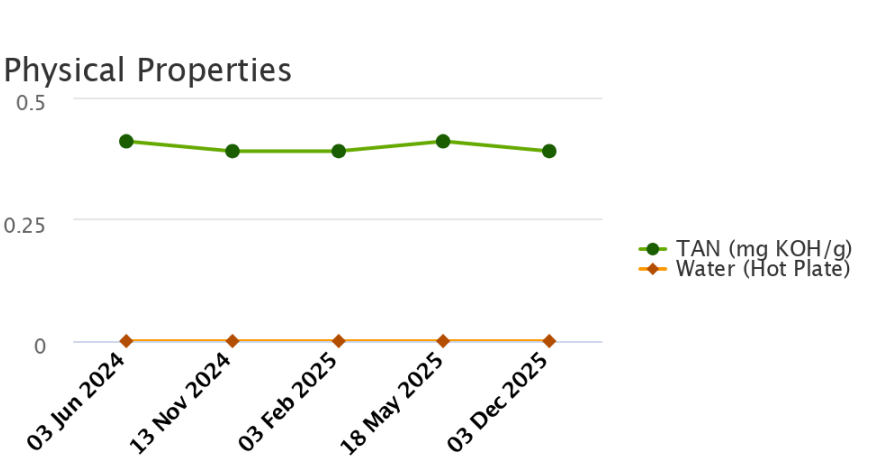
| | Lubricant Rating | Caution | Caution | Caution | Caution | Alert |
| | Visc@40C (cSt) | 755.8 | 779.8 | 780.2 | 759.5 | 783.7 |

ACTION REQUIRED - ELEVATED OIL VISCOSITY. Determine cause of elevated oil viscosity and take corrective action. Elevated viscosities can interfere with the cooling process of components and restrict oil flow causing oil starvation and component wear. Possible causes of elevated viscosity include: a. Contact with oil that has a higher viscosity; b. High rates of oxidation and oil degradation; c. Excessive sediment; d. Coolant contamination. A partial drain and refill with fresh oil may rejuvenate the oil condition. Change the oil immediately if the condition escalates. Contact your ExxonMobil representative for further assistance if necessary.

ACTION REQUIRED - UNSATISFACTORY OIL CONDITION. Test results indicate that the condition of this oil sample is unsatisfactory. The oil may be unfit for continued use and should be closely monitored further condition regressions. Contact your ExxonMobil representative for further assistance if necessary.
