Alert

Unit ID: 7-BL-1 DriveAsset ID: 51875464

Description: Blower

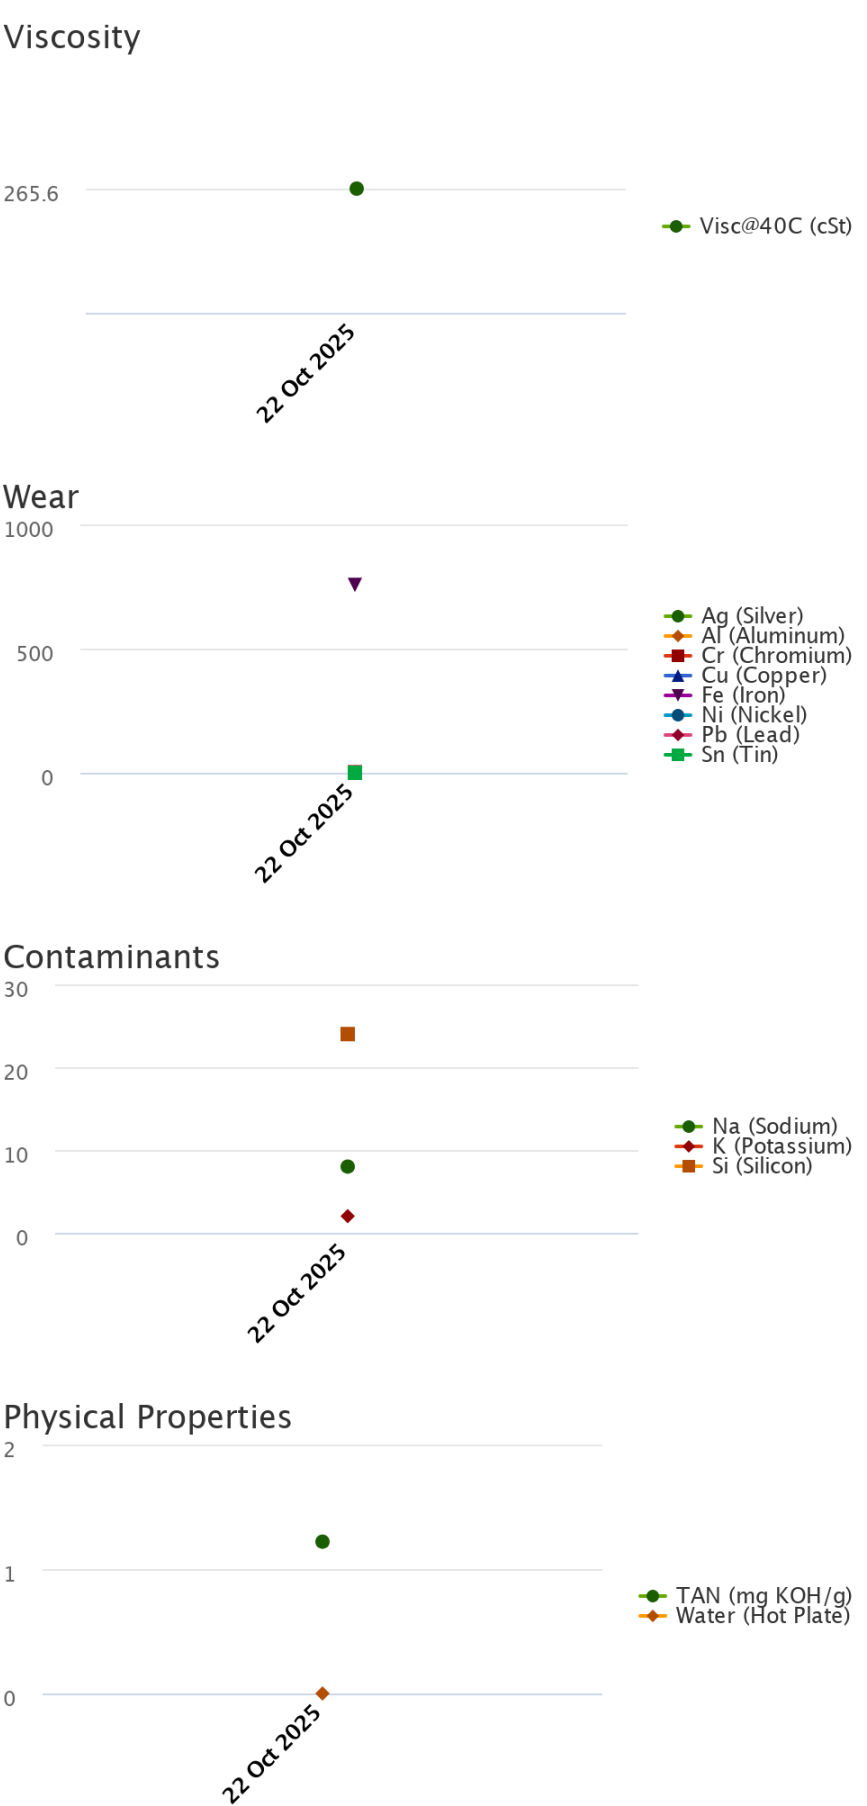
- 22 Oct 2025 9:26 PM UTC - Brad Roy - In Service Oil Sample    Comments: Photo:
