**Government of Telangana  
Hyderabad Metropolitan Water Supply and  
Sewerage Board  
(HMWSSB)**

**OSMAN SAGAR DAM  
Comprehensive Dam Safety Evaluation Report**

**November/ 2025**

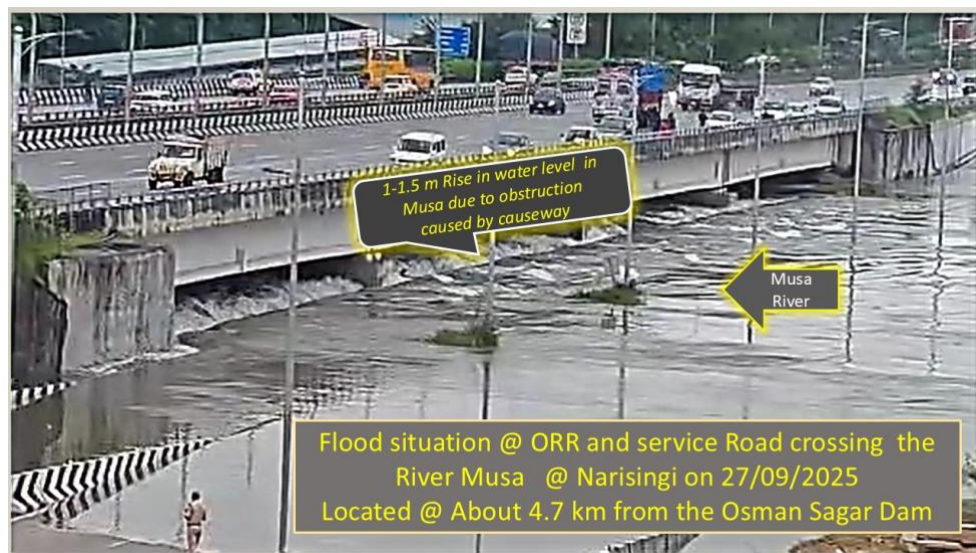
- a. When heavy inflows were received a quantity of 378 cumec was released from 9.00 pm on 26/11 to 5 am on 27/11.

This flood is hardly 15 % of the release capacity of the Spillway of Osman Sagar, but has caused serious disruption to the service Road and the Ring Road, existing close to the Reservoir. Further, disorder along the stream course down below in Hyderabad City was also reported. The visual depicts the rise of water level by 1-1.5m at the first of the two causeways existing in the Musa River Bed. Fundamental requirement of a flood channel is to design bedfall and surface fall based on Conservation of Mass and Energy. The back water curve induced by the said afflux makes the flows sluggish, leading to silting of the River Bed, and inundation of adjoining areas. This condition appears like lack of co-ordination among the line departments to fulfill the Hydrologic needs of the River. It was also reported that free flow of Musi is similarly constricted and in the reaches existing down below.
