DEV NUMBER: DEV25-0151	ORIGINATOR: Roberto Guzmán	DATE: 6-May-25	RAIN BIRD DEVIATION FORM (DRAWING) FORM#233813-01 REV: R		BUSINESS UNIT (SBU and PLANT) W/ PRIMARY DESIGN CONT 025 OTY >> LND	SHEET: 1 OF 1
DMR# (IF APPLICABLE):	DEVIATION TYPE: EXTENSION <input checked="" type="checkbox"/> OF DEV#:			AFFECTED MFG PLANTS (WHERE USED):		
TOP-LEVEL SKU P/N(S) AND MODEL NUMBER(S): A50792, A51021, A51058, A51063, A51095, A51214, A51224, A51230, X64000, X64036, X64039			EFFECTIVITY DATE: 6-May-25	EXPIRATION DATE: 10-Aug-25	005 LAM <input type="checkbox"/> 013S STL <input type="checkbox"/> 025 OTY <input checked="" type="checkbox"/> 041 NOG <input type="checkbox"/> 008 BUY <input type="checkbox"/> 019 AZU <input type="checkbox"/> 028 TUC <input type="checkbox"/> 047 TUC <input type="checkbox"/> 013E EEX <input type="checkbox"/> 020MX NMD <input type="checkbox"/> 026 ELG <input checked="" type="checkbox"/> CHINA <input type="checkbox"/>

DRAWING NUMBER:	DRAWING REVISION:	DEVIATION REVISION:	DRAWING TITLE/ PART DESCRIPTION:		VENDOR:	APPROVALS (ALL REQUIRED):
177449	C	C2	STREAM 360, MICRO SPRAY		RB El Lago	QUALITY MGR. OR QUALITY ENG. Indira Aragón / Ramiro Casas
						MANUFACTURING ENGINEER

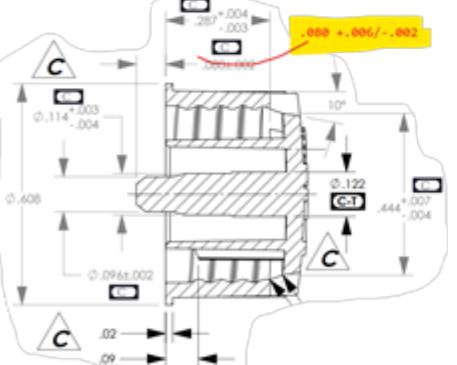
PROJECT NAME OR NO. (OPTIONAL):						
REASON FOR DEVIATION: Conditional approval of QAP1001 for P/N 177449, mold 45117 @ El Lago Molding Facility with optimal process, accepting described conditions and the recommended deviated allowances: 1. .080" +.006" / -.002", CPK 1.0885 proposing .081" +/- .004", CPK 2.30 2. Porosity, weld lines, mold marks, inner rib short shot and drag marks are acceptable. This conditions occurred also when molding in China and Nogales. Be aware that we don't have material available and need to build units to cover backlogged orders.						
RISK ASSESSMENT/ CORRECTIVE ACTION PLAN (NAMES & DATES)/ COMMITMENT:						
Risk assessment: Low: 700 assemblies were tested for leakage at closed position in Arimex. 90 assemblies leaked below 20 ml/min. 610 assemblies did not leak. Corrective action plan: 1. Review component design to standardize features in product family Roberto Guzmán May 25, 2025 2. Identify differences and have a clear path to update design intent Roberto Guzmán June 15, 2025 3. Propose design changes Roberto Guzmán June 22, 2025 4. Test design proposal Roberto Guzmán / Delfino Ramírez / Omar Curiel August 31, 2025 5. Implement design changes Roberto Guzmán / RB El Lago Team December 28, 2025

<u>Acceptable:</u> Porosity

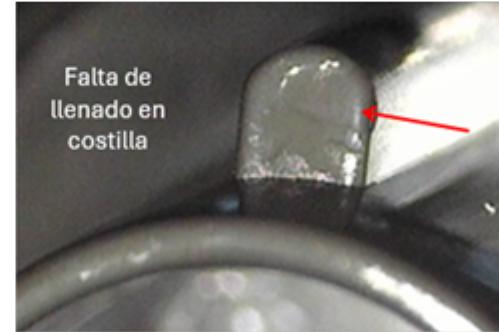
Inner rib short shot

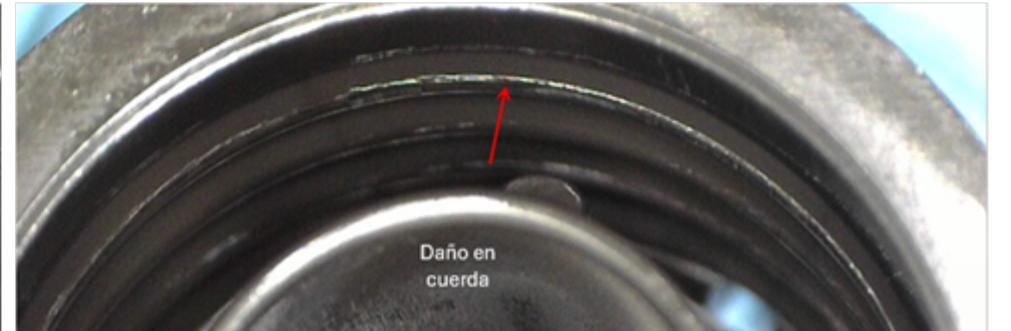
Drag mark
