# Bridge Inspection Report

180570026103105

LOOP 12 WB

US 67

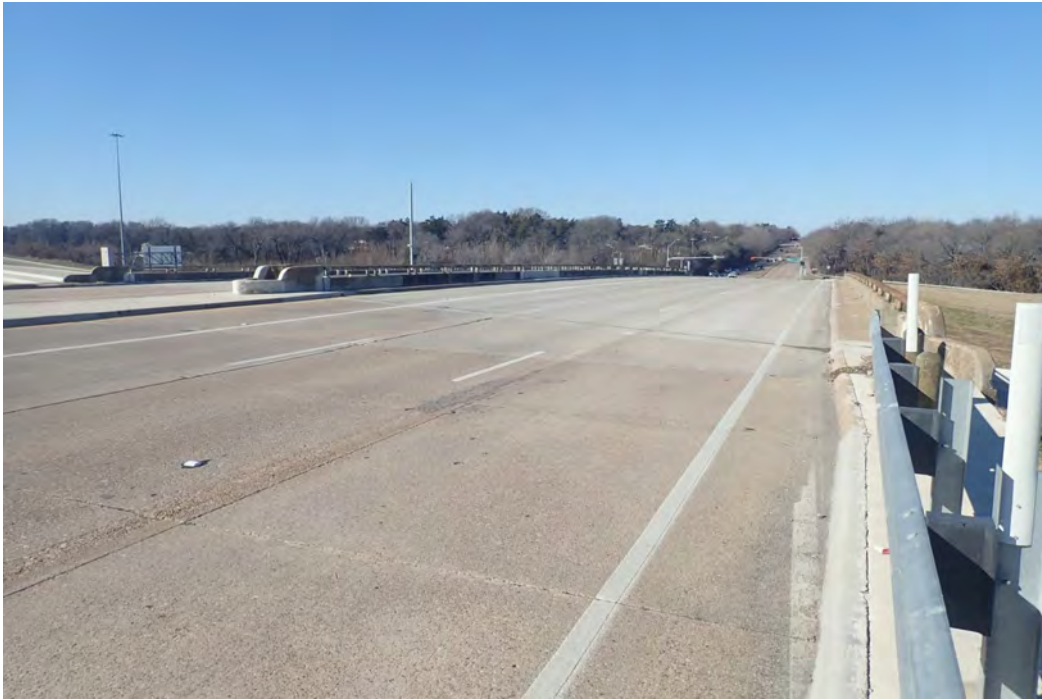
PHOTO 1 Roadway View

Description Looking West

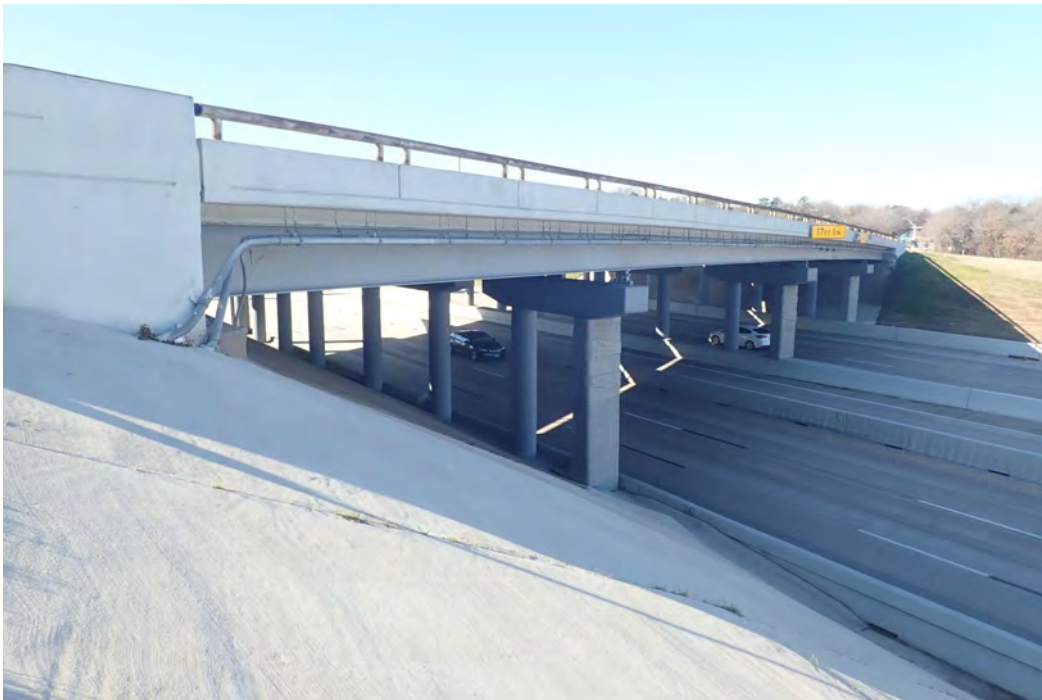
PHOTO 2 Elevation View

Description Looking SW

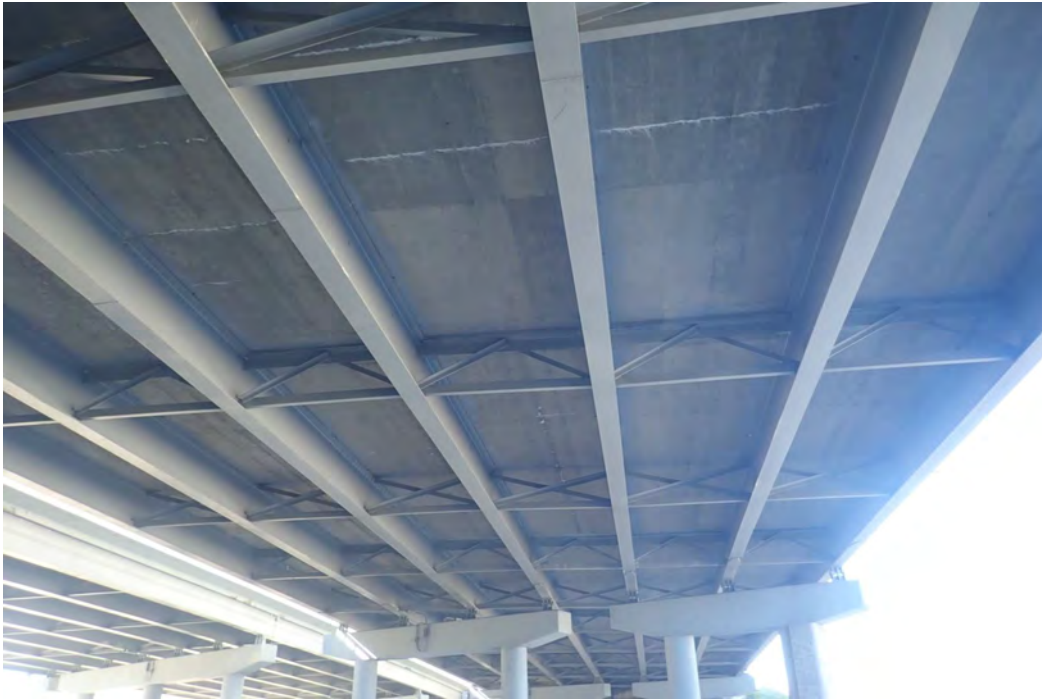
PHOTO 3 Superstructure View

Description Looking West

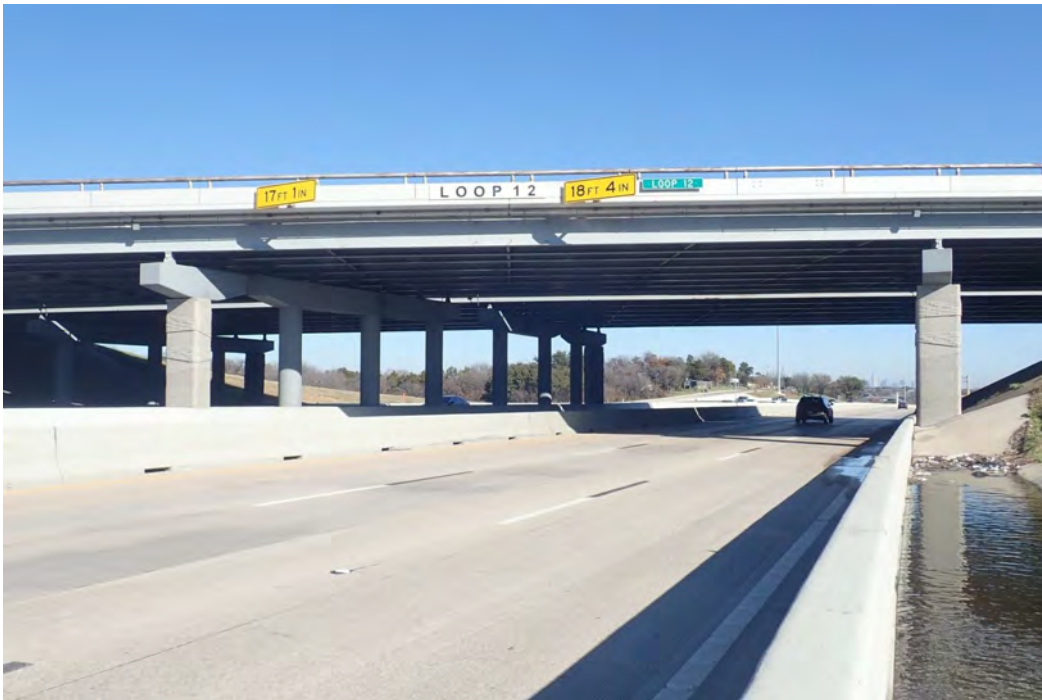
PHOTO 4 Roadway Under View

Description US 67 NB - Looking NE

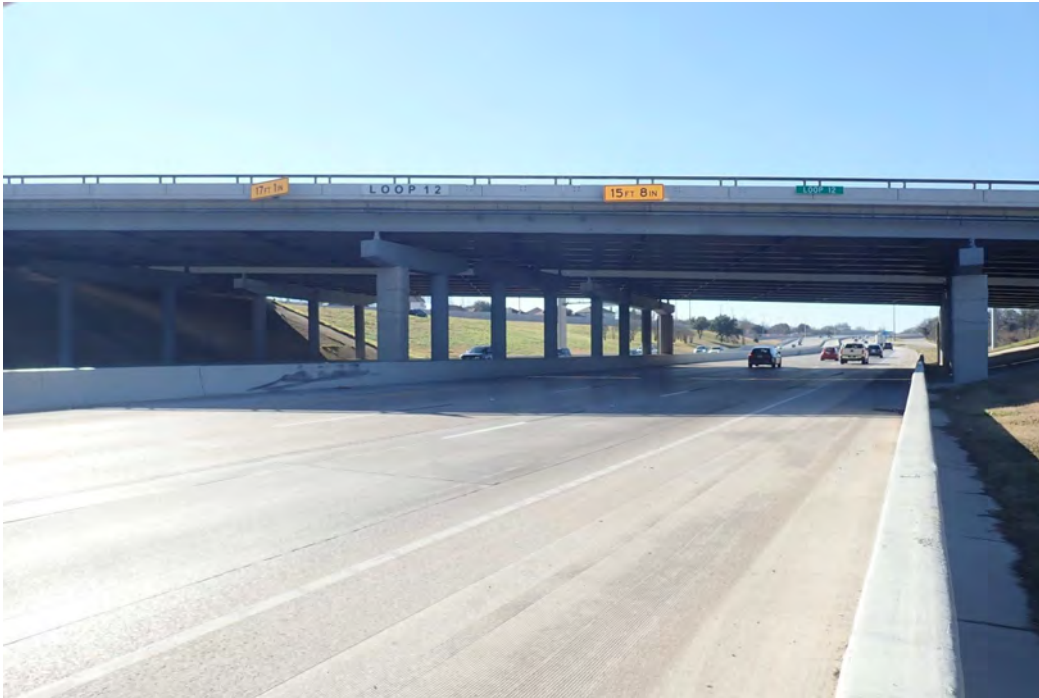
PHOTO 5 Roadway Under View

Description US 67 SB - Looking SW

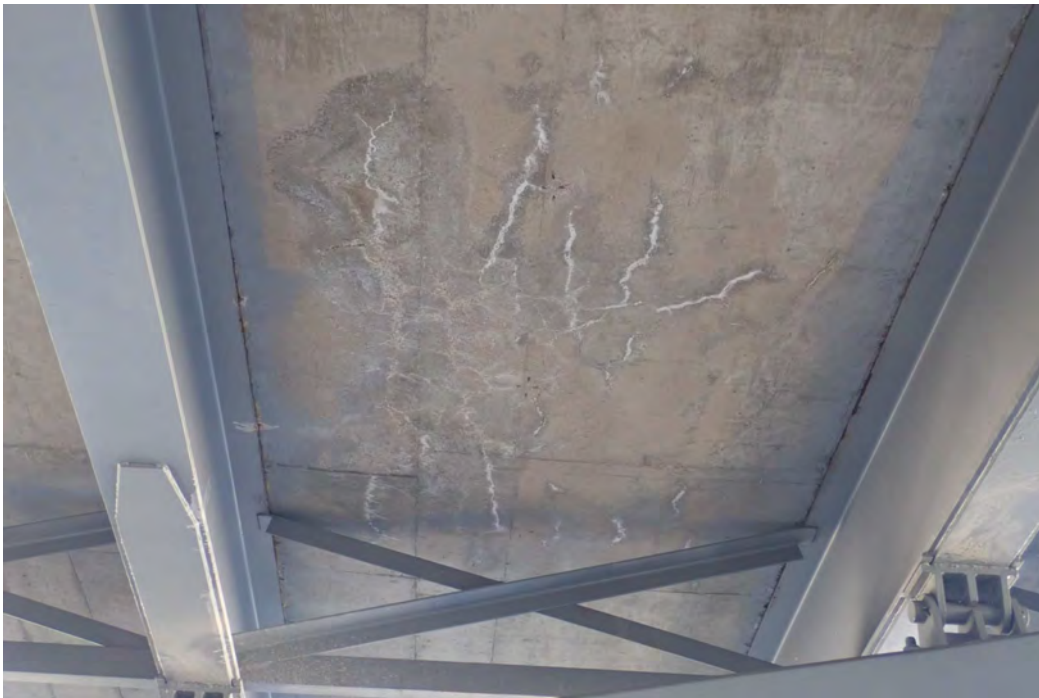
PHOTO 6 Defect

| Component | Description | Min. | Rating | Comment |
|---|---|---|---|---|
| Wearing Surface | None | 6 | N | 1. Concrete deck top surface has minor wear and cracks. Deck soffit has a few minor cracks with efflorescence and isolated minor spalls with exposed rebar. Original deck soffit has some areas with map pattern cracks with efflorescence near the interior supports (see photo) and have some patched areas. |

Description Deck soffit map pattern cracks over Bent 4 - Looking West - Rating: 6  
Original deck soffit has some areas with map pattern cracks with efflorescence near the interior supports.
