# Bridge Inspection Report

180430C00812001  
COLDWATER CRK LANE  
over  
COTTONWOOD CREEK TRIB

Inspection Date: 03/18/2023

Inspected By: Modjeski and Masters, Inc.

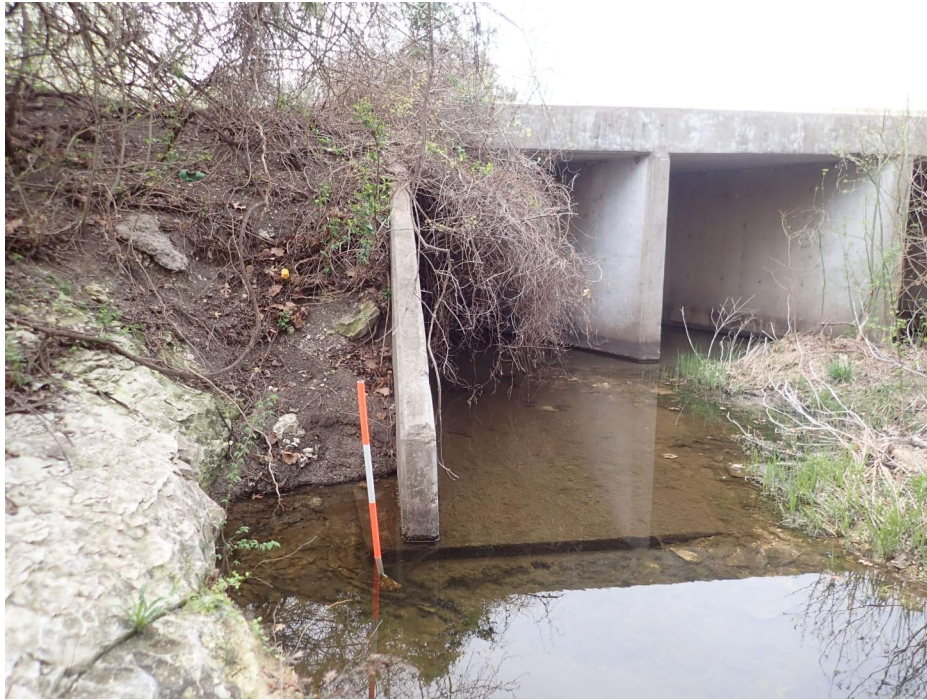
PHOTO 1 Recommended Maintenance Needs

A large area of erosion is present behind the northeast wingwall up to 2' deep, and scour has exposed the wingwall footing and upstream apron toewall up to 1.5' and is beginning to undermine at the northeast corner. There is erosion up to 1' deep behind the northwest wingwall.

Description Large area of erosion behind NE wingwall (up to ~ 2' deep), footing at end of wingwall and upstream apron toewall are exposed up to 1.5' and beginning to undermine, looking south.

Recommendation: Fill voids behind the northeast and northwest wingwalls and provide scour countermeasures.

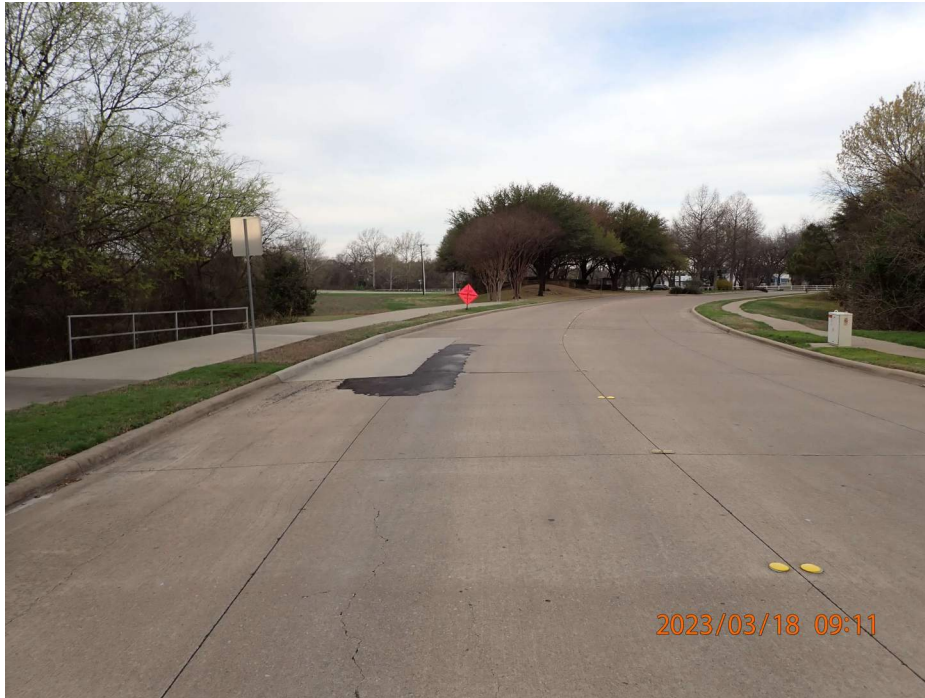
PHOTO 1 Roadway View

Description Roadway (Coldwater CRK Lane Rd), looking west.

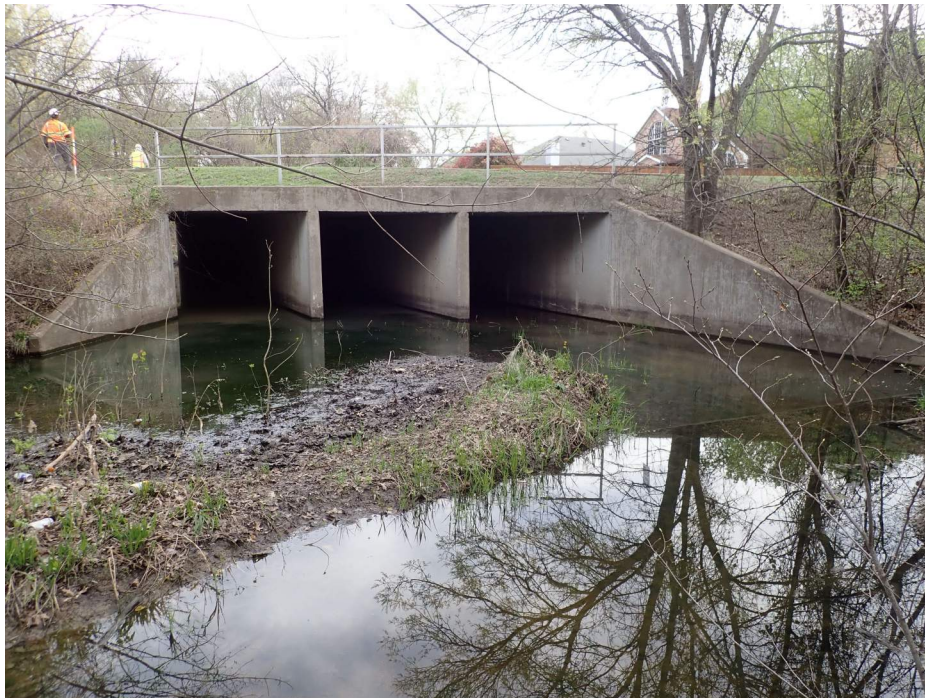
PHOTO 2 Elevation View

Description South bridge elevation view, looking northeast.

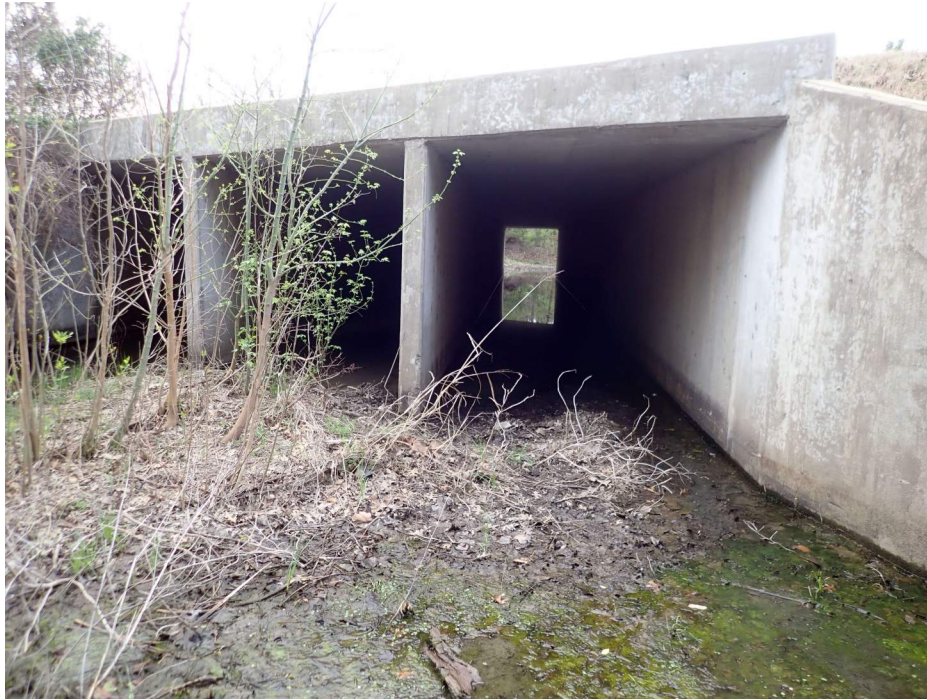
PHOTO 3 Stream Under View

Description Stream under view, looking southeast.

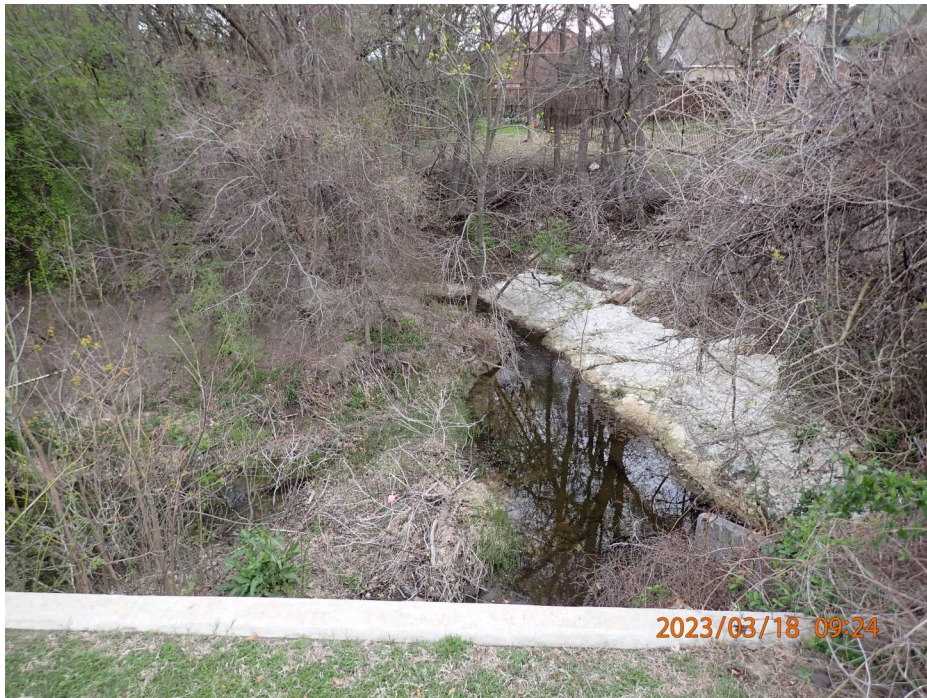
PHOTO 4 Upstream View

Description Upstream view, looking north.

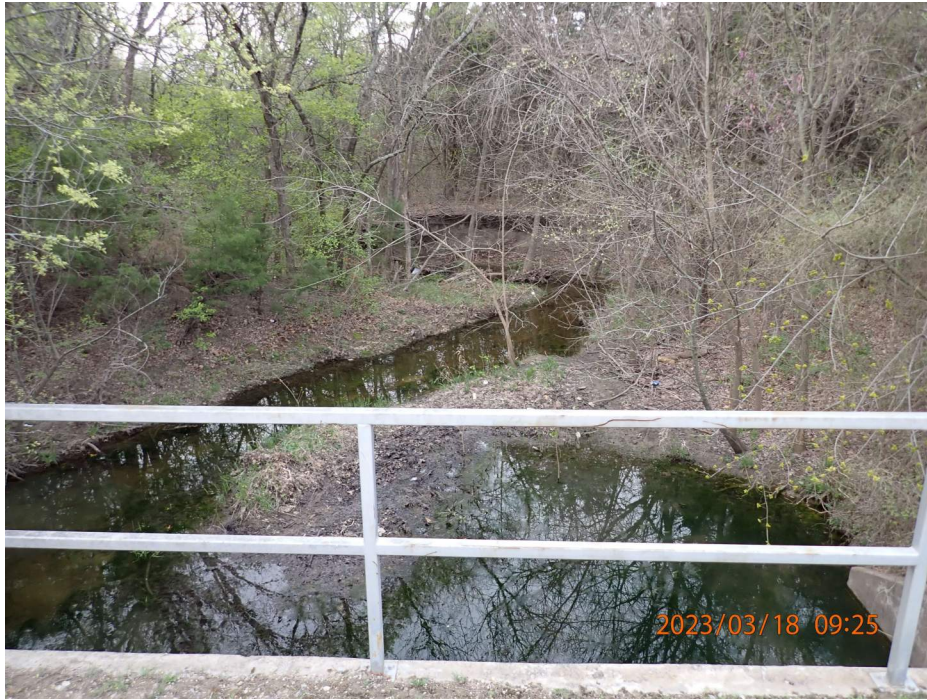
PHOTO 5 Downstream View

Description Downstream view, looking south.

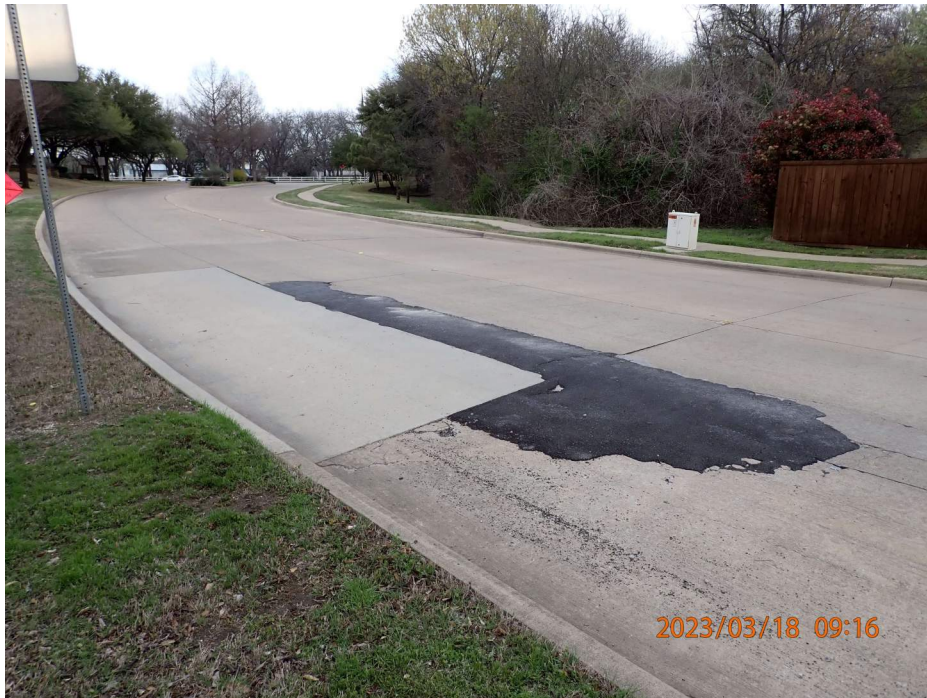
PHOTO 6 Defect

| Component | Description | Min. | Rating | Comment |
|---|---|---|---|---|
| Roadway | Concrete | 5 | 7 | A previously deteriorated area of the east approach concrete pavement, next to a large concrete patch near connection to culvert, has been repaired with an asphalt overlay. Transverse and longitudinal cracks are common along the approach concrete pavement. |

Description A previously deteriorated area of the east approach concrete pavement next to large concrete patch has been repaired with an asphalt overlay, looking northwest. (Condition Rating: 7)

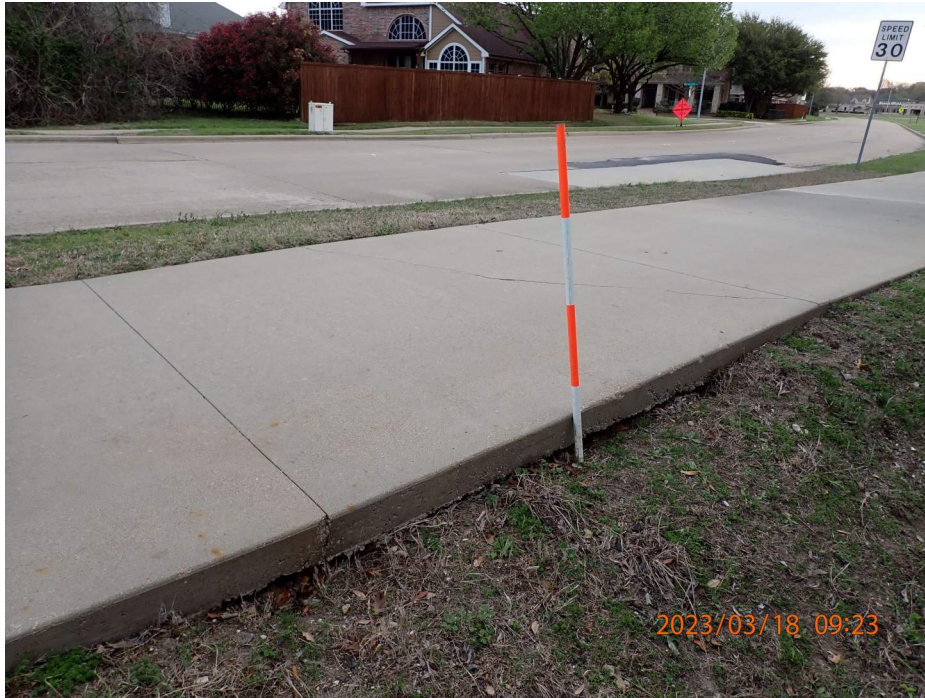
PHOTO 7 Defect

| Component | Description | Min. | Rating | Comment |
|---|---|---|---|---|
| Embankments | | 0 | 6 | A large area of erosion is present behind the northeast wingwall up to 2' deep. There is erosion up to 1' deep behind the northwest wingwall. Erosion and settlement of the embankment between sidewalk and curb at the northeast corner connection to culvert, sidewalk has slightly settled. Erosion (up to 6" deep) is slightly undermining sidewalk near southwest corner of culvert. |

Description Erosion (up to 6" deep) slightly undermining sidewalk near southwest corner of culvert, looking northeast. (Condition Rating: 6)

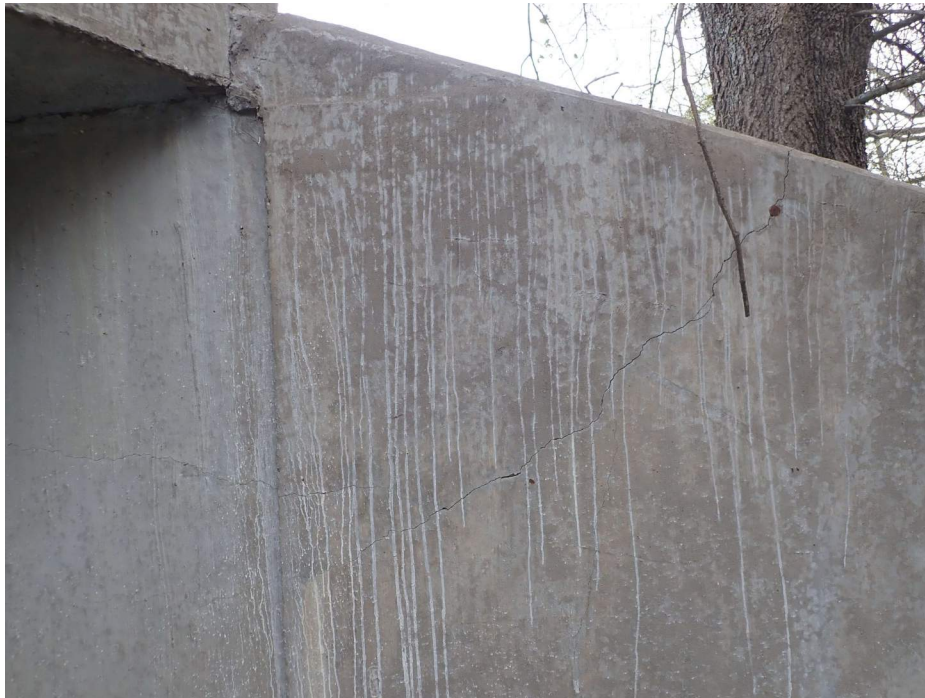
PHOTO 8 Defect

| Component | Description | Min. | Rating | Comment |
|---|---|---|---|---|
| Headwalls & Wingwalls | | 5 | 7 | Vertical cracks (< 0.012" wide) with isolated light efflorescence. Minor spalls of headwalls at connection to top slab. Vertical cracks (< 0.012" wide) in wingwalls at connections to abutments. Diagonal cracks in southeast wingwall. |

Description Vertical and diagonal cracks in southeast wingwall, looking east. (Condition Rating: 7)

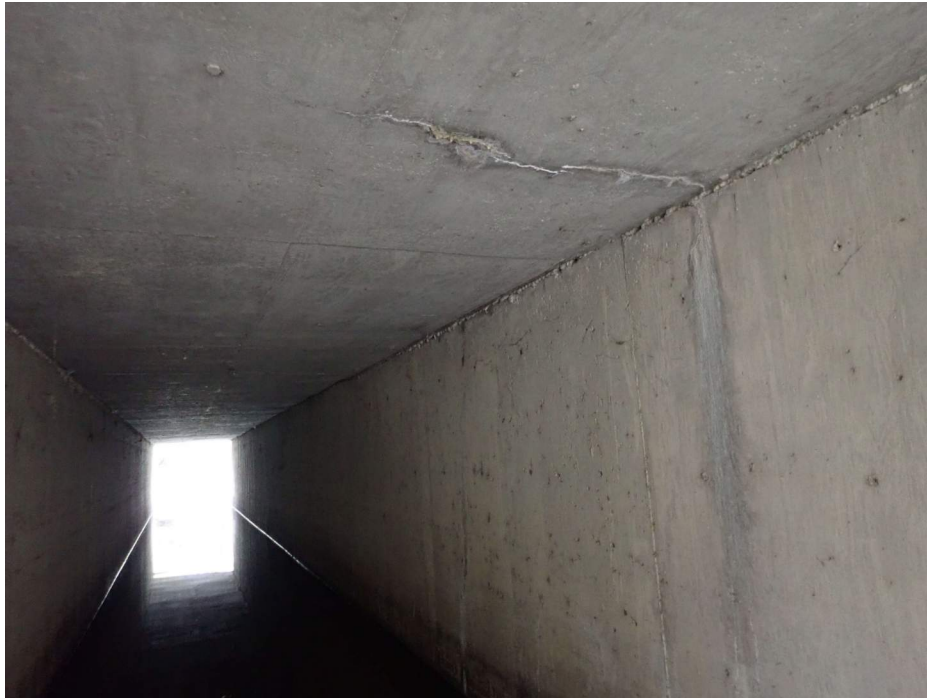
PHOTO 9 Defect

| Component | Description | Min. | Rating | Comment |
|---|---|---|---|---|
| Top Slabs | | 0 | 7 | Transverse cracks (< 0.012" wide) with efflorescence in underside of top slabs. Isolated shallow spalls (< 4" dia.) with exposed reinforcing at the upstream ends of each barrels. |

Description Transverse cracks ( $< 0.012$ " wide) with efflorescence in underside of top slabs, looking south.  
(Condition Rating: 7)

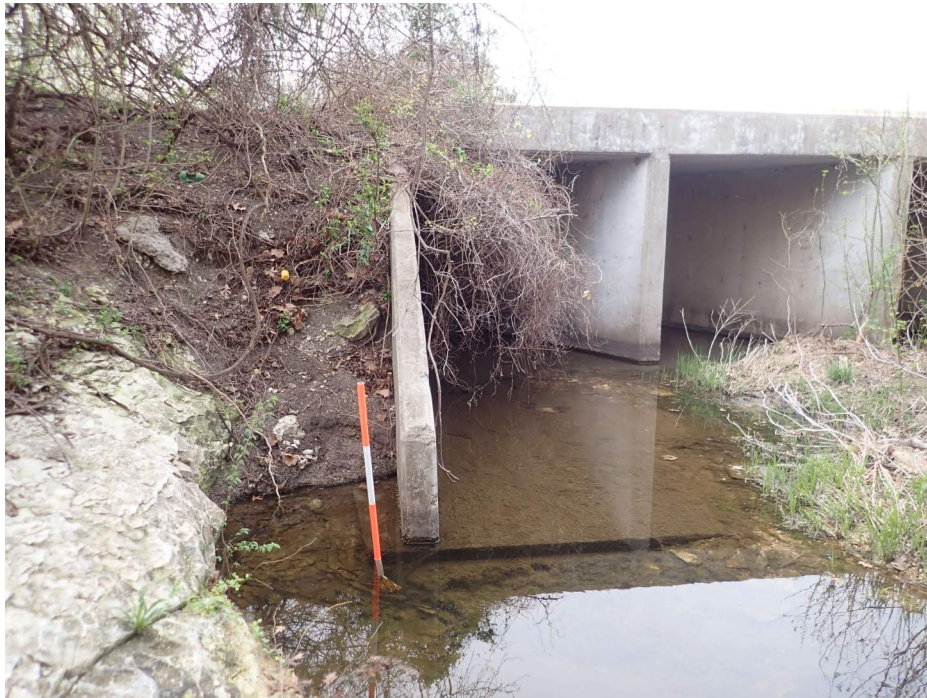
PHOTO 10 Defect

| Component | Description | Min. | Rating | Comment |
|---|---|---|---|---|
| Channel Banks | | 0 | 6 | A large area of erosion is present behind the northeast wingwall up to 2' deep. Scour has exposed the wingwall footing and upstream apron toewall up to 1.5' and is beginning to undermine at the northeast corner. Minor to moderate erosion along other channel banks. |

Description Large area of erosion behind NE wingwall (up to ~ 2' deep), footing at end of wingwall and upstream apron toewall are exposed up to 1.5' and beginning to undermine, looking south.  
(Condition Rating: 6)
