# Bridge Inspection Report

180430K00170001

SANDEN BLVD

MUDDY CREEK

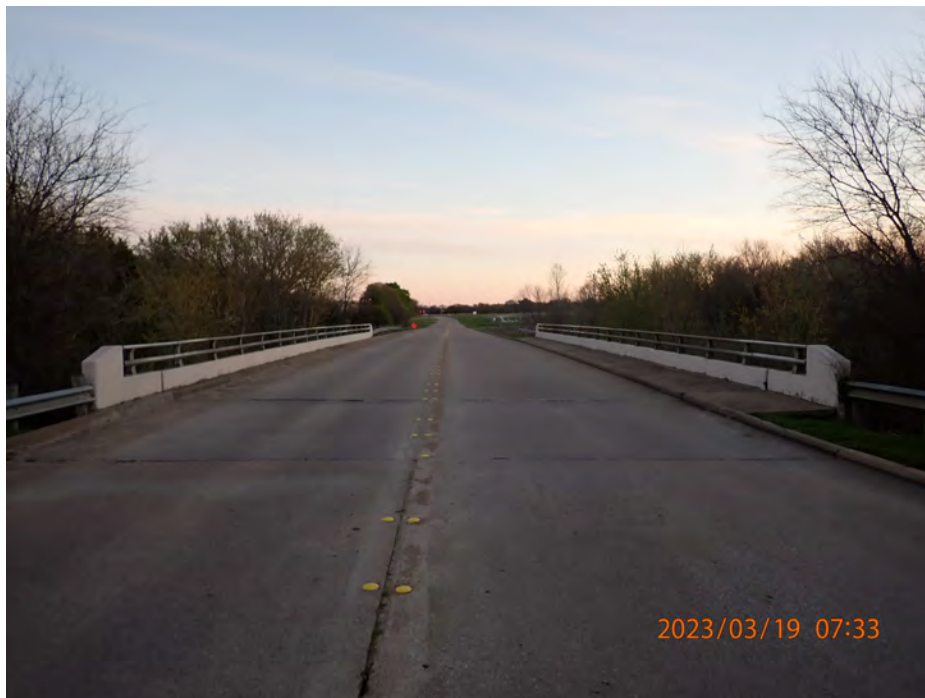
PHOTO 1 Recommended Maintenance Needs

No object markers are present.

Description No object markers are present, looking north.

Recommendation: Provide standard object markers at all four corners of the structure in accordance with TxDOT standards.

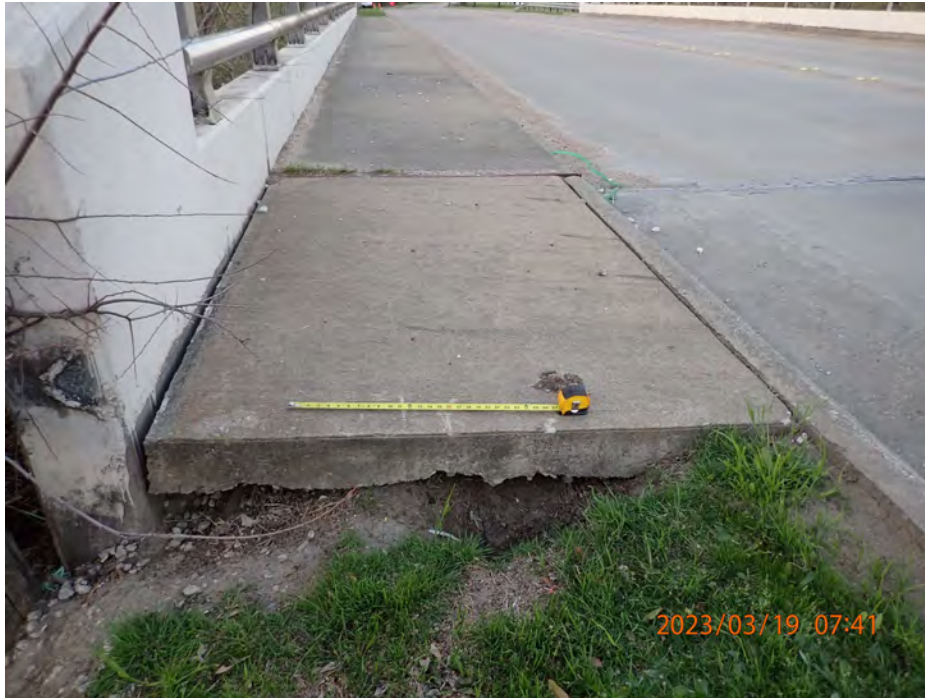
PHOTO 1 Recommended Maintenance Needs

Description Sidewalk on east side is undermined at south ends, looking south.

Sidewalk on east side is undermined at south ends. North approach slab undermined at west corner at past foam injection repair location. South approach slab is undermined ~ 1' deep on the west side with more than 8' of penetration.  
 Recommendation: Repair erosion with backfill of concrete.

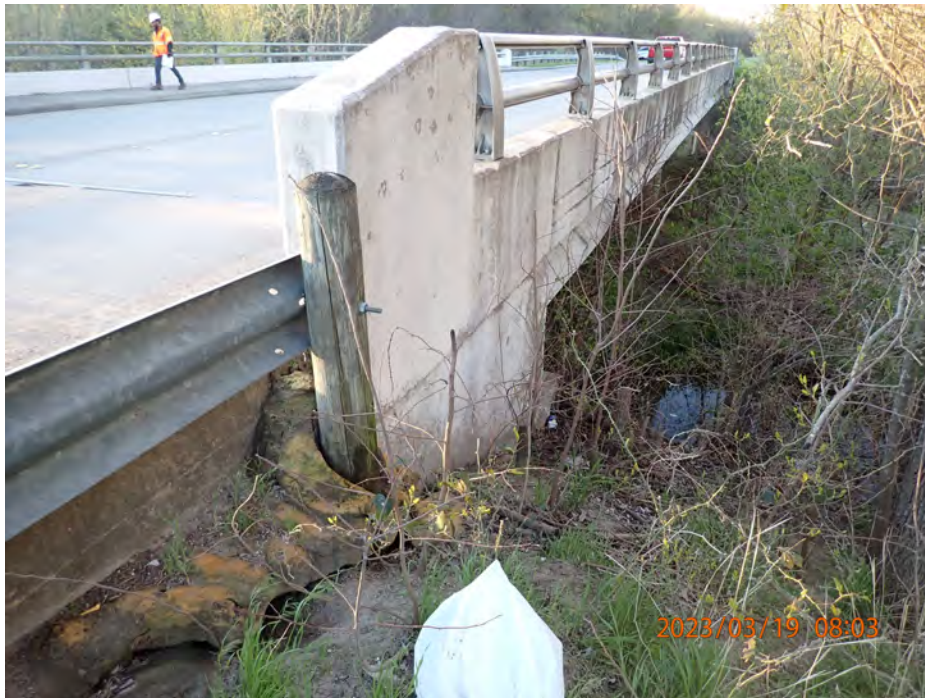
PHOTO 2 Recommended Maintenance Needs

Description North approach slab undermined at west corner at past foam injection repair location, looking southeast.

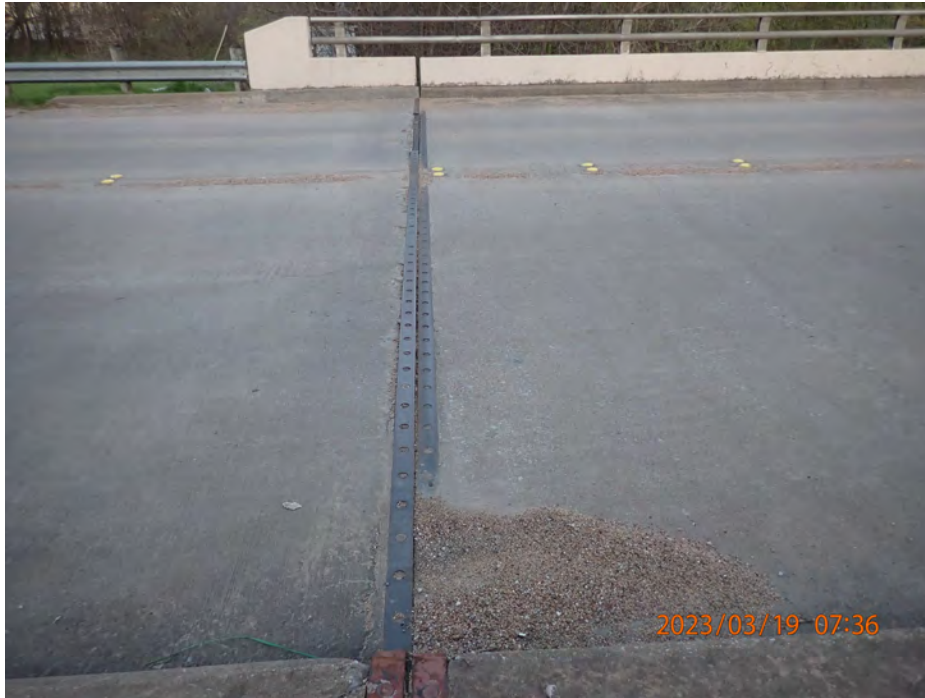
PHOTO 1 Recommended Maintenance Needs

An ~ 8' section of joint armor missing at south abutment joint with minor spalling along the approach slab.

Description An ~ 8' section of joint armor missing at south abutment joint with minor spalling along the approach slab, looking west.

Recommendation: Repair Armor Joint

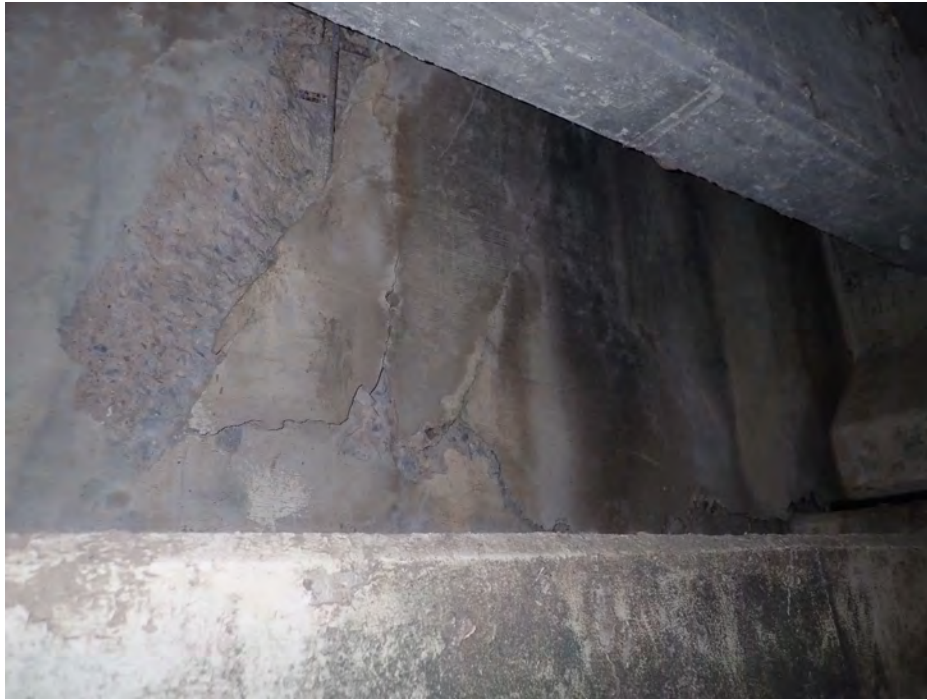
PHOTO 1 Recommended Maintenance Needs

Large delaminations and spalling with exposed reinforcing steel in south abutment backwall near the east end and at west corner connection to wingwall.

Description Large delaminations and spalling with exposed reinforcing steel in south abutment backwall near the east end, looking southwest.

Recommendation: Perform Concrete Repair to Spalls.

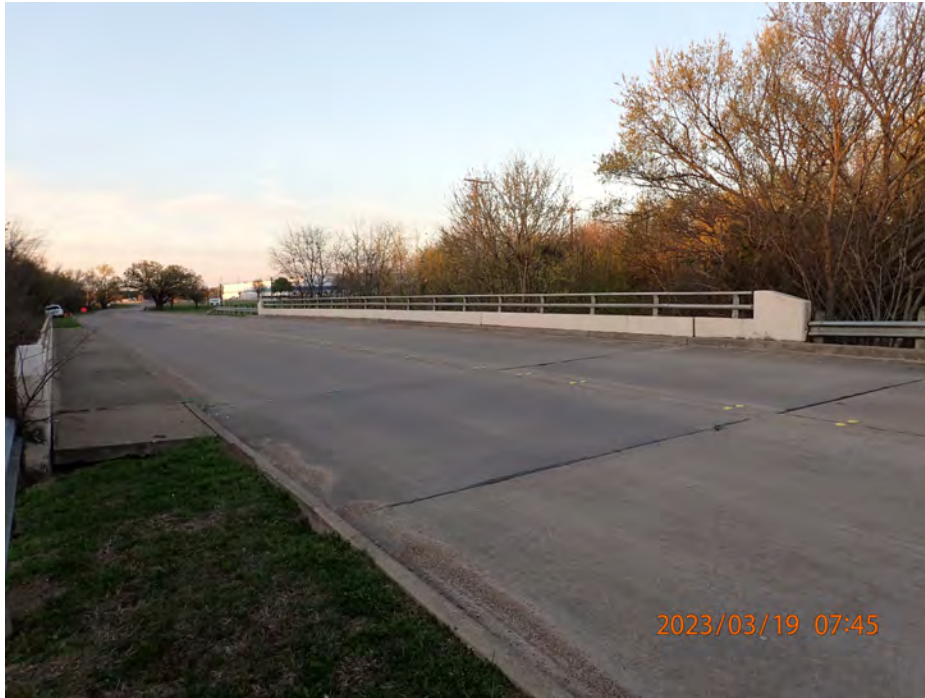
PHOTO 1 Roadway View

Description Roadway (Sanden BLVD) view, looking south.

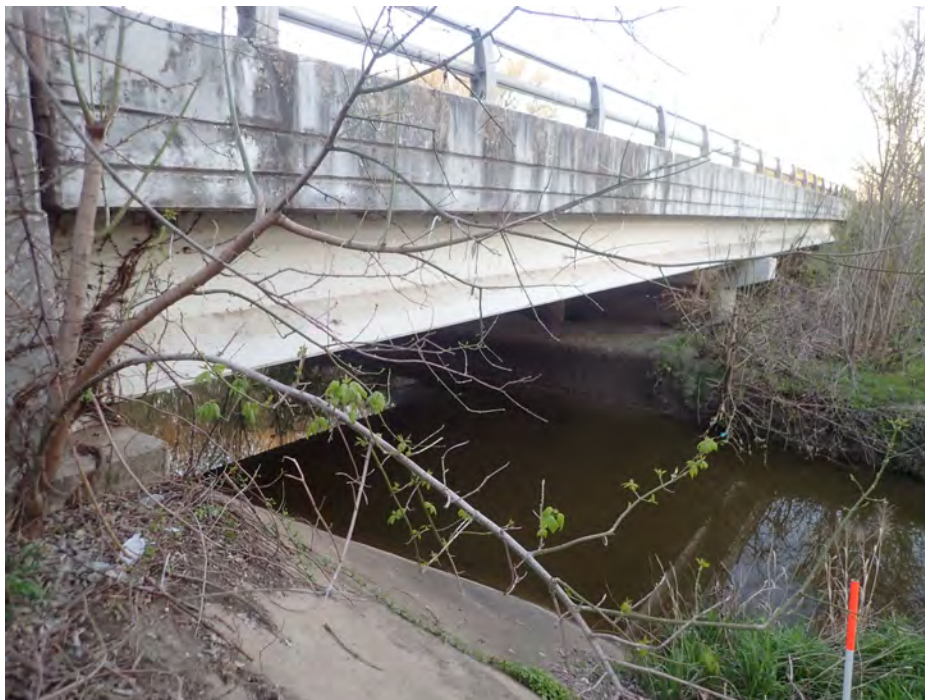
PHOTO 2 Elevation View

Description East bridge elevation view, looking northwest.

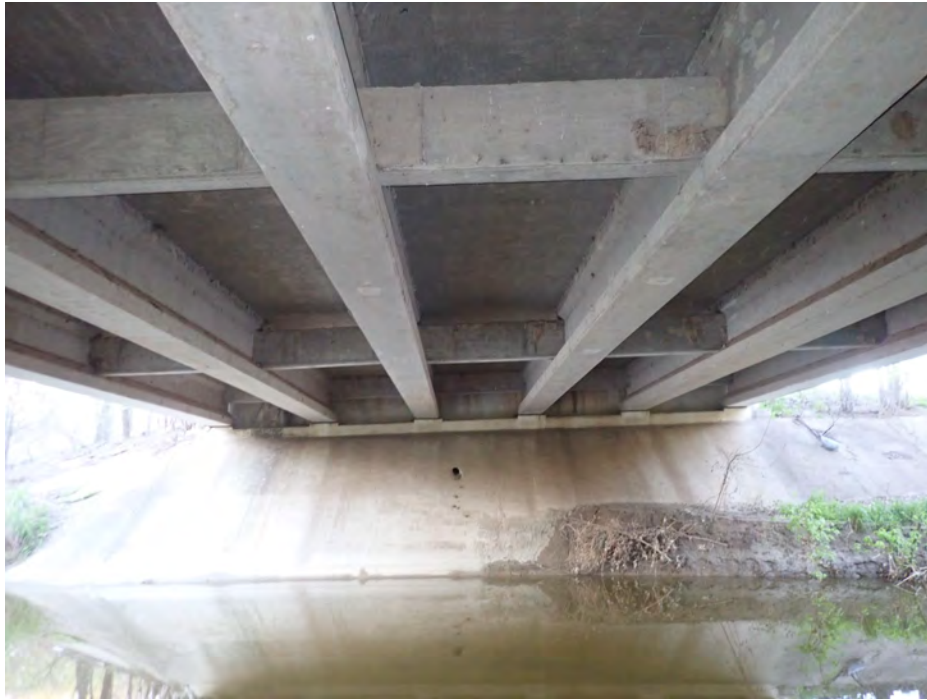
PHOTO 3 Superstructure View

Description Superstructure under view, looking south.

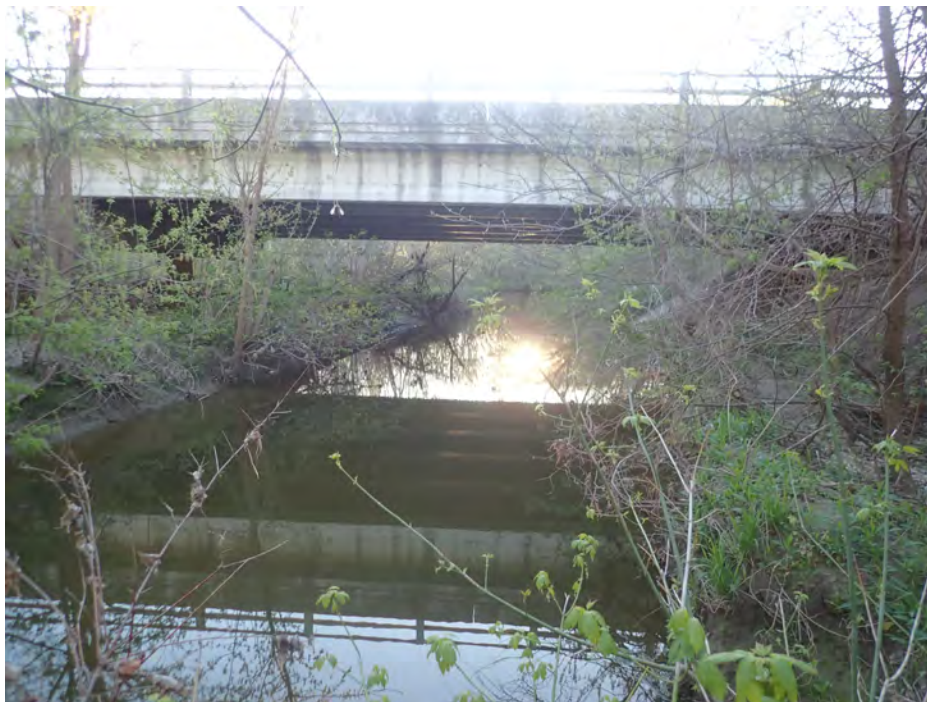
PHOTO 4 Stream Under View

Description Stream under view, looking east.

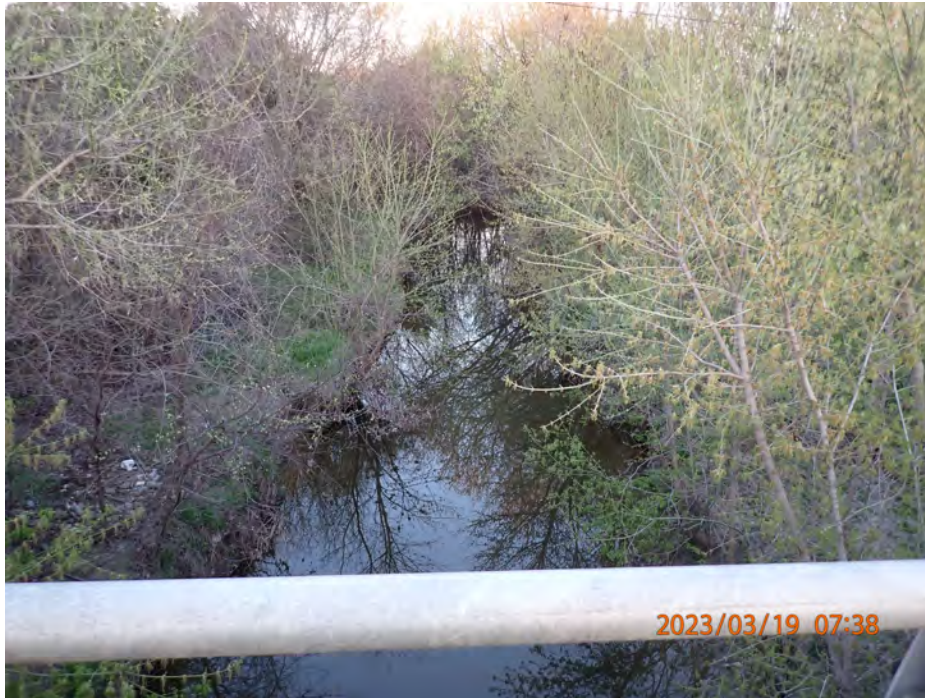
PHOTO 5 Upstream View

Description Upstream view, looking west.

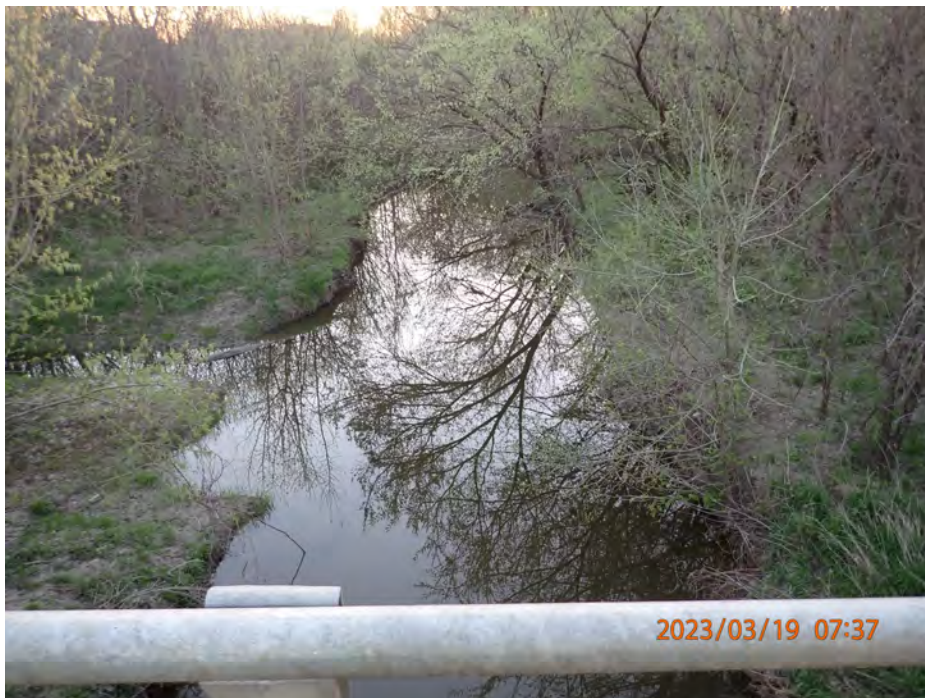
PHOTO 6 Downstream View

Description Downstream view, looking east.

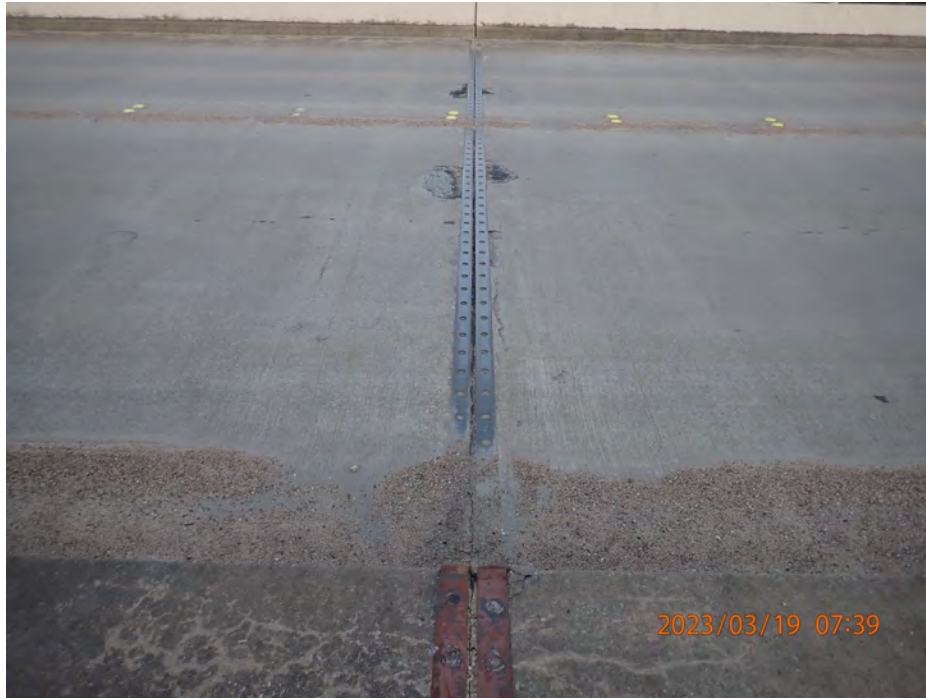
PHOTO 7 Defect

Description Minor spalling and delaminations with some asphalt patching in both spans along joint over Bent 2, looking west. (Condition Rating: 7)

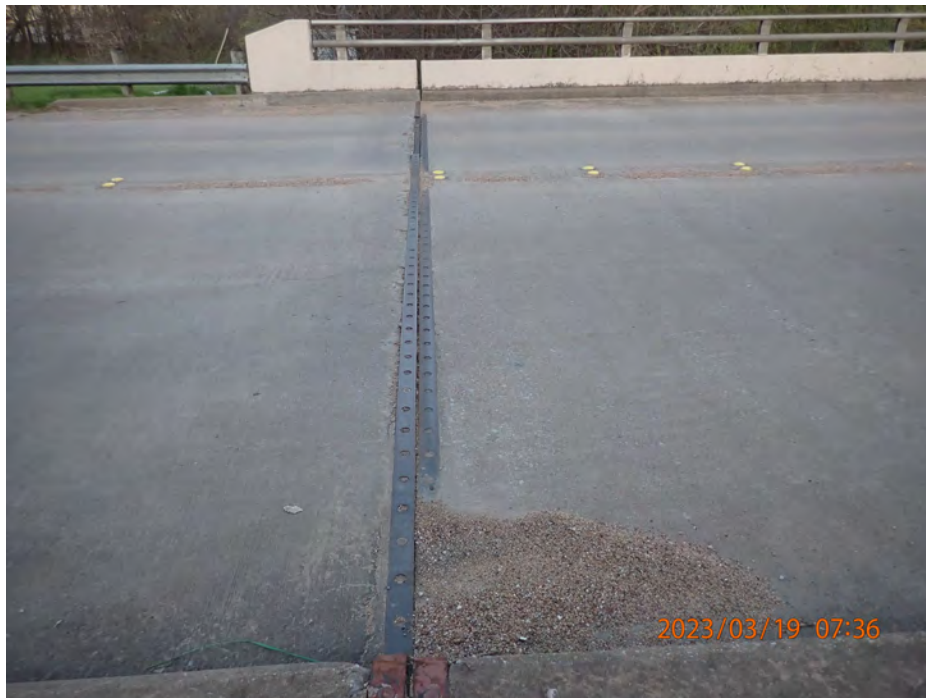
PHOTO 8 Defect

| Component | Description | Min. | Rating | Comment |
|---|---|---|---|---|
| Joints, Expansion, Open | | 6 | N | Joint seals have failed. An ~ 8' section of joint armor missing at south abutment joint with minor spalling along the approach slab. North abutment joint has minor deformation of the joint armor and spalling and patching of the deck surface and approach slab along the joint. |

Description An ~ 8' section of joint armor missing at south abutment joint with minor spalling along the approach slab, looking west. (Condition Rating: 6)

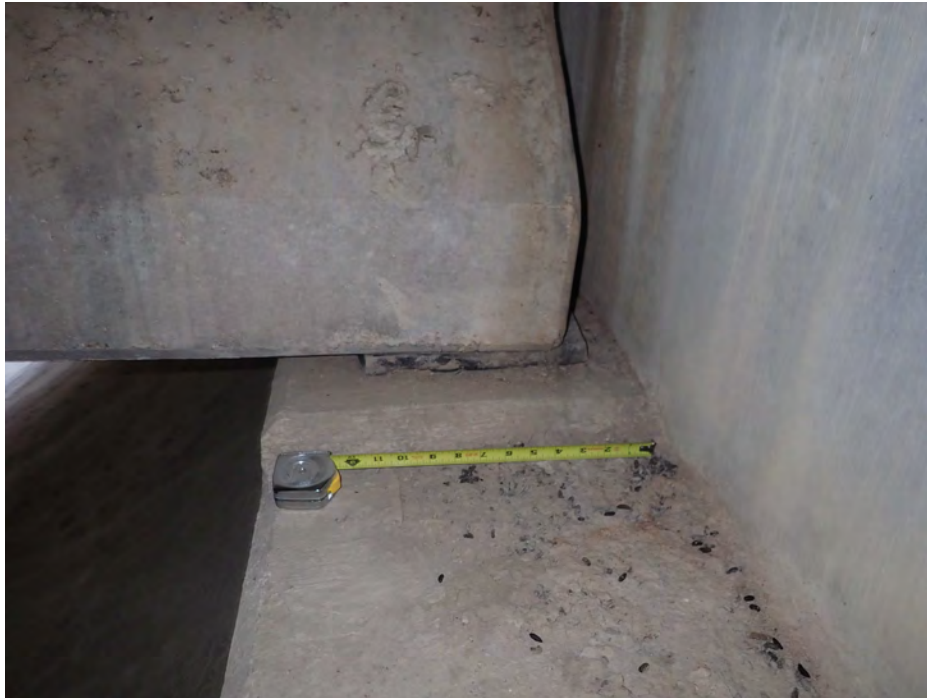
PHOTO 9 Defect

| Main Members - Concrete | 0 | 6 | West exterior I-beams over Bent 2 appear to have hairline horizontal cracking in the bottom flange and diagonal cracking in the web. Several girders at the South Abutment have 1-3/4" loss of bearing pad area due to longitudinal misalignment between the bearing pad and the girder bottom flange. |

Description Girders at the South Abutment with 1-3/4" loss of bearing pad area due to longitudinal misalignment between the bearing pad and the girder bottom flange, looking east. (Condition Rating 6)

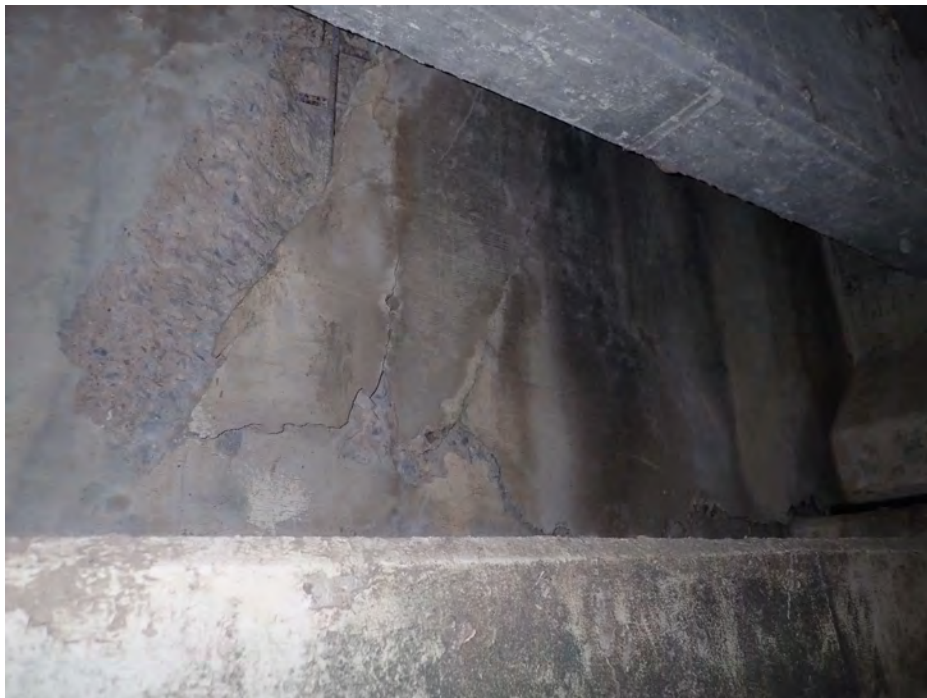
PHOTO 10 Defect

| Component | Description | Min. | Rating | Comment |
|---|---|---|---|---|
| Backwalls & Wingwalls | | 0 | 6 | Large delaminations and spalling with exposed reinforcing steel in south abutment backwall near the east end and at west corner connection to wingwall. Minor spalling with isolated exposed reinforcing steel and delaminations at west end of north backwall. Vertical cracking (up to ~ 1/8" wide) at east end of north backwall at connection to wingwall. |

Description Large delaminations and spalling with exposed reinforcing steel in south abutment backwall near the east end, looking southwest. (Condition Rating: 6)

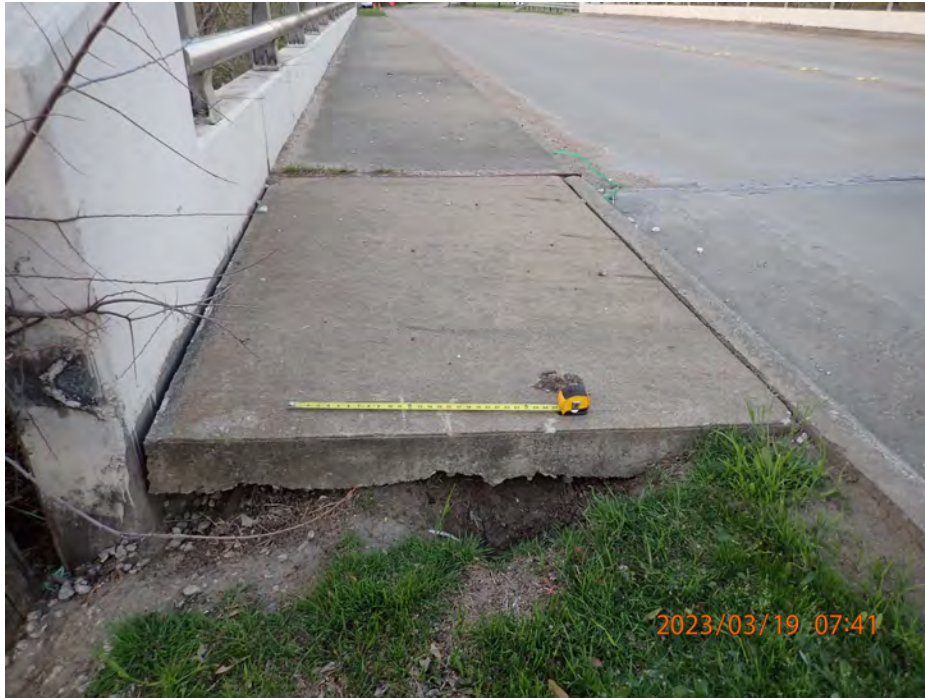
PHOTO 11 Defect

Description Sidewalk on east side is undermined at south ends, looking south. (Condition Rating: 7)

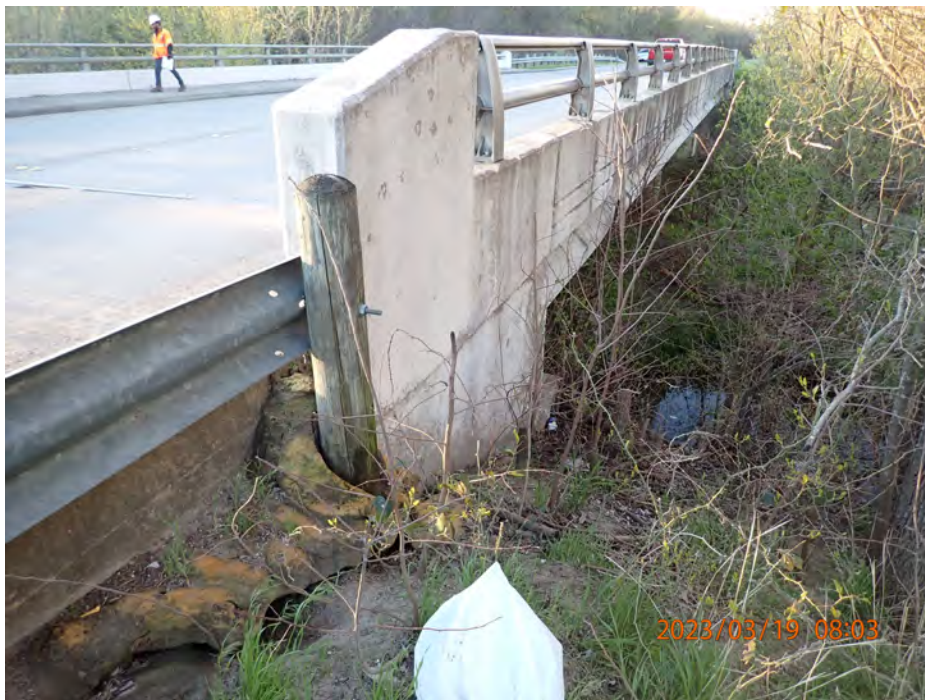
PHOTO 12 Defect

Description North approach slab undermined at west corner at past foam injection repair location, looking southeast. (Condition Rating: 6)
