# Bridge Inspection Report

00261

(7) Facility Carried: SC 261

(6) Crossing: BOGGY SWAMP

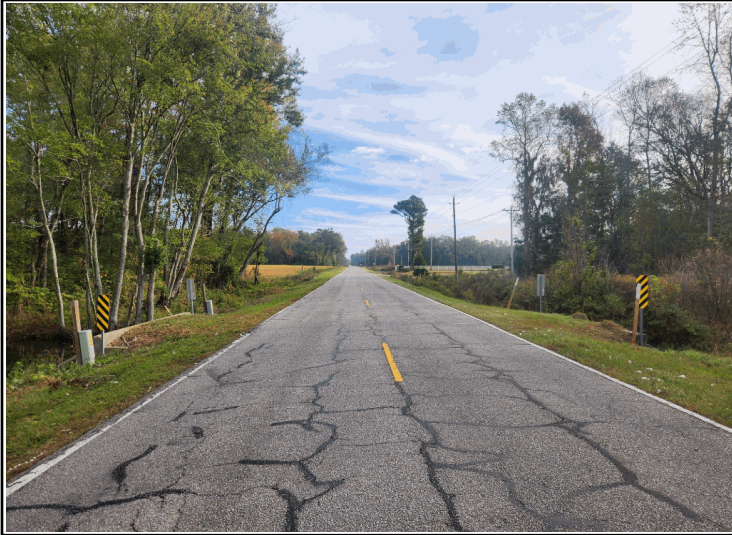
**Photo 1:**  
West Approach Looking East

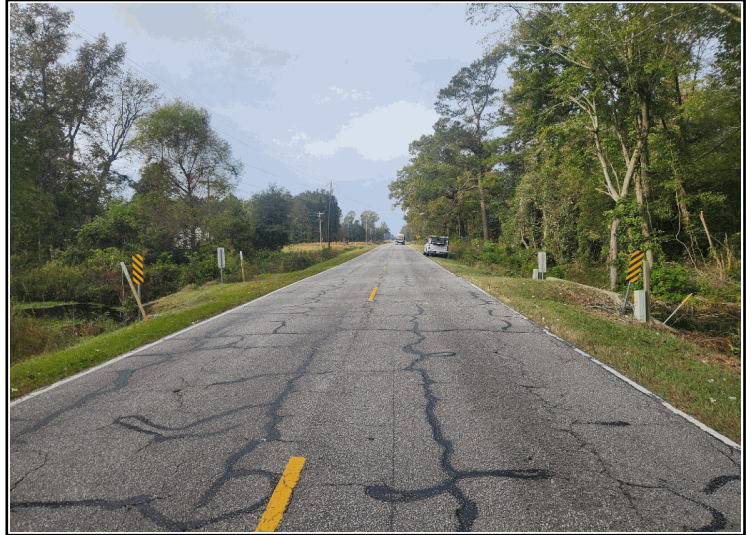
**Photo 2:**  
East Approach Looking West

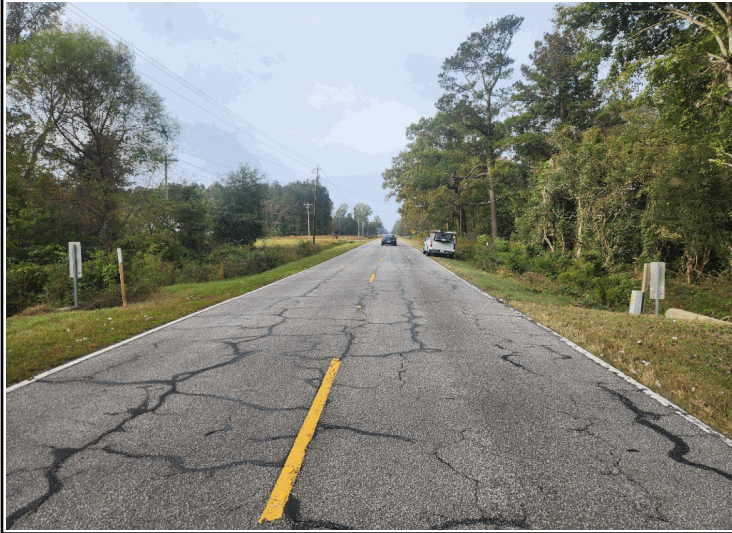
**Photo 3:**  
Backstation (West Approach Looking West)

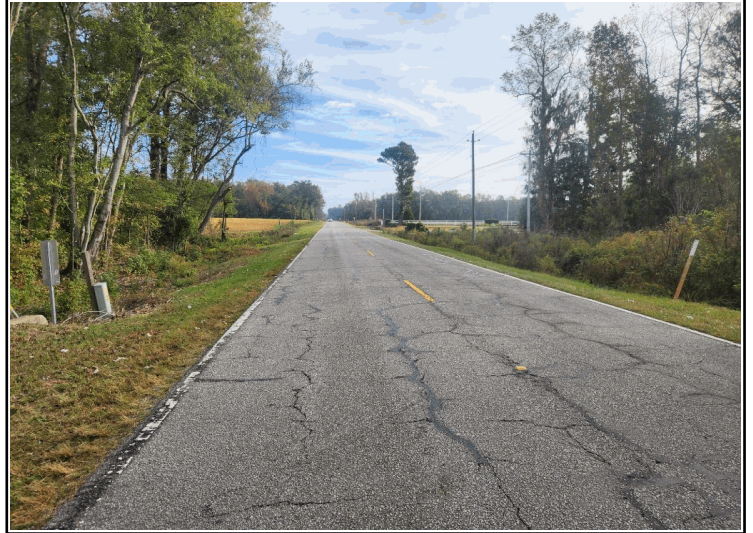
**Photo 4:**  
Upstation (East Approach Looking East)

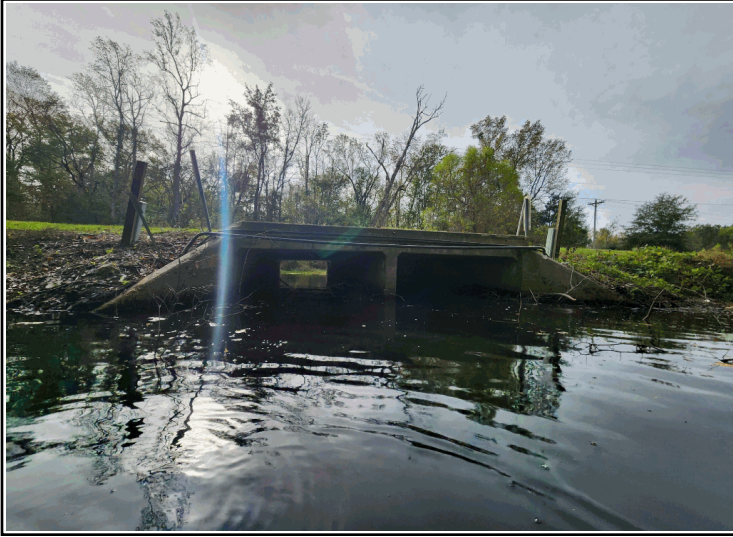
**Photo 5:**  
North Profile Looking South

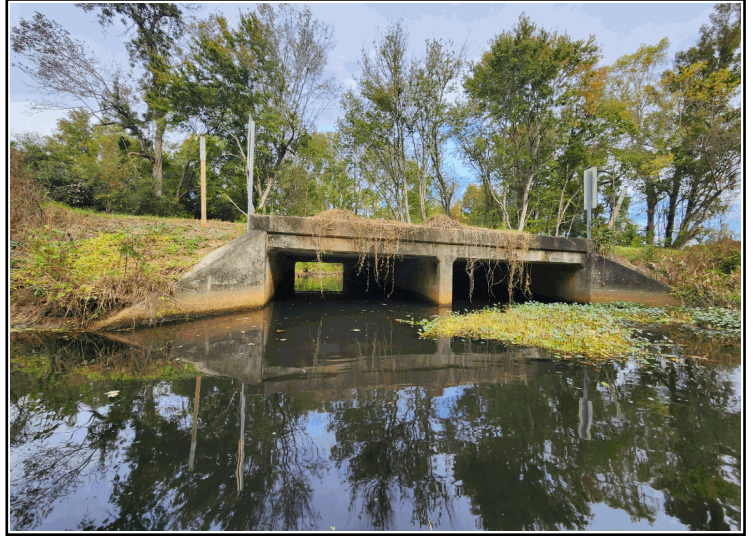
**Photo 6:**  
South Profile Looking North

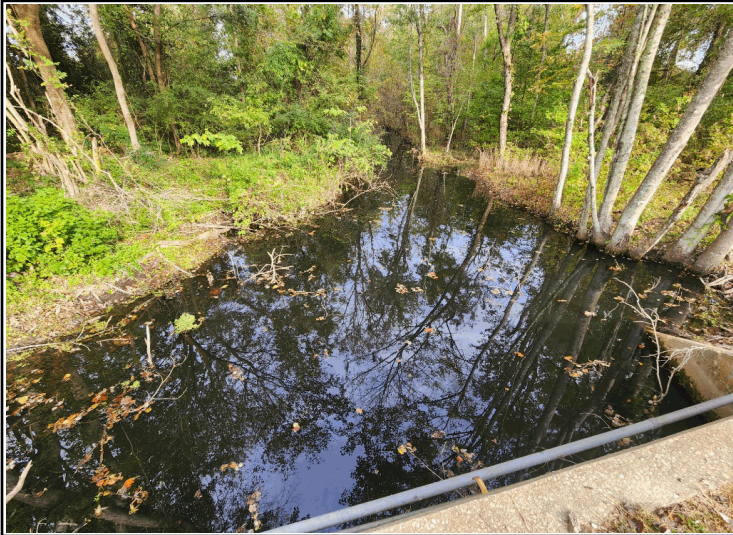
**Photo 7:**  
Feature Intersected (Looking Upstream) (North)

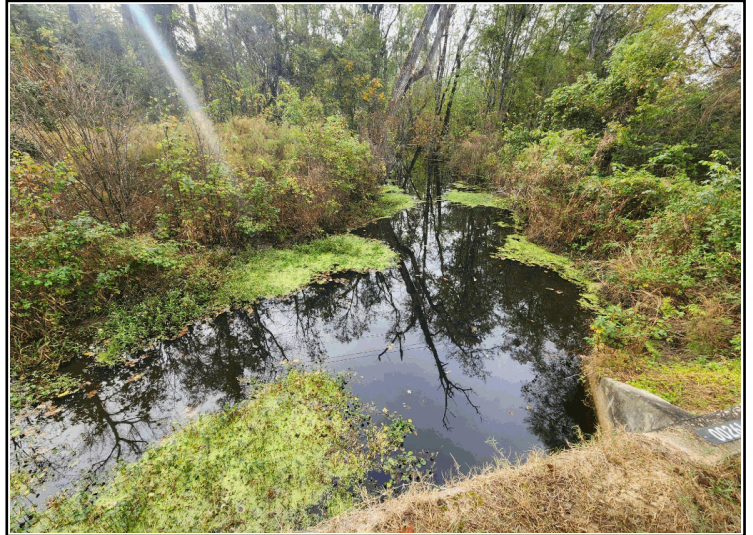
**Photo 8:**  
Feature Intersected (Looking Downstream) (South)

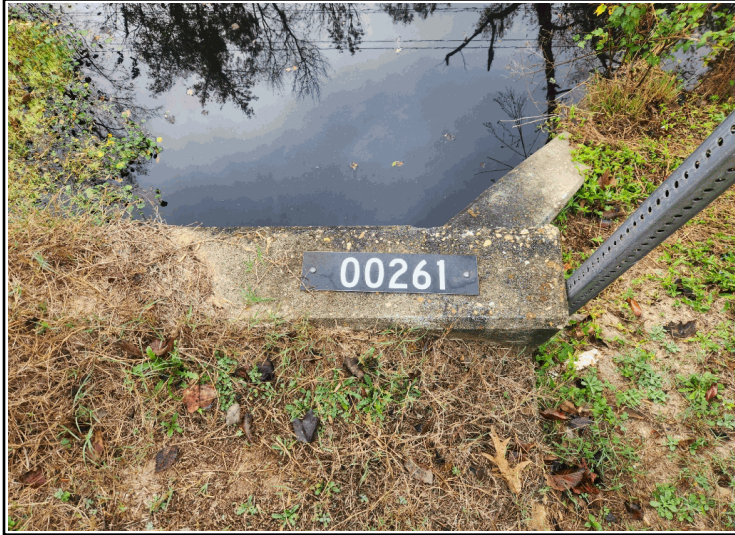
**Photo 9:**  
Asset ID Plaque at Bent 1 (SW Corner)

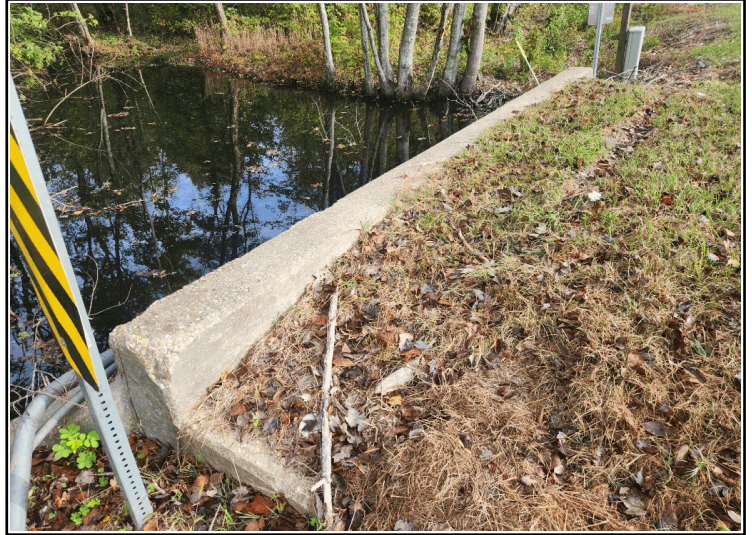
North headwall, at West end, scattered spalling (4ft total long x up to 4in wide x up to 1in deep).

North headwall, at East end, spall (14in long x 11in wide x up to 12in deep).

**Photo 10:**  
Typical Reinforced Concrete Headwall (North Shown)

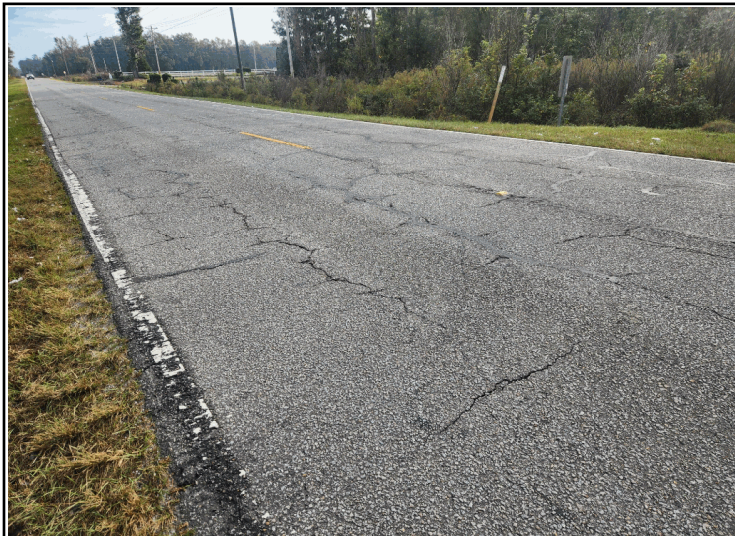
Wearing surface over the culvert, sealed and open cracks, up to 1/4in wide, throughout.

**Photo 11:**  
Asphalt Wearing Surface

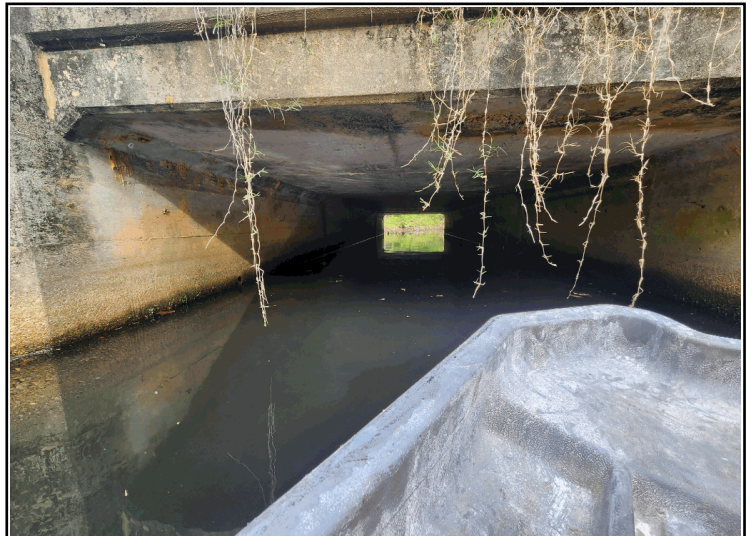
**Photo 12:**  
Looking North through Barrel 1

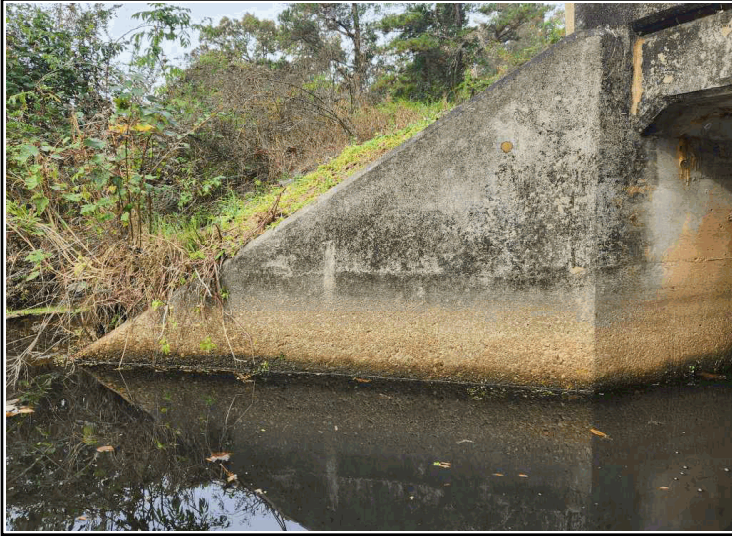
All wingwalls, scattered spalls along top inside corner.

**Photo 13:**  
Typical Wingwall (All Corners) (Southwest Shown)

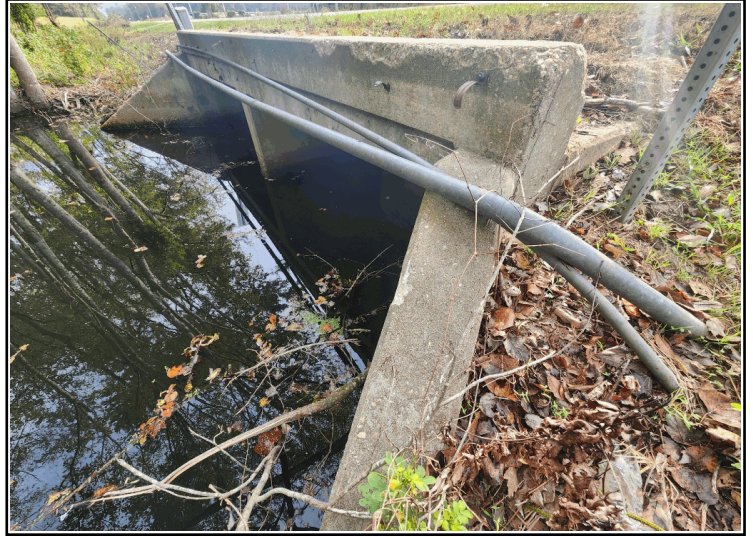
**Photo 14:**  
(1) metal conduit (1-1/2in diameter) and (1) metal conduit (2-1/2in diameter) along North end of culvert.

(1) metal conduit (1-1/2in diameter) and (1) metal conduit (2-1/2in diameter) along North end of culvert.

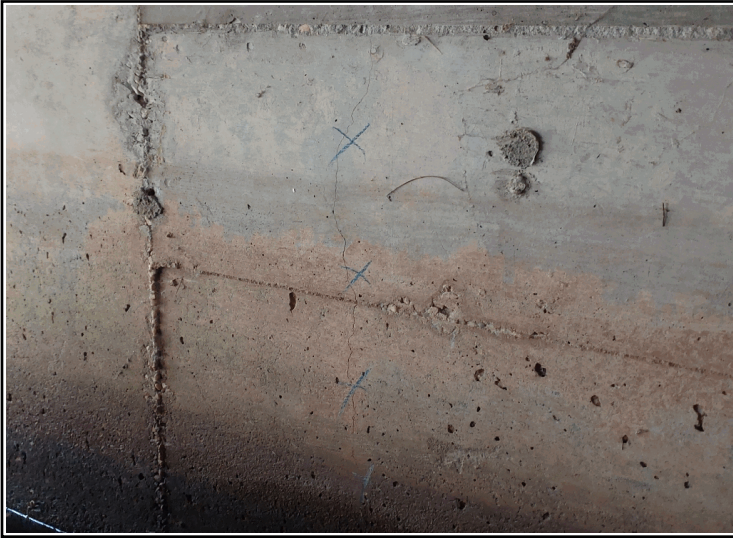
**Photo 17:**

IW 1, North widened portion, vertical crack (full height x 1/32in).

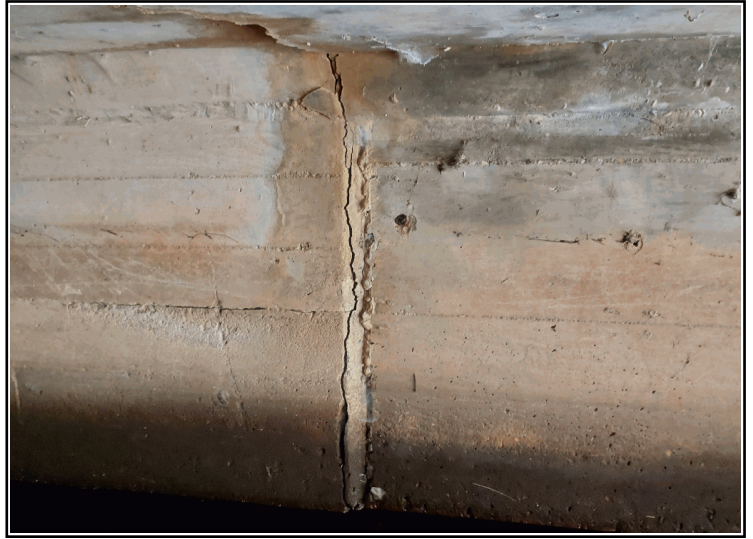
**Photo 18:**

IW 1, at South widened construction joint, vertical cracks (full height x 3/16in).

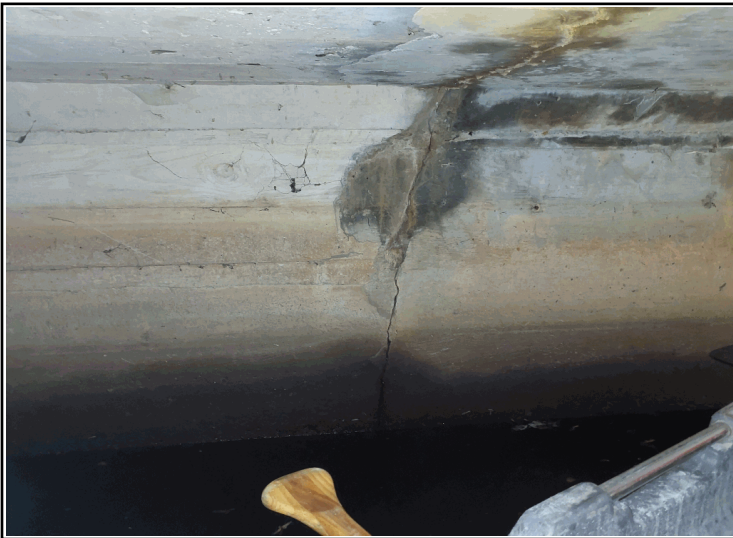
**Photo 19:**

EW 2, at South widened construction joint, vertical cracks (full height x 3/16in).

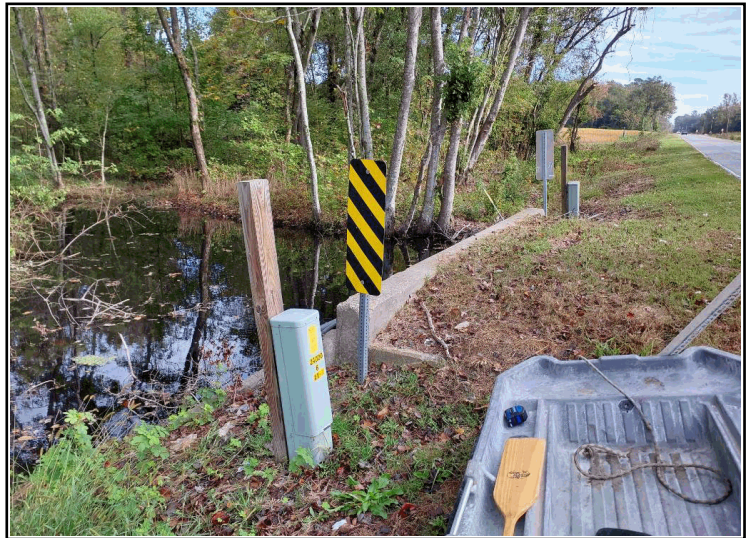
**Photo 20:**

NW delineator is set low and partially obstructed by telephone cable enclosure.

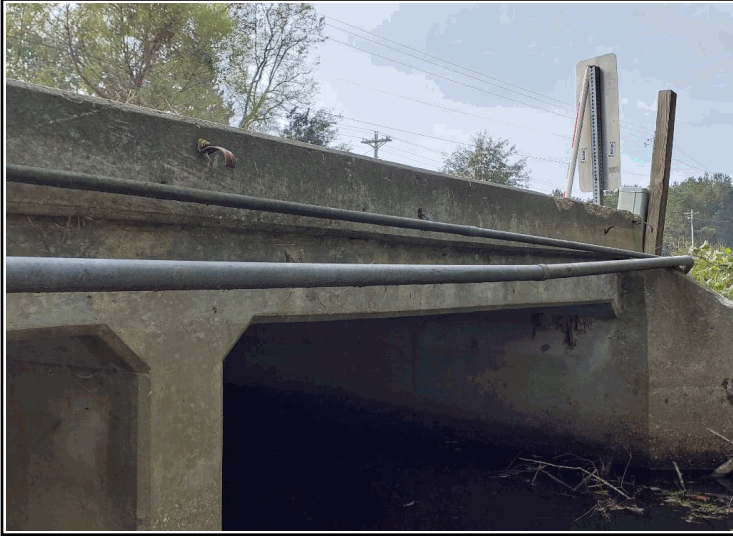
**Photo 21:**

Utility conduits disconnected from support brackets over IW 1.

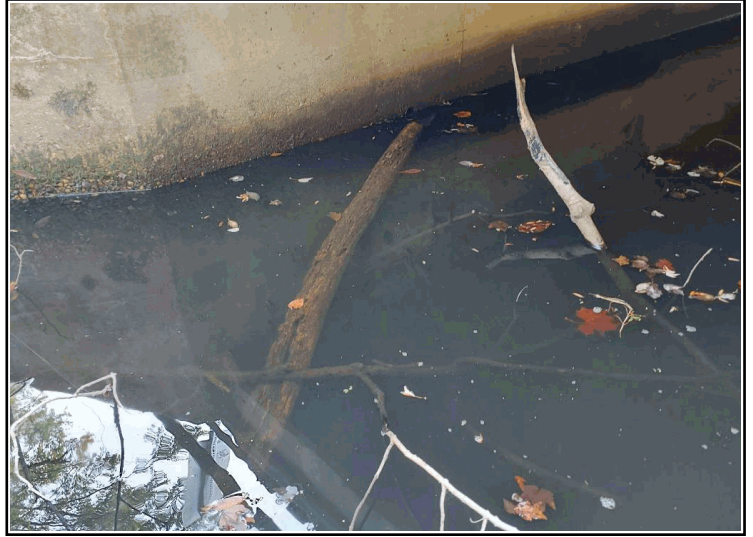
**Photo 22:**

- Both barrels at inlet, drift accumulation (20ft W x 4ft L x up to 2ft D).
- Both barrels have approximately 60% blockage due to sediment buildup (6ft high x full length).
- Barrel 2 at outlet heavy silt accumulation (5ft deep) with heavy vegetation growth restricting water flow through the barrel.

Both barrels at inlet, drift accumulation (20ft W x 4ft L x up to 2ft D).

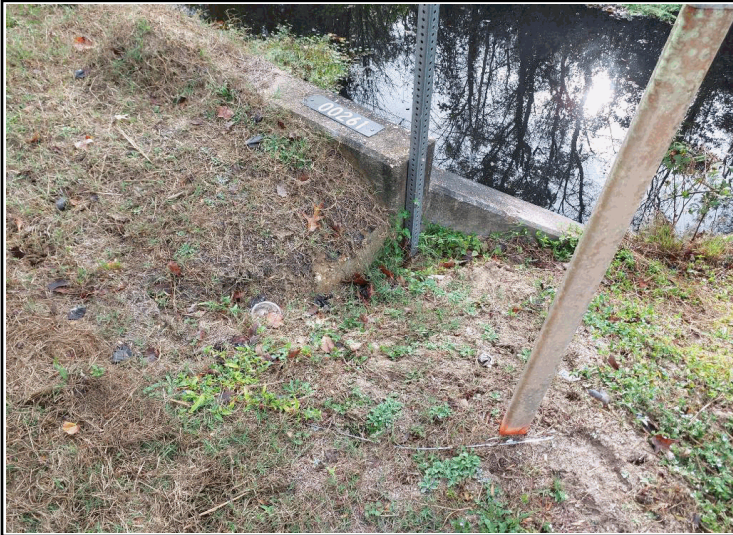
**Photo 23:**

Approach erosion at all corners of culvert exposing top slab.

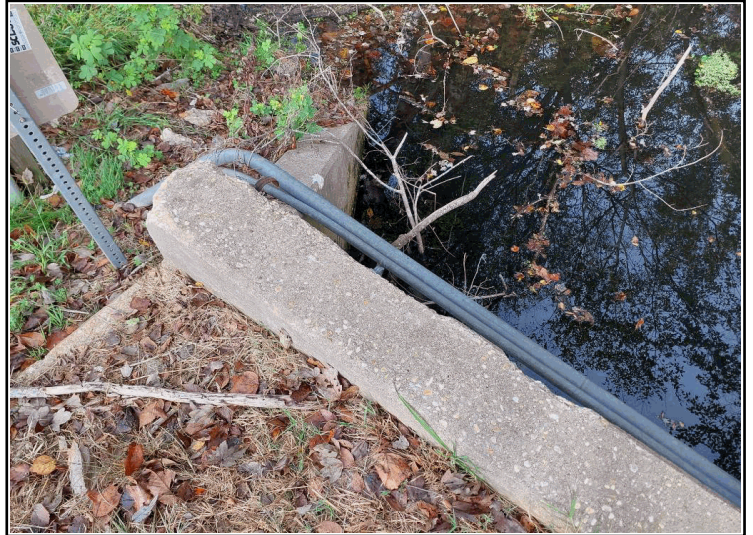
**Photo 24:**

North headwall, at West end, scattered spalling (4ft total long x up to 4in wide x up to 1in deep).

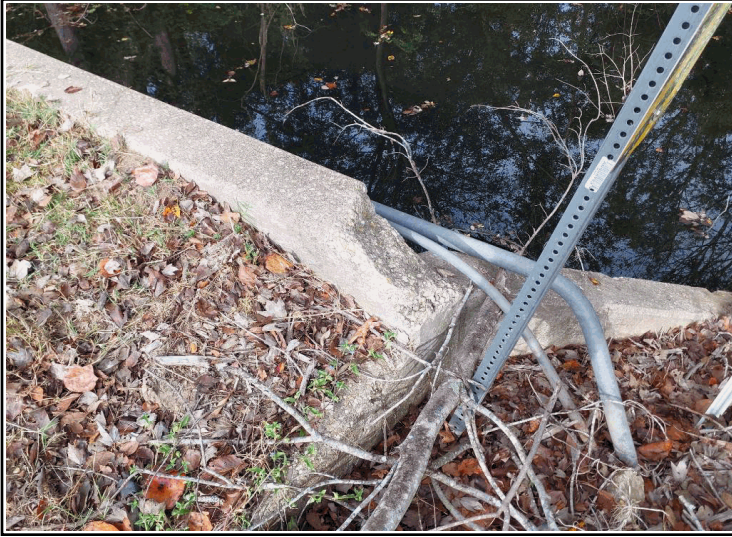
**Photo 25:**

North headwall, at East end, spall (14in long x 11in wide x up to 12in deep).

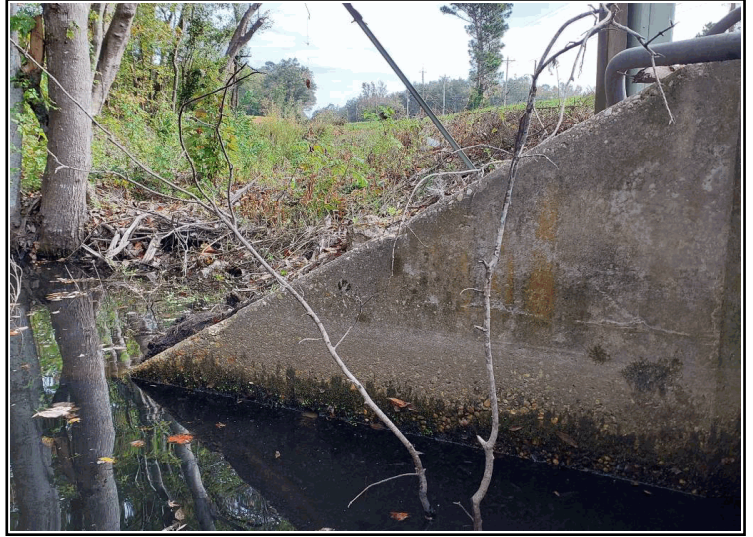
**Photo 26:**

All wingwalls, scattered spalls along top inside corner.
