# Bridge Inspection Report

00237

(7) Facility Carried: SC 341

Inspection Type(s): Underwater (Unscheduled)

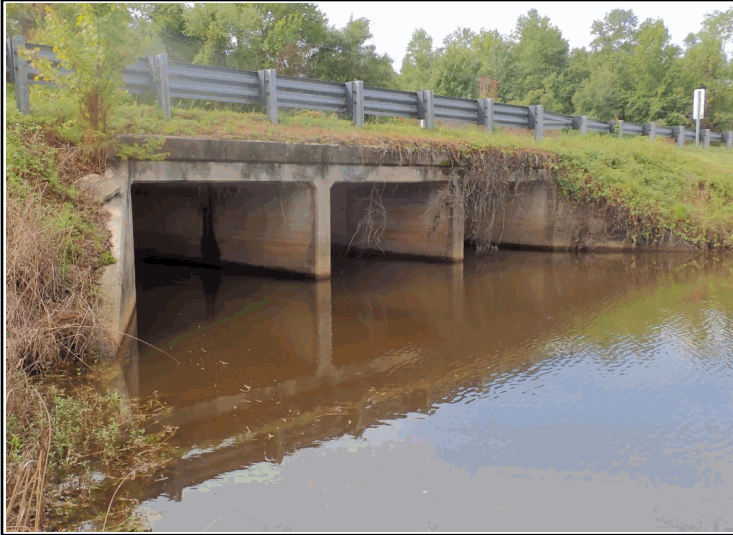
**Photo 1:**  
Inlet / North Elevation

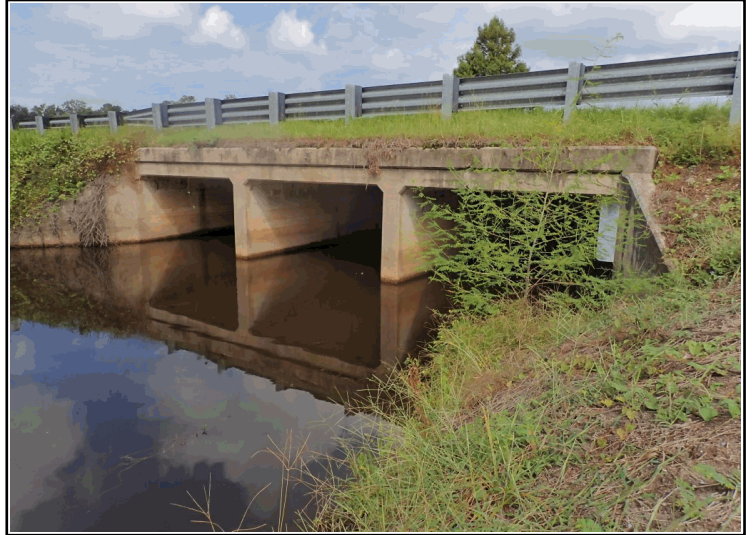
**Photo 2:**  
Outlet / South Elevation

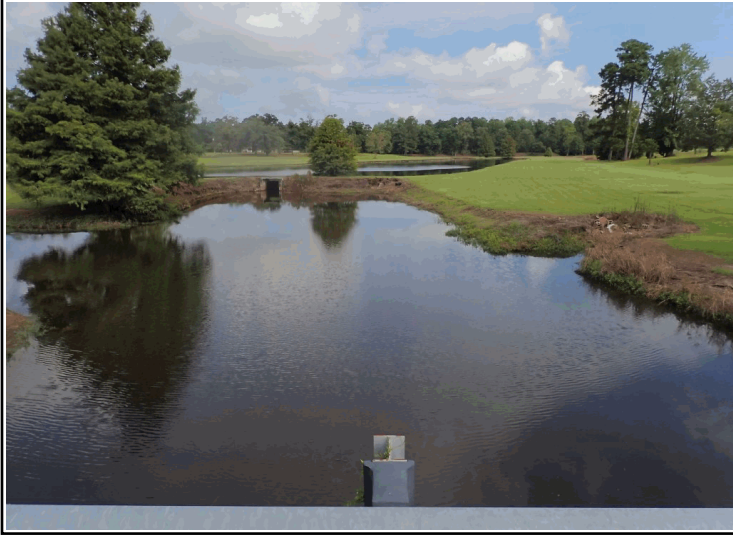
**Photo 3:**  
View Upstream from Top of Culvert

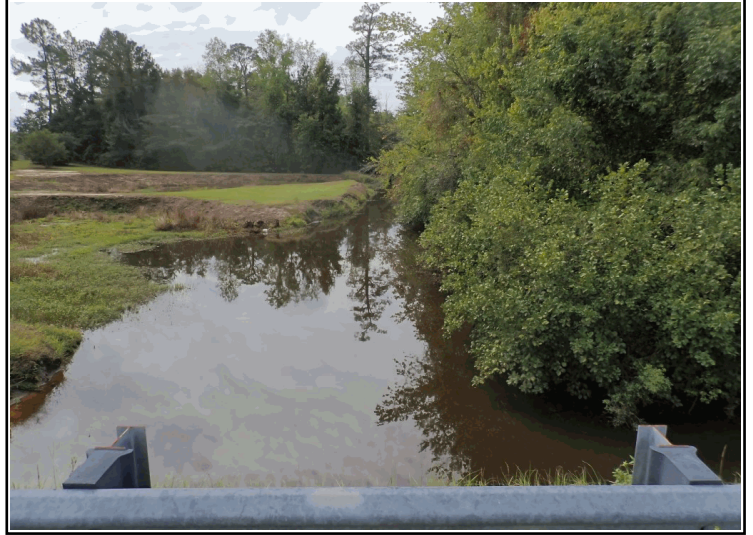
**Photo 4:**  
View Downstream from Top of Culvert

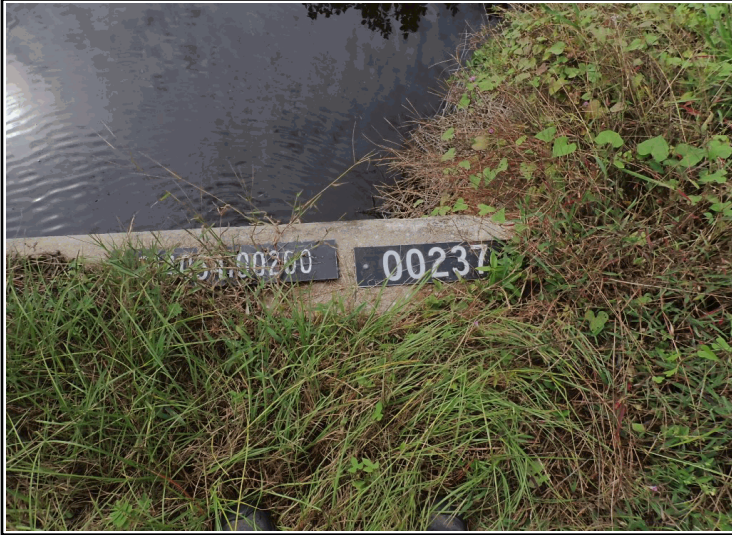
**Photo 5:**  
Asset ID, Southwest Corner

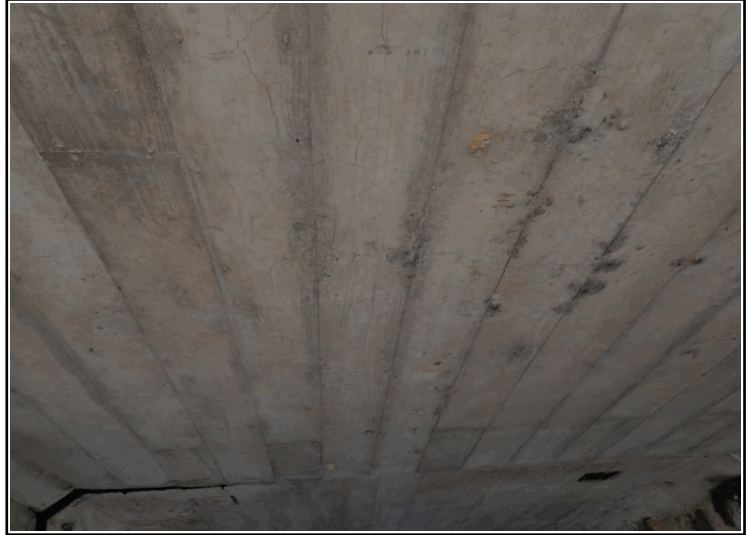
**Photo 6:**  
Typical Culvert Ceiling, Barrel 1

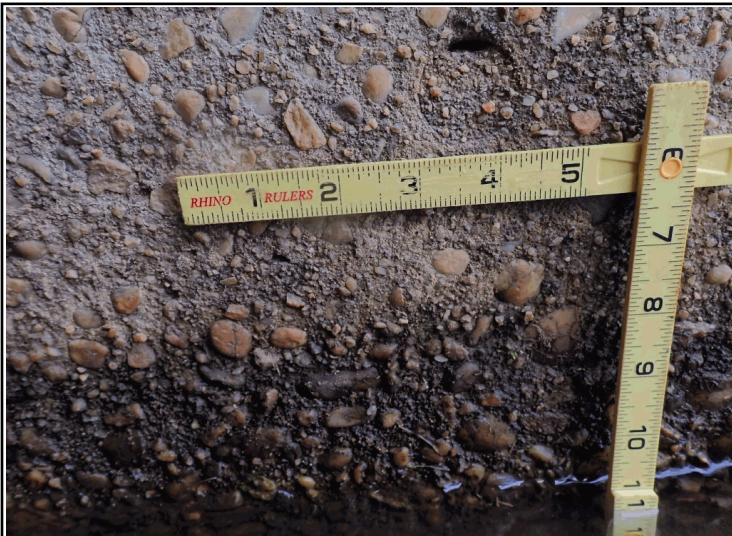
**Photo 7:**  
Typical Concrete Condition at Waterline  
(IW1 Inlet shown)

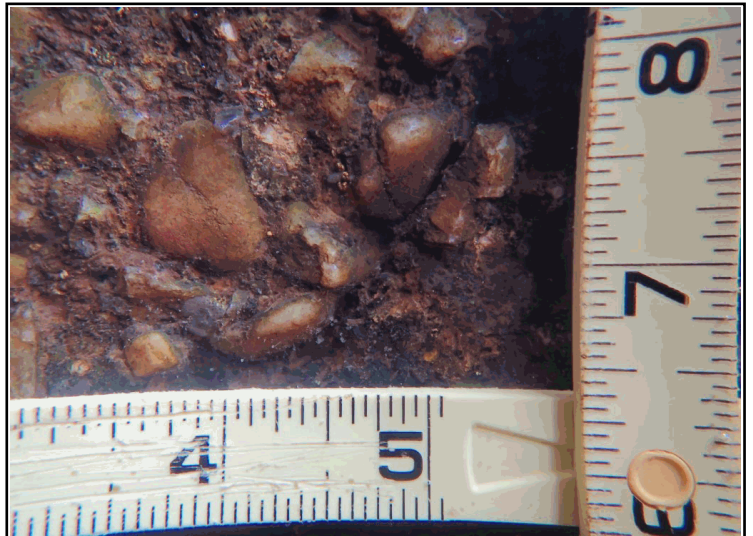
**Photo 8:**  
Typical Concrete Condition below Waterline  
(IW1 Inlet shown)

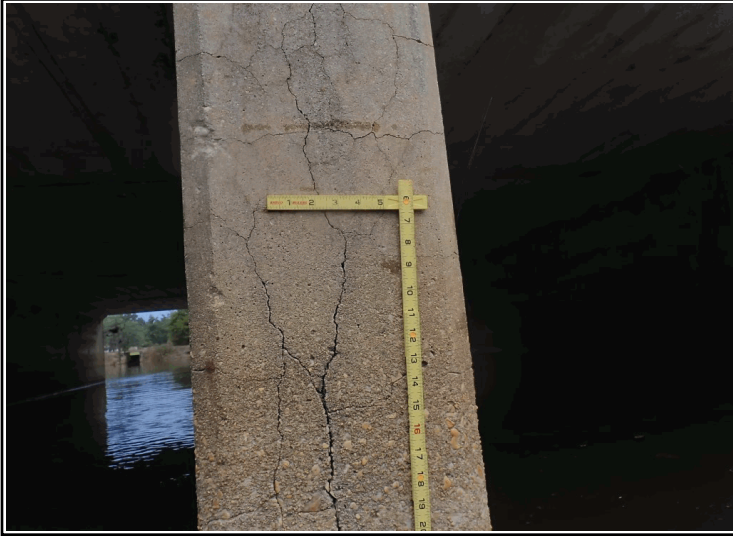
Map cracking up to 1/16in wide extends from barrel up to 2ft into wingwalls.

**Photo 9:**  
IW1 typical cracking condition at outlet.

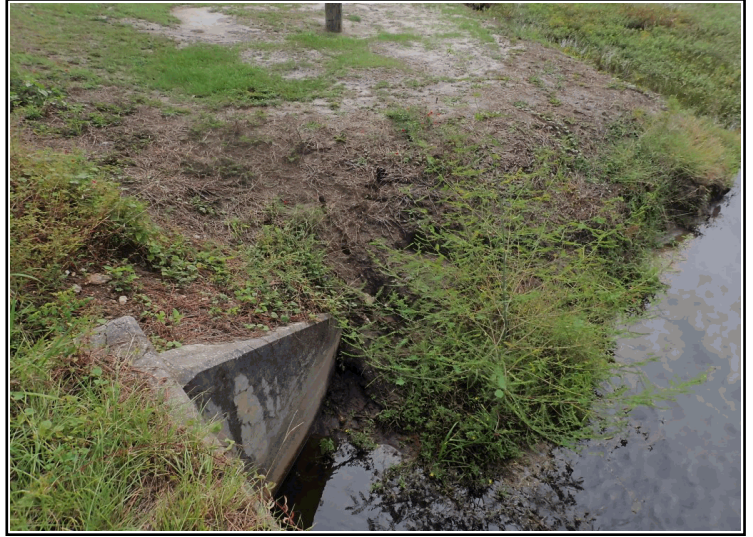
- No channel protection devices observed. [Photos 10 through 13]

**Photo 10:**  
Near / Southeast Embankment

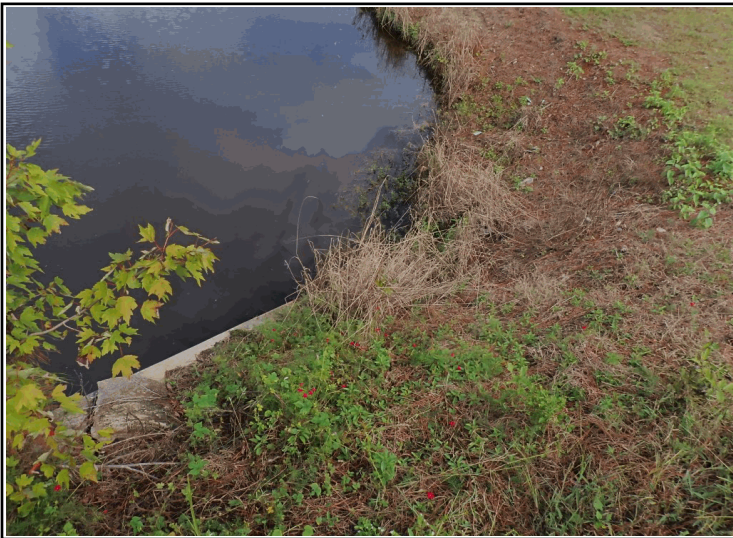
- Near/Northeast embankment, erosion/scour hole at wingwall tip (3ft diameter x up to 2ft deep).

**Photo 11:**  
Near / Northeast Embankment

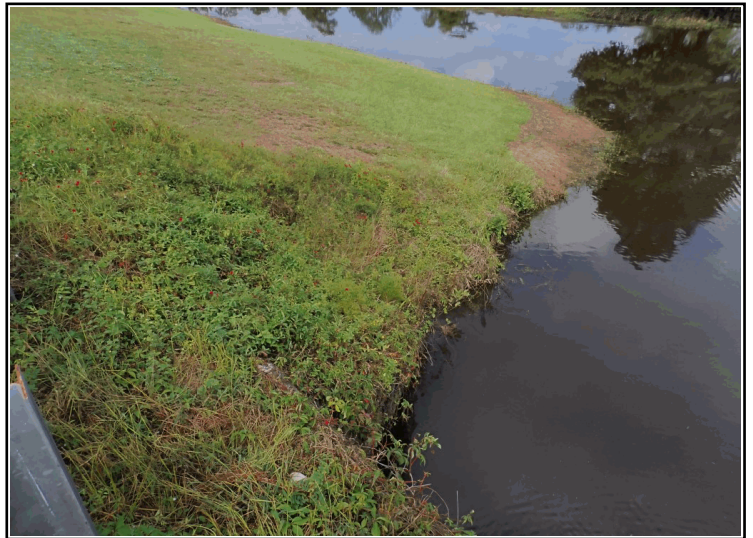
**Photo 12:**  
Far / Northwest Embankment

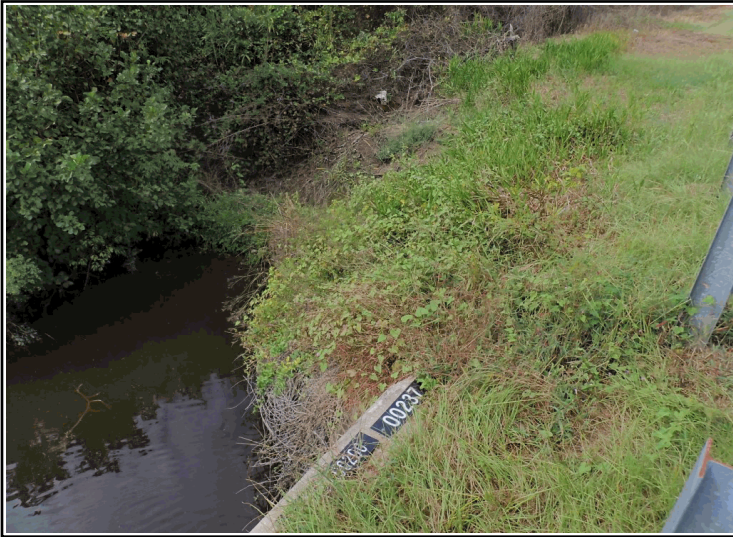
**Photo 13:**  
Far / Southwest Embankment

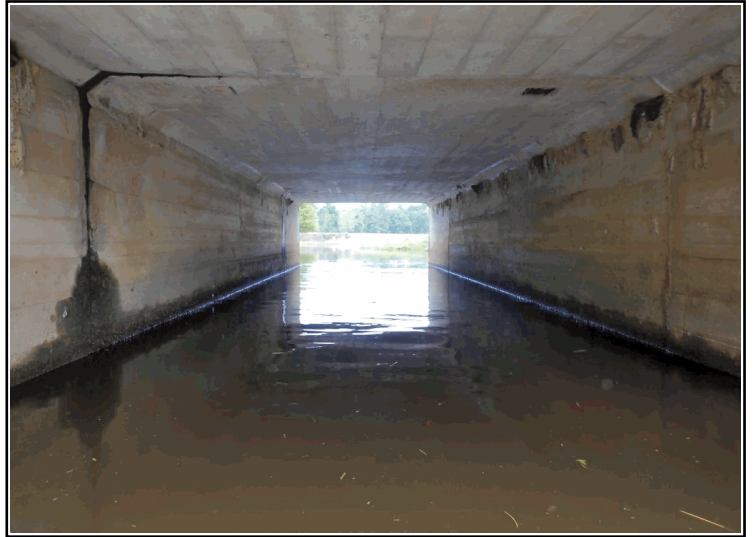
**Photo 14:**  
Looking through Barrel 1 from Outlet

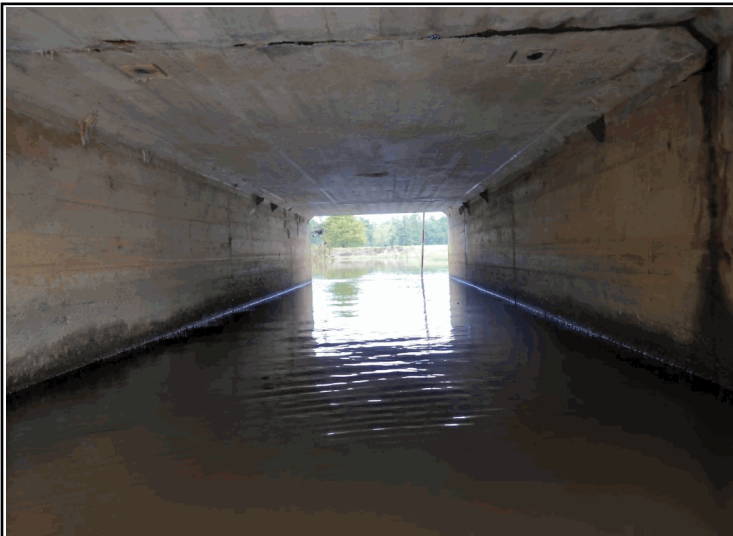
**Photo 15:**  
Looking through Barrel 2 from Outlet

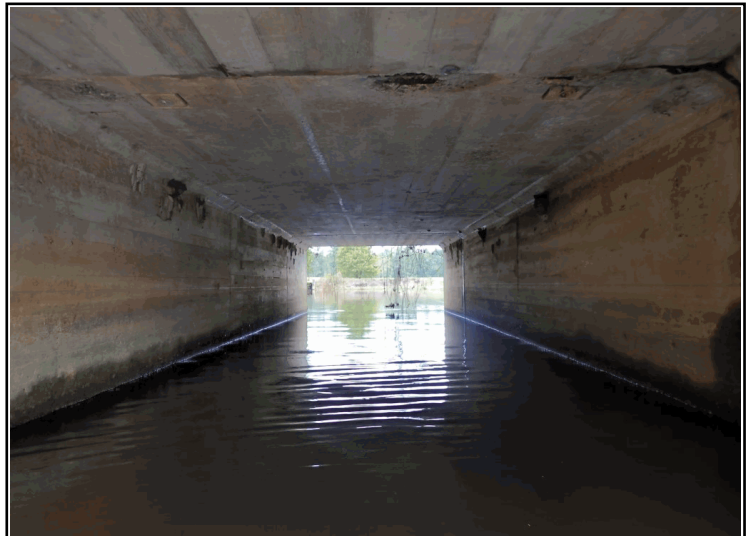
**Photo 16:**  
Looking through Barrel 3 from Outlet

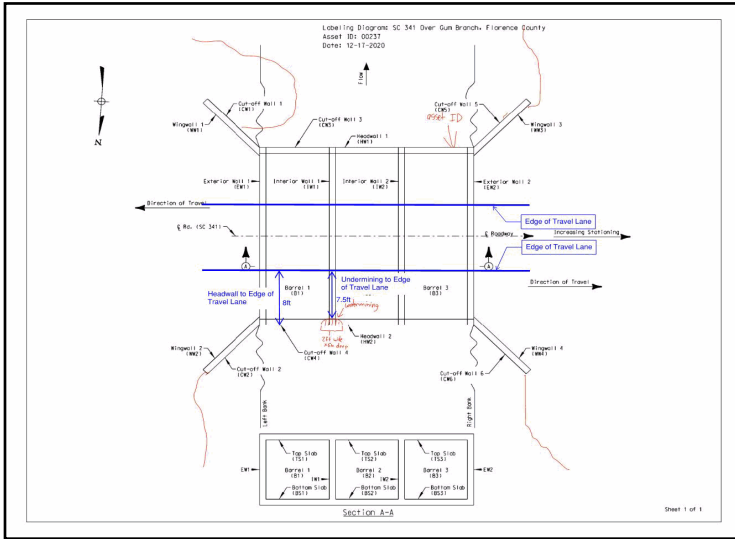
**Photo 17:**

| ELEM/ENV | ELEMENT NAME | QUANTITY | UNITS | QTY ST 1 | QTY ST 2 | QTY ST 3 | QTY ST 4 |
|---|---|---|---|---|---|---|---|
| <p>[3] Barrel (10ft wide x 8ft high) Reinforced Concrete Culvert (42ft long)</p> <p>10/17/2023 Routine Inspection findings:</p> <p>North headwall, at West end, spall (10in long x 6in wide x 1in deep). [1080, CS3, Q1]</p> <p>North headwall, at East end, spall (9in long x 7in high x 7in wide x 1in deep). [1080, CS3, Q0]</p> <p>South headwall, at West end, spall (2ft long x up to 7in wide x 0.5in deep). [1080, CS3, Q1]</p> <p>South headwall, at East end, vertical crack (up to 1/4in wide). [1130, CS3, Q0]</p> <p>Barrel 1 top slab at outlet, spall (9in long x 3in high x 2in deep). [1080, CS3, Q1]</p> <p>Barrel 3 top slab at construction joint, (2) spalls (1ft long x 1ft wide x 2in deep) with exposed rebar with section loss (40% section loss). [1090, CS3, Q2]</p> <p>9/19/2024 Underwater inspection findings:</p> <p>Throughout all barrels, from high-water line to top of bottom slab, abrasion (up to 1/16in deep) with exposed secure aggregate. [1190, CS2, Q66]</p> <p>Barrels 1 through 3, at widened sections, throughout all surfaces, map cracking (up to 1/16in wide). [1130, CS3, Q52, Photo 9]</p> <p>Barrels 1 and 2, IW1, scour/undermining (2in high x 2ft wide x 6in deep). [6000, CS3, Q2, Photo 17]</p> | | | | | | | |

- Barrel 1, (up to 2.4ft) of scour since 2006 Routine Inspection.
- Barrel 3, (up to 2.4ft) of scour since 2020 Routine Inspection.
- IW1, scour/undermining (2in high x 2ft wide x 6in deep) [Photo 17].

Extent of Undermining at Inlet of Culvert
