# Bridge Inspection Report

02753

(7) Facility Carried: US 501 BYP

(6) Crossing: WACCAMAW RIVER

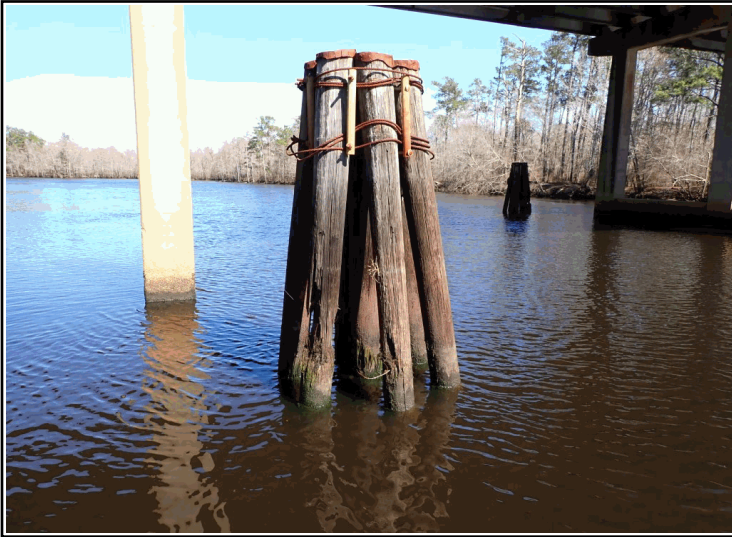
**Photo 5:**

Typical Pier Protection, SW Dolphin Pile Cluster shown

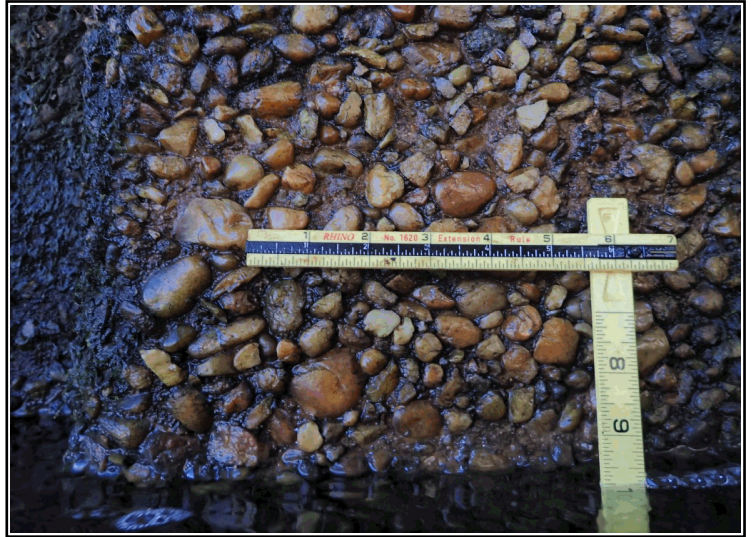
**Photo 6:**

Typical Concrete Condition at Waterline  
(Bent 14, Column 2 shown)

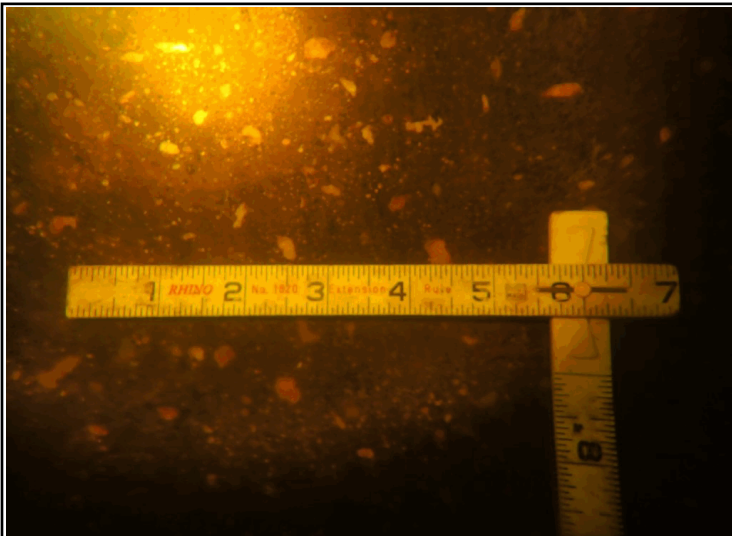
**Photo 7:**

Typical Concrete Condition below Waterline  
(Bent 12, Column 3)

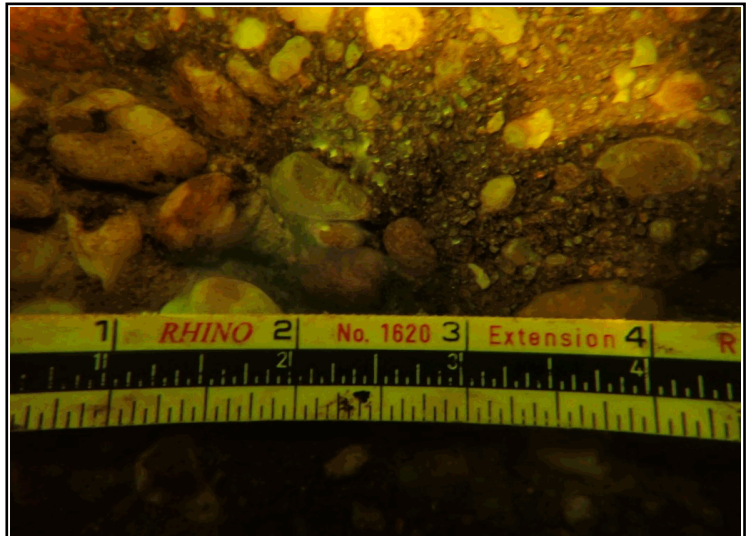
**Photo 8:**

Typical Concrete Condition below Waterline  
(Bent 11, Footing 3)

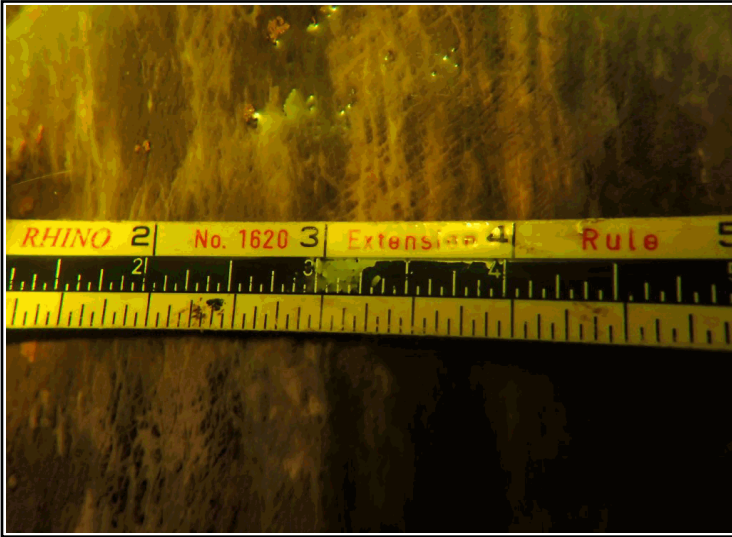
Bents 11 and 12, exterior piles are sound with no significant deterioration observed. [Photo 9]

**Photo 9:**  
Typical Timber Condition below Waterline  
(Footing 11-3, NW Pile)

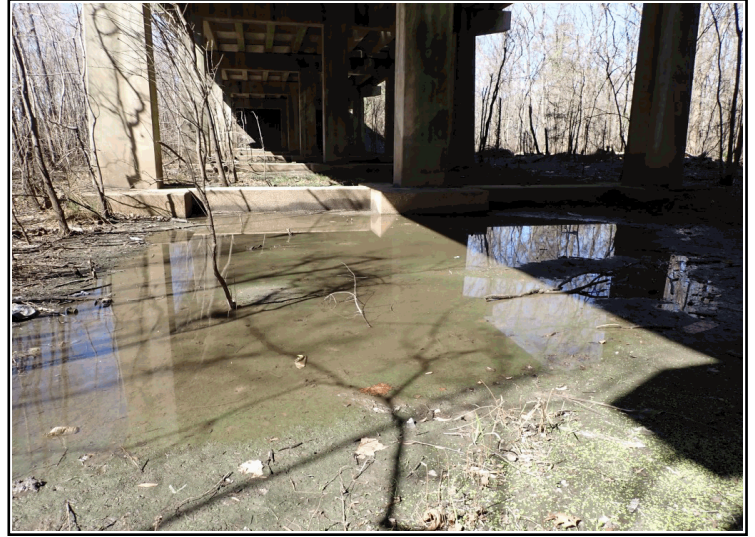
**Photo 14:**  
West Floodplain, under bridge, minor scour (up to 1ft deep)

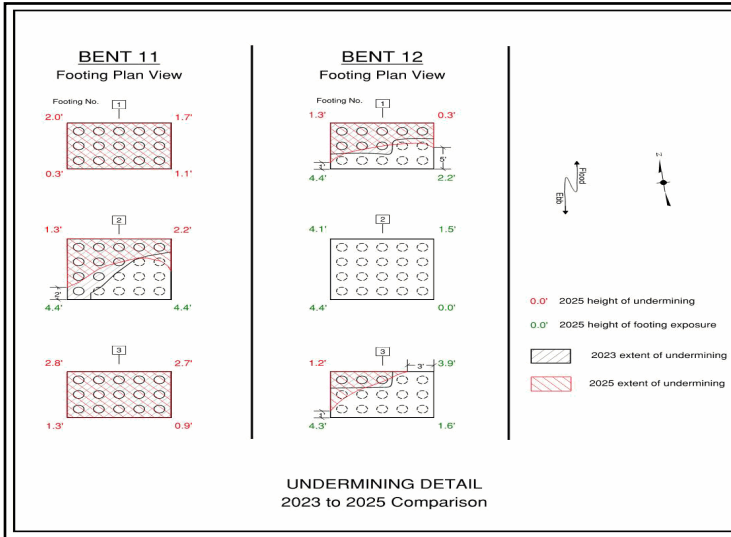
**Photo 16:**  
Downstream Streambed Cross Section, Right View

- From Bents 10 through 13, (up to 7.5ft) of scour since construction.
- Bents 11 and 12, (up to 2.3ft) of scour since 2021 Underwater Inspection.
- Streambed cross sections from 2011, 2016, 2021, and 2023 Underwater Inspections added for comparison. [Photos 15 and 16]
- Due to a combination of contraction and local scour, Footings 11-1, 11-2, 11-3, 12-1, and 12-3 are undermined (up to 2.8ft high), exposing (approx. 54) untreated timber foundational piles. [Photo 17]
- No significant change in scour conditions observed since 2023 Underwater Inspection. [Photo 18]
- Bents 11 and 12, height of footing exposure/undermining comparison for all underwater inspections completed since first reported in 2011. [Photos 18 through 21]

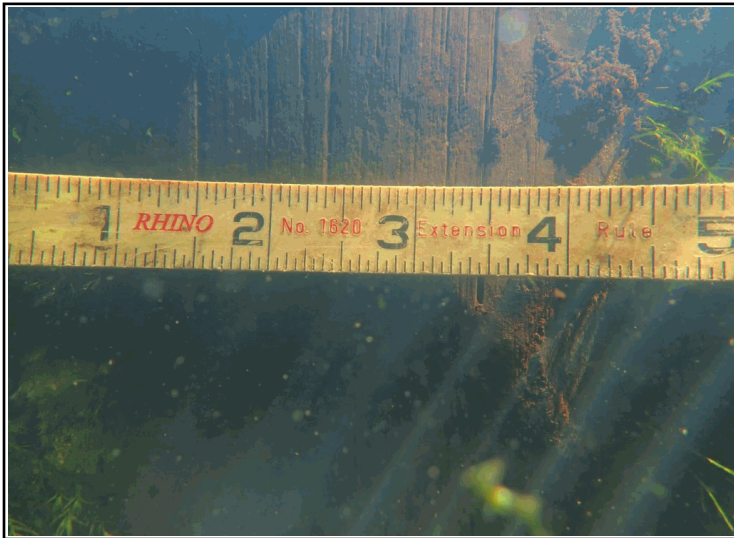
**Photo 23:**

- All dolphin clusters, from top of pile to 1ft below waterline, decay/rot (up to 90% section loss). [Photos 22 and 23]

Typical Dolphin Timber Pile Condition below Waterline (SW Cluster shown)
