# Bridge Inspection Report

09697

(7) Facility Carried: SC 22 WB

(6) Crossing: WACCAMAW RIVER

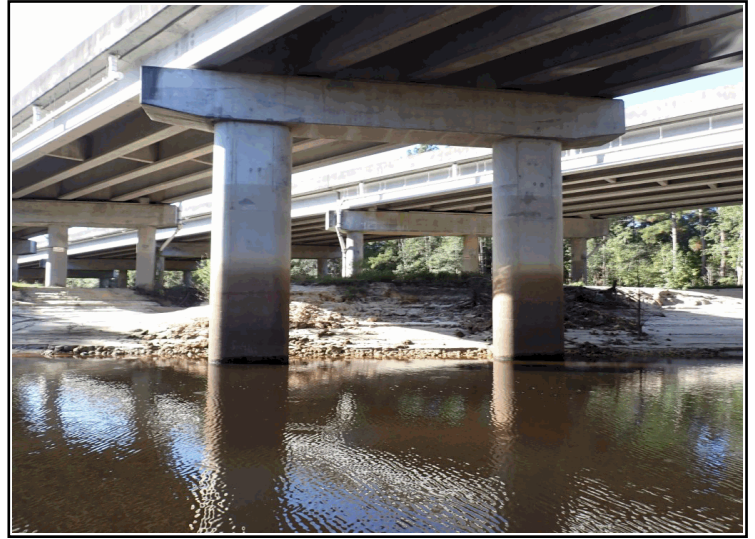
**Photo 6:**  
Bent Configuration, Bents 2 through 4  
(Bent 4 shown)

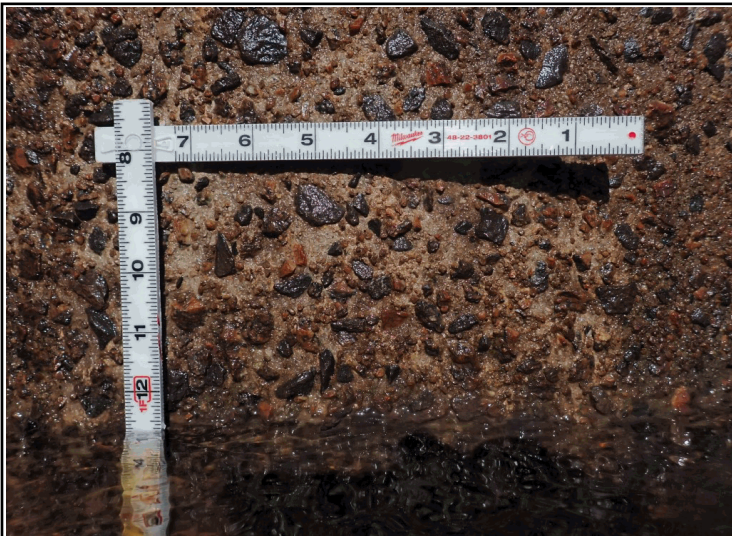
| ELEM/ENV | ELEMENT NAME | QUANTITY | UNITS | QTY ST 1 | QTY ST 2 | QTY ST 3 | QTY ST 4 |
|---|---|---|---|---|---|---|---|
| BTs 2 thru 4: (2) Reinforced Concrete Bullnose Columns (4ft W x 8ft L) per bent.<br>BTs 5 thru 13: (3) Reinforced Concrete Columns (4ft diameter) per bent.<br><br>Column 5-1, minor scour (up to 2ft H). [6000, CS2, Q1]<br>Column 5-3, footing exposed (up to 4ft L x 1ft W x 18in H). [6000, CS3, Q1]<br>Column 8-1, North face at groundline, spall (3in H x 8in W x 1/2in D). [1080, CS2, Q1]<br>Column 10-1, Southwest face, 2ft above ground, spall (3in H x 8in W x 1/2in D). [1080, CS2, Q1]<br>Column 13-1, East face, unsound patch (18in diameter). [1080, CS2, Q1]<br>Column 13-2, West face, unsound patch (18in diameter). [1080, CS2, Q1]<br>Column 13-3, West face, unsound patch (18in diameter). [1080, CS2, Q1]<br><br>10/07/2025 Underwater Inspection Findings:<br>Bents 2 thru 4, all columns, at waterline, abrasion (up to 1/4in D) with exposed coarse aggregate. [1190, CS2, Q6, Photos 7 and 8] | | | | | | | |

**Photo 7:**  
Typical Concrete Condition at Waterline  
(Column 3-1 shown)

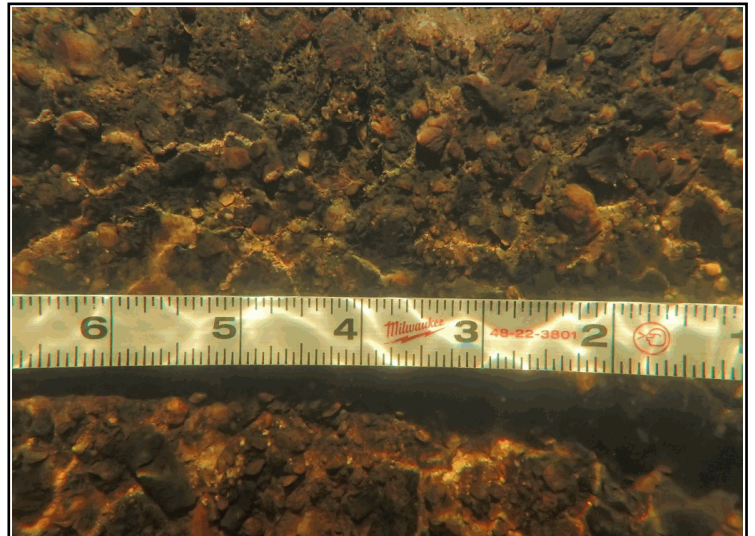
**Photo 8:**  
Typical Concrete Condition below Waterline  
(Column 3-1 shown)

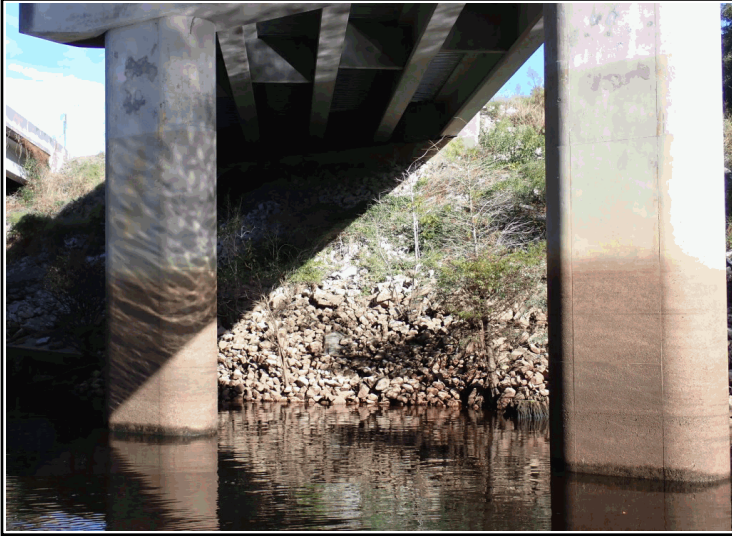
**Photo 9:**  
Near/North Embankment

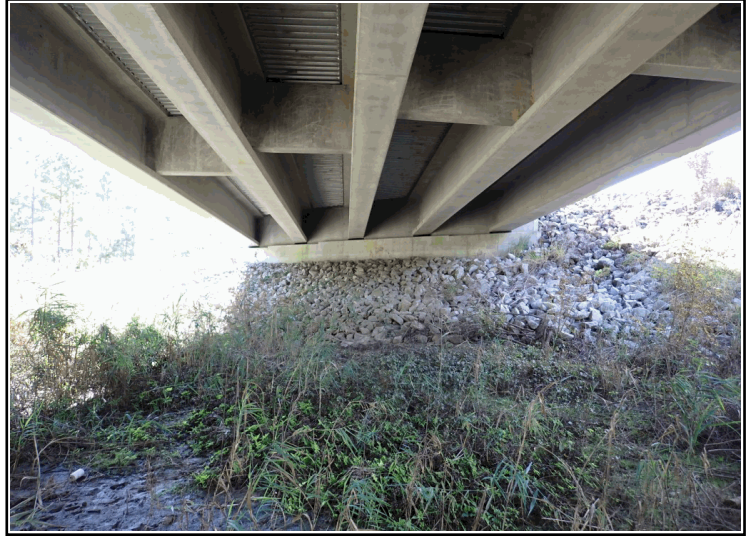
**Photo 10:**  
Far/South Embankment

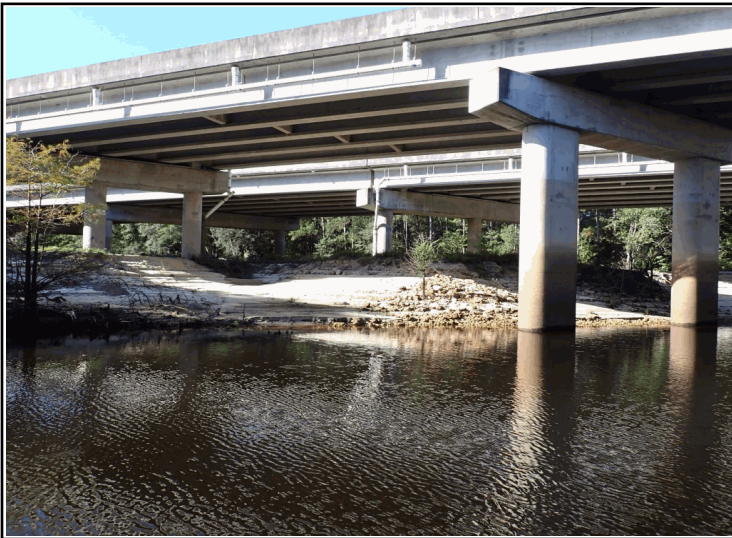
**Photo 11:**  
South Channel Bank

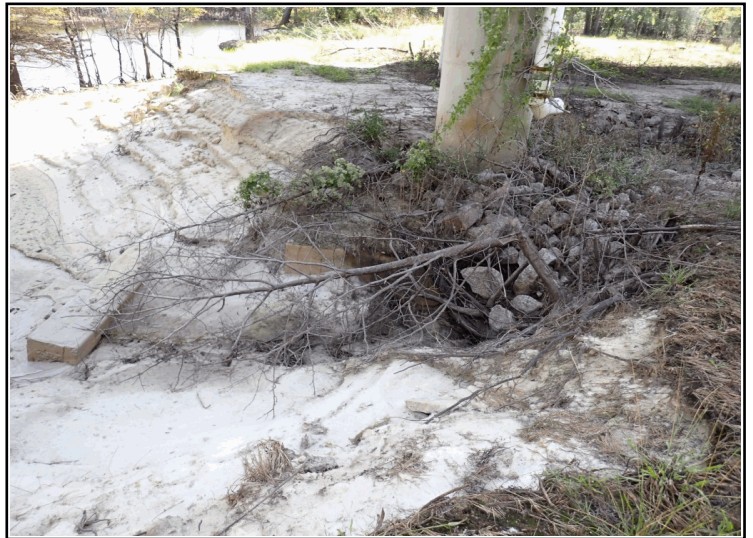
**Photo 12:**  
South channel bank erosion (approx. 60ft long x 40ft wide x 6ft deep) from scupper discharge at BT5

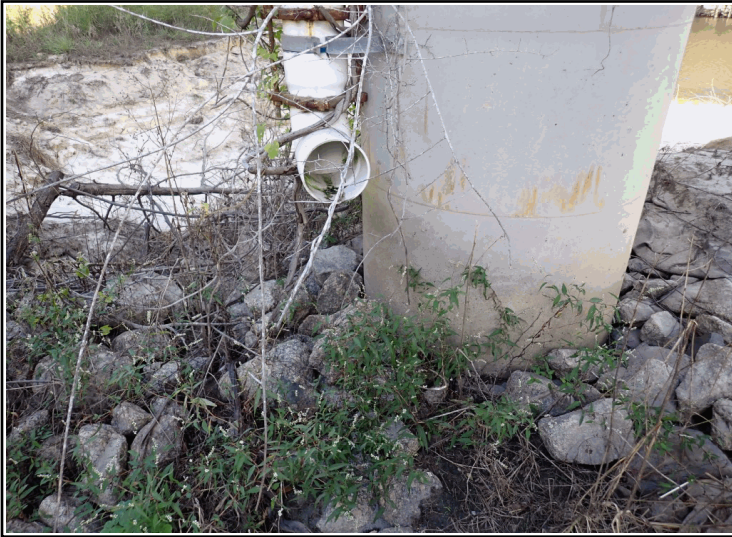
**Photo 13:**

Scupper discharge attached to Column 5-2

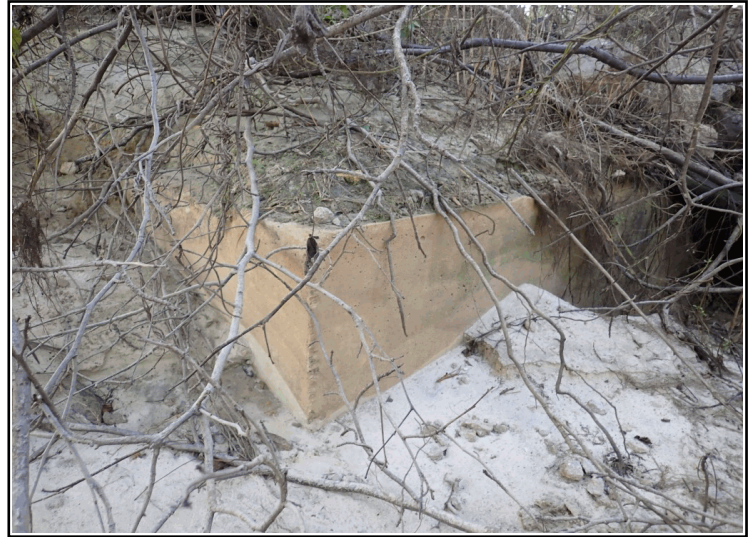
**Photo 14:**

Footing 5-2, NW and NE corners, vertical exposure (up to 2ft high) due to bank erosion from scupper discharge
