# Bridge Inspection Report

09698

(7) Facility Carried: SC 22 EB

(6) Crossing: JONES BIG SWAMP

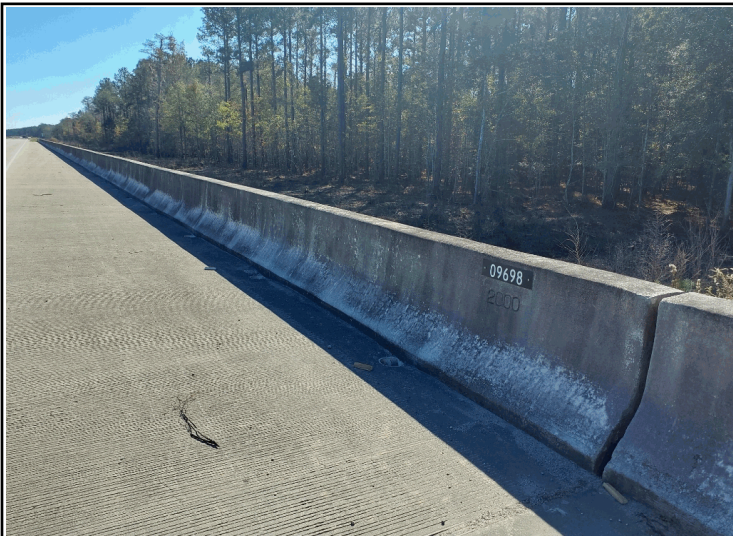
**Photo 11:**  
Typical Bridge Rail (West Shown)

Throughout all spans, both rails, spaced 2-4ft apart, vertical cracks (FH x HL) some with efflorescence.

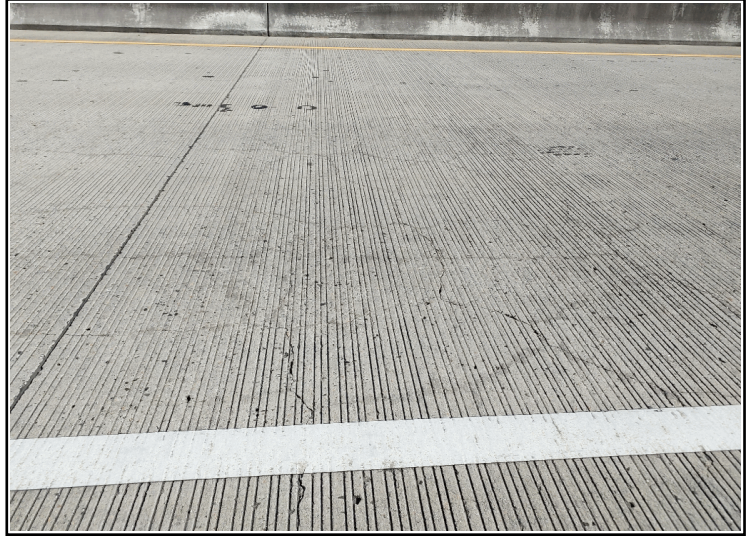
| ELEM/ENV | ELEMENT NAME | QUANTITY | UNITS | QTY ST 1 | QTY ST 2 | QTY ST 3 | QTY ST 4 |
|---|---|---|---|---|---|---|---|
| Throughout all spans, longitudinal, diagonal, and map cracking (up to 1/8in W x 20% of surface area). [3220, CS2, Q2415 and 3220, CS3, Q2415]<br>Span 2 left shoulder at BT 2, spall (3ft W x 9in L x 1in deep). [3210, CS3, Q3]<br>Span 7 left shoulder at BT8, spall (2ft-8in W x 1ft L x 1in deep). [3210, CS3, Q3]<br>Span 10 left shoulder at BT10, spall (6in L x 2in W x 1/4in deep). [3210, CS2, Q1]<br>Span 11 left travel lane at BT11, spall (6in L x 5in W x 1-1/2in deep). [3210, CS3, Q1]<br>Span 15 left travel lane at BT15, spall (4in L x 6in W x 1/2in deep). [3210, CS2, Q1] | | | | | | | |

**Photo 18:**  
Wearing surface, throughout all spans, longitudinal, diagonal, and map cracking (up to 1/8in W x 20% of surface area).

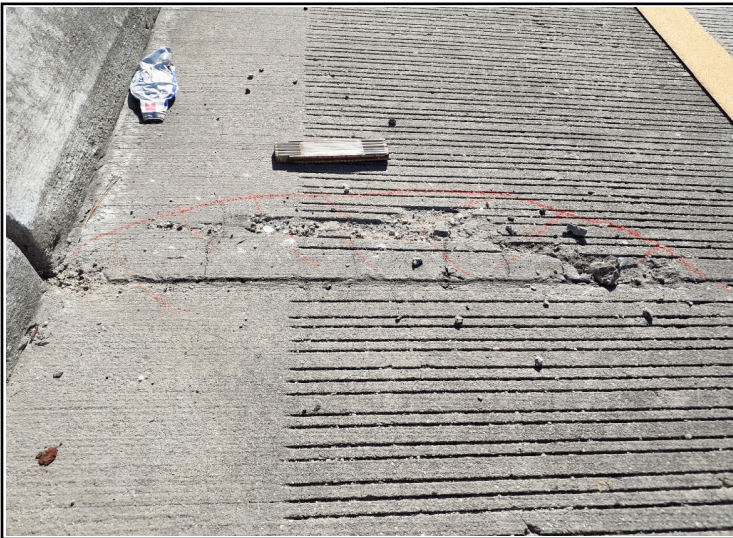
**Photo 19:**  
Wearing surface, Span 2 left shoulder at BT 2, spall (3ft W x 9in L x 1in deep)

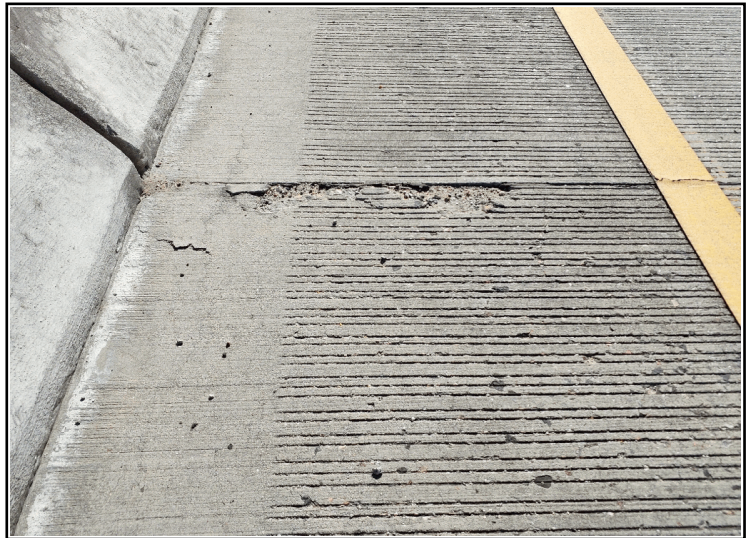
**Photo 20:**  
Wearing surface, Span 7 left shoulder at BT8, spall (2ft-8in W x 1ft L x 1in deep).

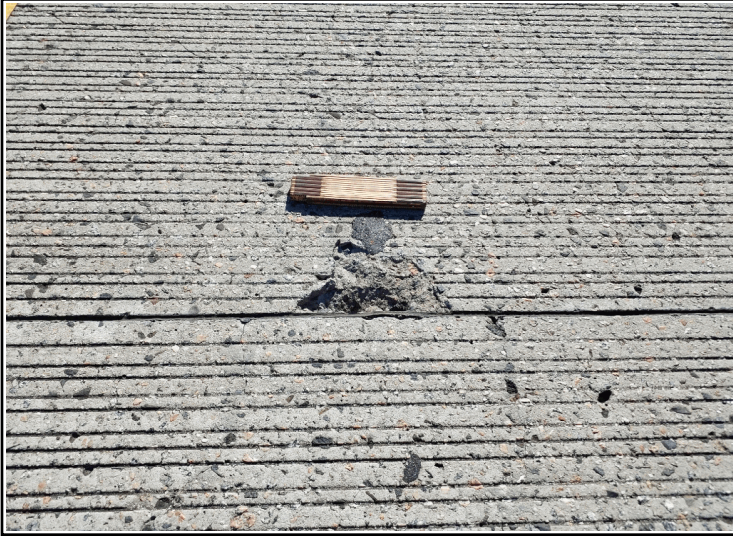
**Photo 21:**

Wearing surface, Span 11 left travel lane at BT11, spall (6in L x 5in W x 1-1/2in deep).

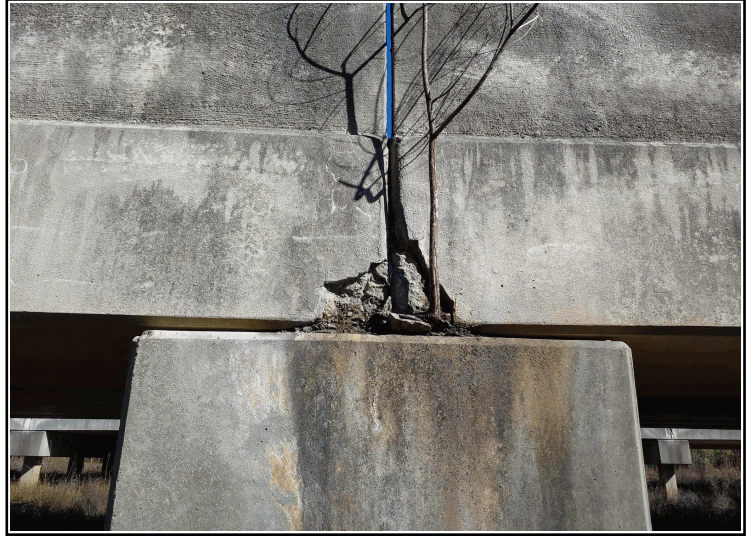
**Photo 22:**

Throughout all spans over interior bents on West fascia of Beams, spalls/delaminations (up to 6in L x FH x up to 3in deep) with adjacent vertical crack (FH x up to 1/8in W) at the following locations [1080, CS3, Q14]:

Throughout all spans over interior bents on East fascia of Beams, spalls/delaminations (up to 6in L x FH x up to 3in deep) with adjacent vertical crack (FH x up to 1/8in W) at the following locations [1080, CS3, Q12]:

Throughout all spans over interior bents on East and West fascias of Beams, spalls/delaminations (up to 6in L x FH x up to 3in deep) with adjacent vertical crack (FH x up to 1/8in W).

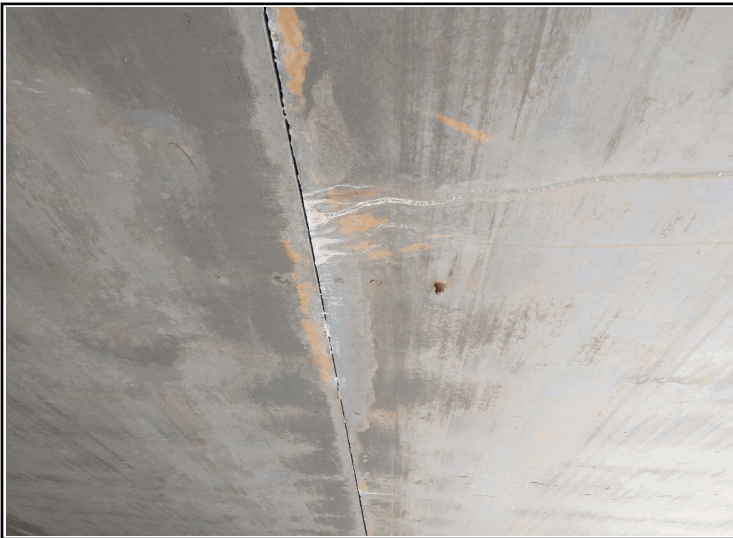
**Photo 23:**

Scattered throughout all spans, between beams, efflorescence leaching out.

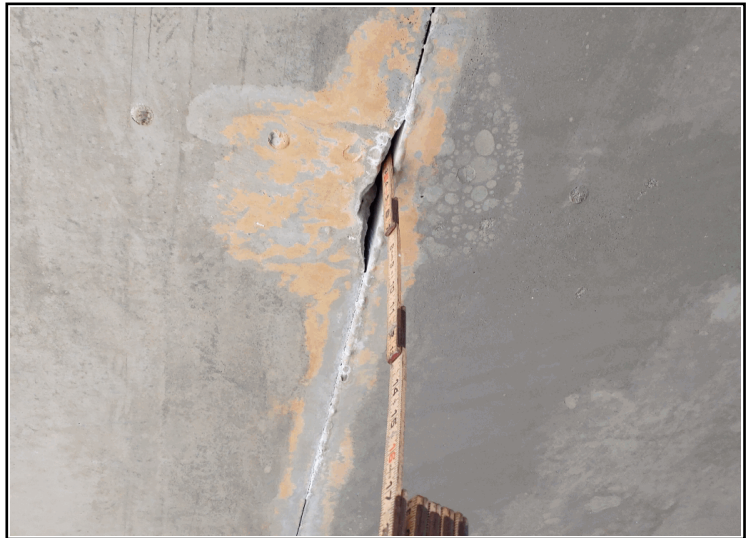
**Photo 24:**

BM 12-5 at 5ft from BT12, left edge, spall (7in L x 1in W x 3in deep). [1080, CS3, Q1]

BM 12-5 at 5ft from BT12, left edge, spall (7in L x 1in W x 3in deep).

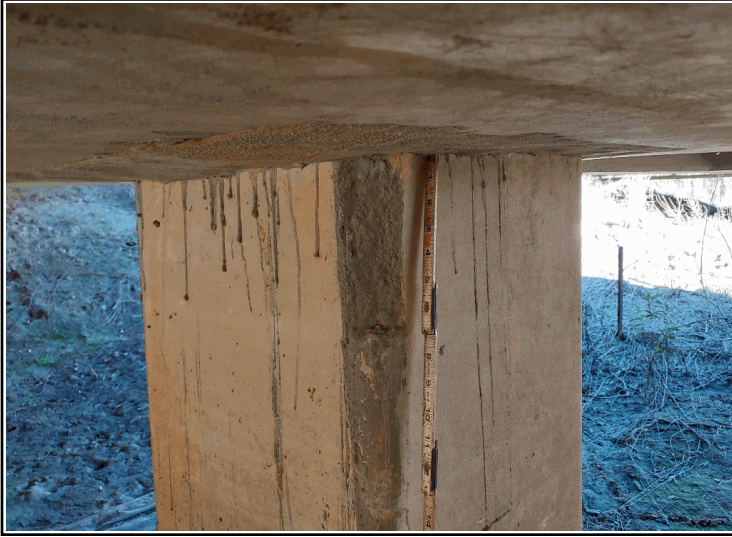
**Photo 25:**

Pile 2-2, SW corner at cap, spall (1ft-2in H x 2in W x 1in deep).

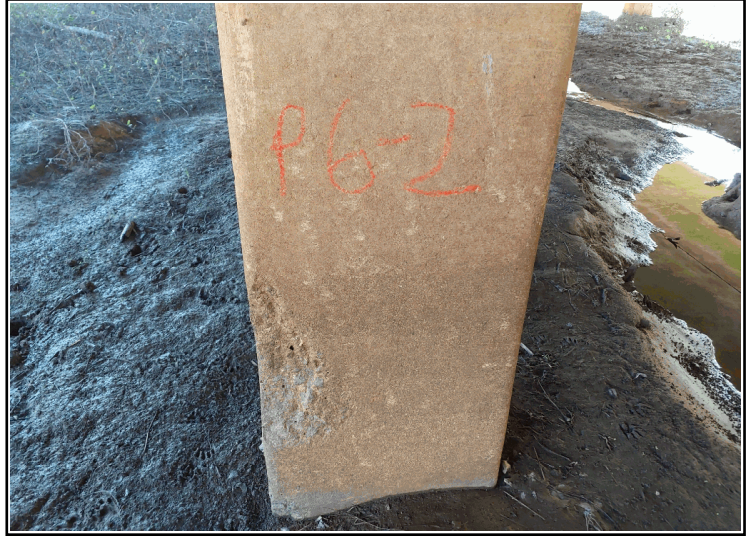
**Photo 26:**

Pile 6-2, NE corner at 1ft from ground, spall (14in H x 7in W x up to 2in deep).

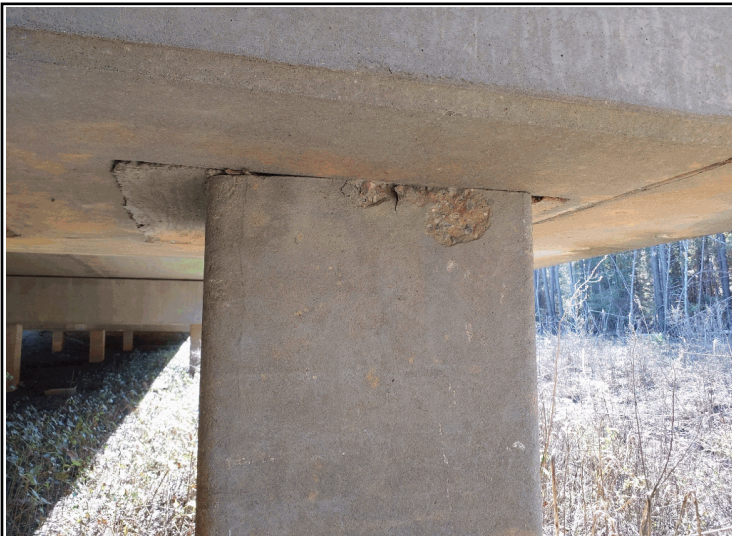
**Photo 27:**

Pile 12-4, North face at cap, spall (3-1/2in H x 8in W x 1/2in deep).

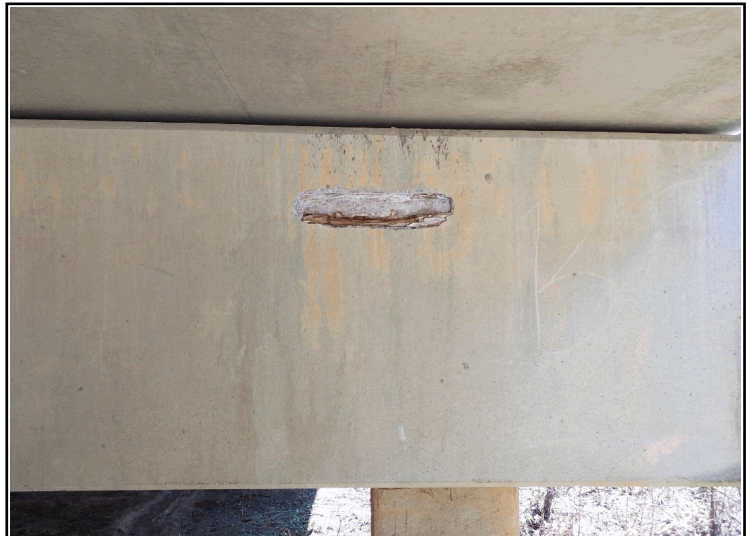
**Photo 28:**

Bent 2 Cap, North face at West end, void (15in L x 4in H x 1-1/2in deep).

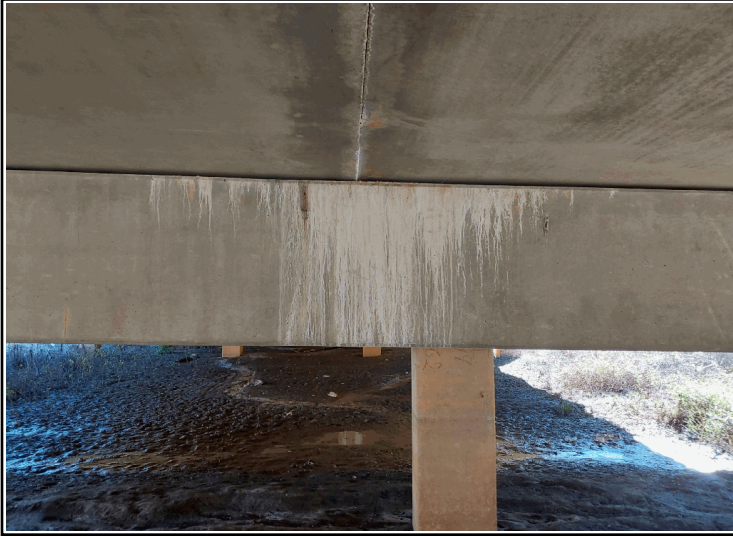
**Photo 29:**

Bent 14 Cap, North face above Pile 3, efflorescence build-up (7ft L x up to full height).

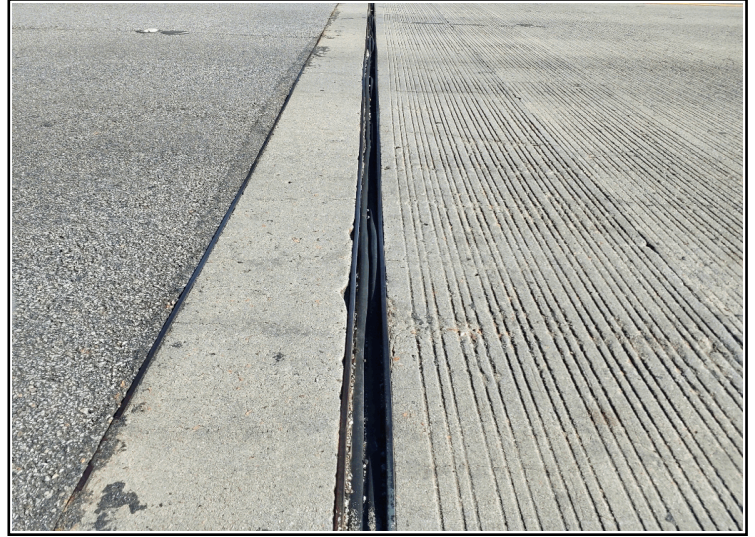
**Photo 30:**

Joint at End Bent 1, throughout travel lanes, areas of depressed seal (up to 1-1/2in deep x 5ft L total), throughout both shoulders debris impaction (5ft L total).

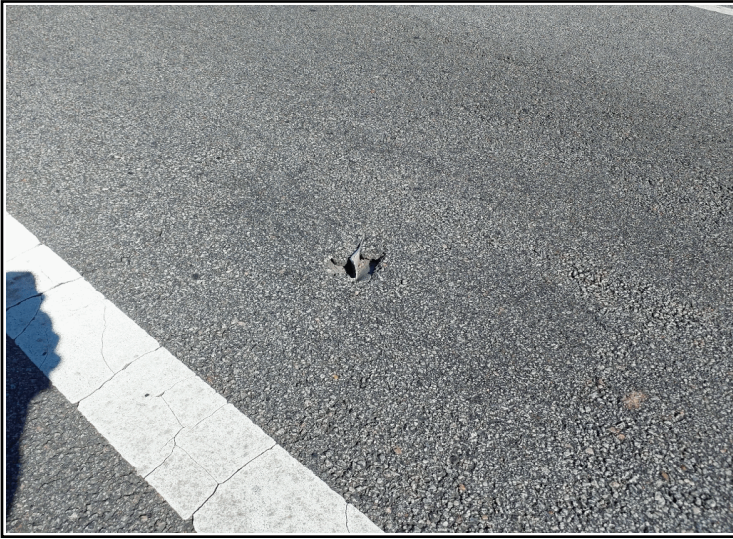
**Photo 33:**

North Approach Slab, right lane, next to white line at end of approach slab, pothole (6in diameter x 1-1/2in deep) with exposed steel plate (which is embedded in the asphalt).

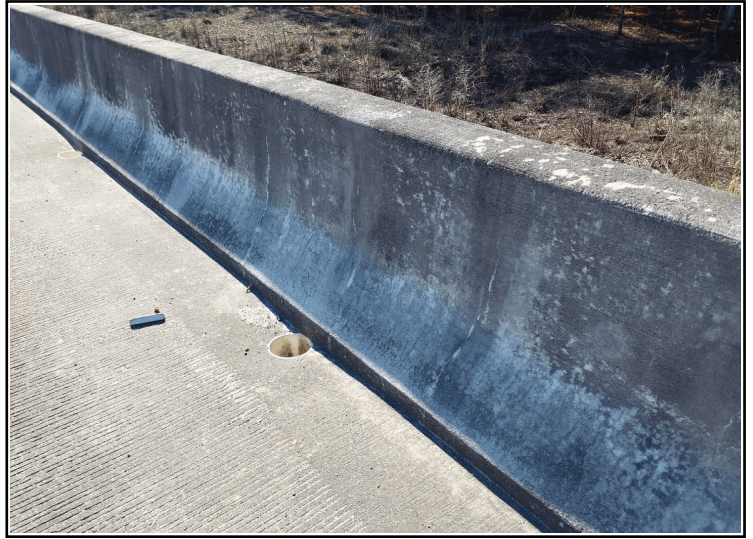
**Photo 34:**

| ELEM/ENV | ELEMENT NAME | QUANTITY | UNITS | QTY ST 1 | QTY ST 2 | QTY ST 3 | QTY ST 4 |
|---|---|---|---|---|---|---|---|
| Throughout all spans, both rails, spaced 2-4ft apart, vertical cracks (FH x HL) some with efflorescence. [1120, CS2, Q150] | | | | | | | |

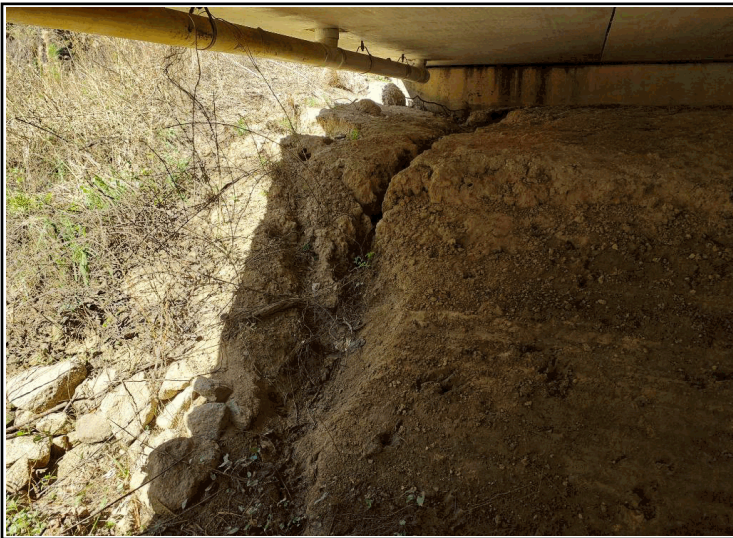
**Photo 35:**

EB1 slope protection, West end, starting at EB1, erosion gully (22ft L x up to 3ft W x up to 2ft deep).

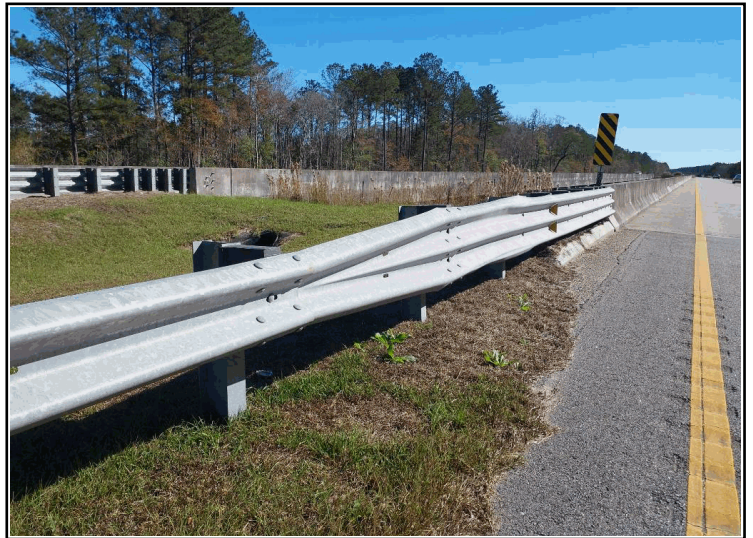
**Photo 36:**

NE guardrail transition 20ft from EB1, impact damage (8ft L).

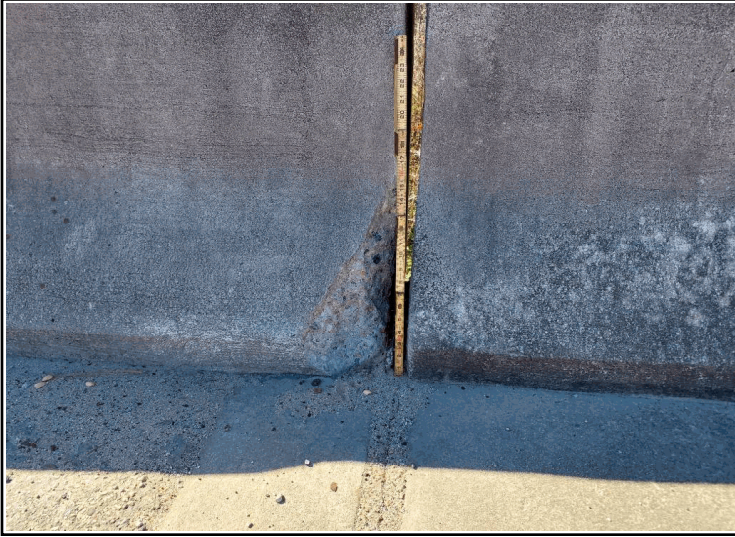
**Photo 37:**

East approach rail, at EB16, spall (8in L x 16in H x up to 2-1/2in deep).
