# Bridge Inspection Report

09789

(7) Facility Carried: SC 31 NBL

Inspection Type(s): Routine

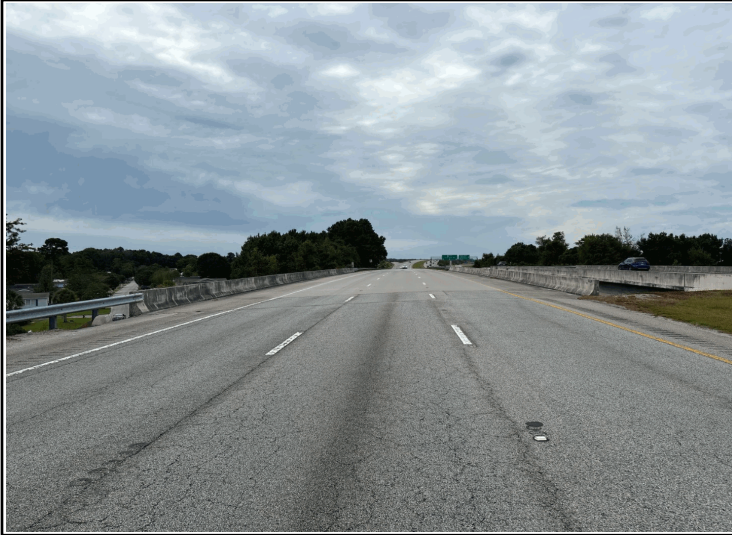
**Photo 1:**  
North Approach Looking South

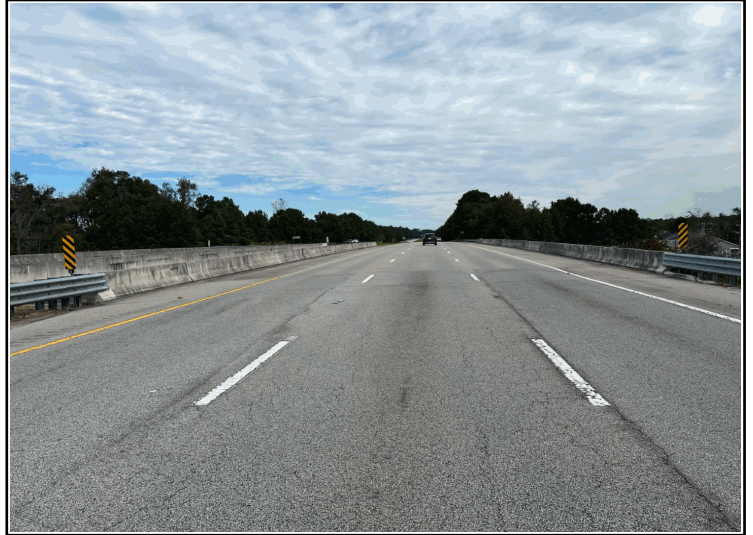
**Photo 2:**  
South Approach Looking North

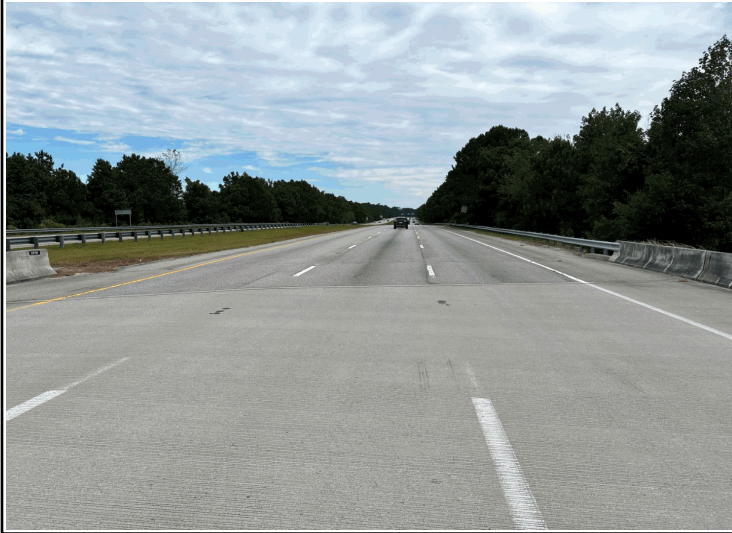
**Photo 3:**  
Backstation (North Approach Looking North)

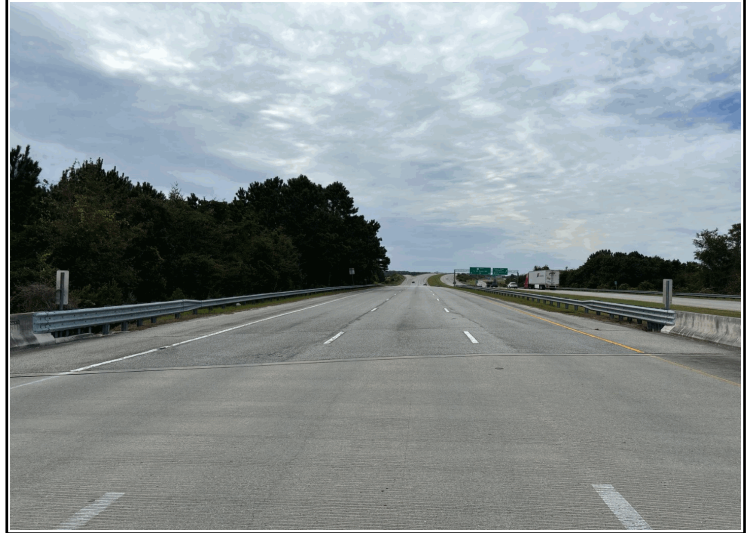
**Photo 4:**  
Upstation (South Approach Looking South)

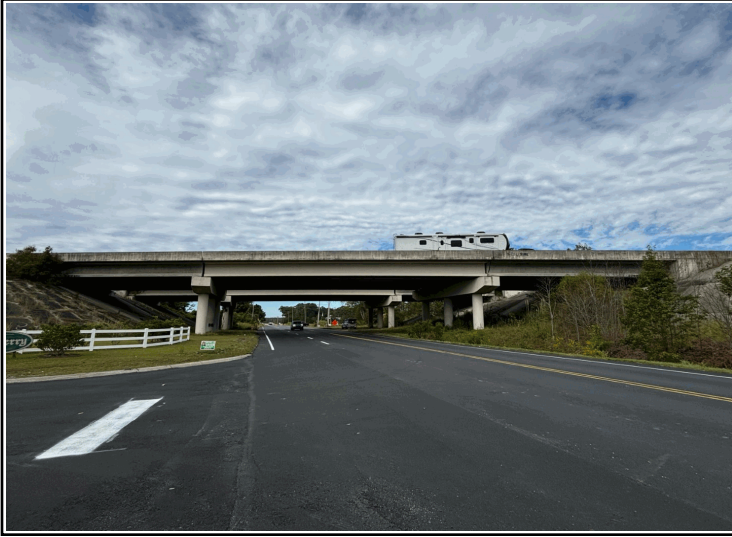
**Photo 5:**  
East Profile Looking West

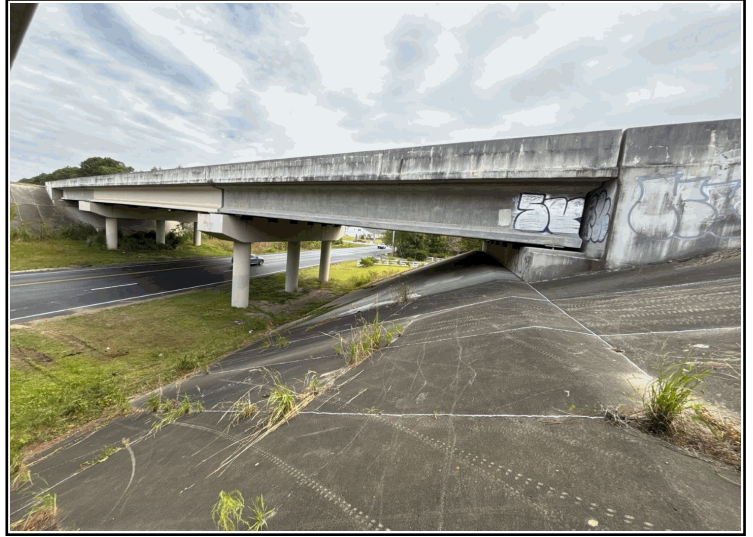
**Photo 6:**  
West Profile Looking East

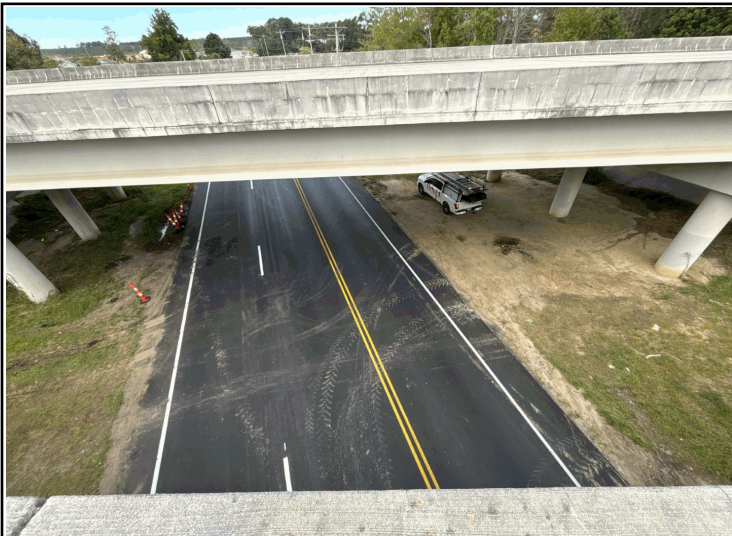
**Photo 7:**  
Feature Intersected (Looking West)

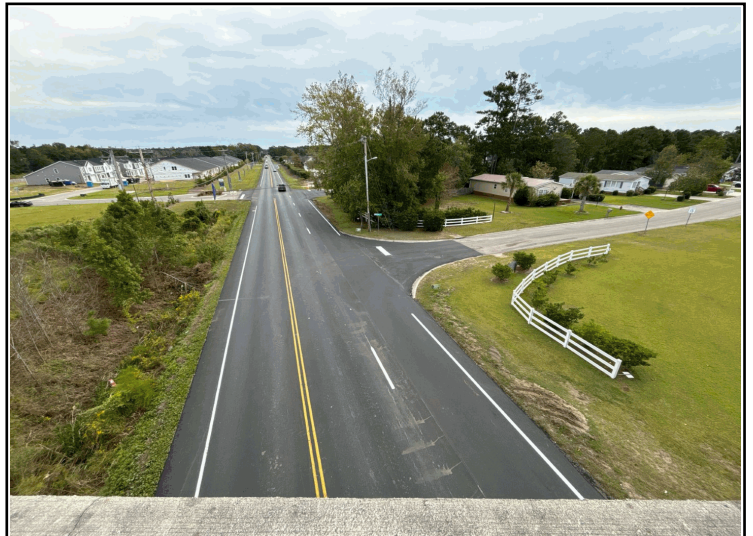
**Photo 8:**  
Feature Intersected (Looking East)

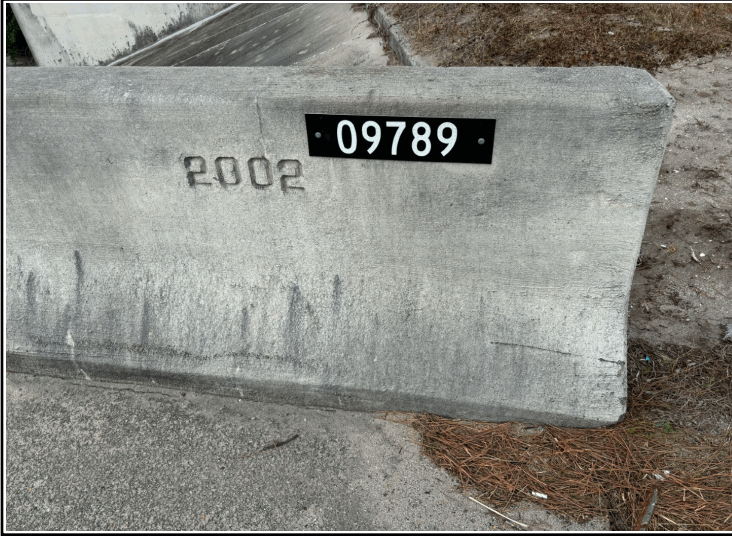
**Photo 9:**  
Asset ID Plaque at Bent 1 (NW Corner)

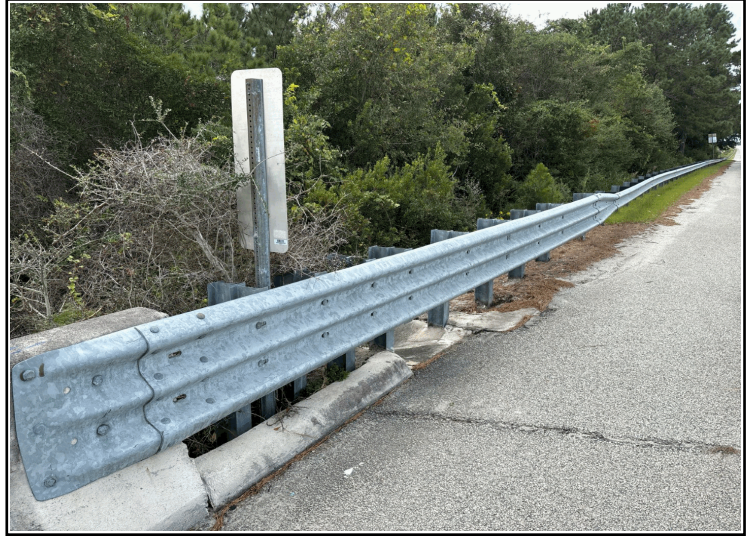
**Photo 10:**  
Southeast Guardrail Transition

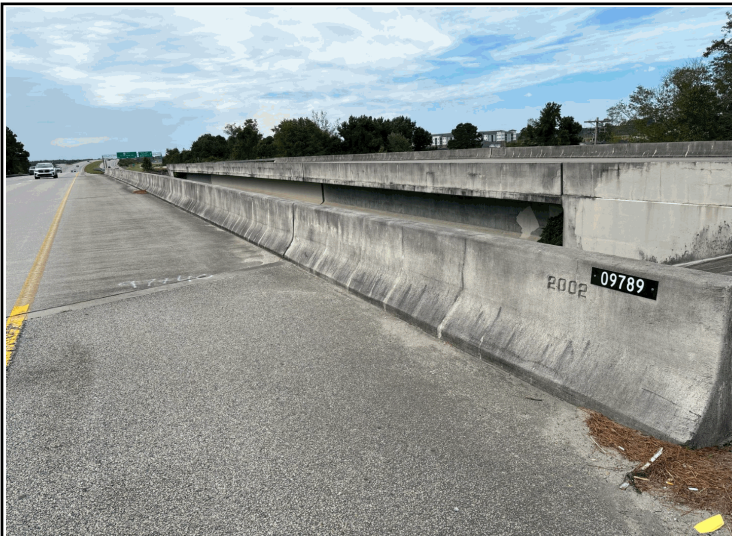
**Photo 11:**  
Typical Bridge Rail (West Shown)

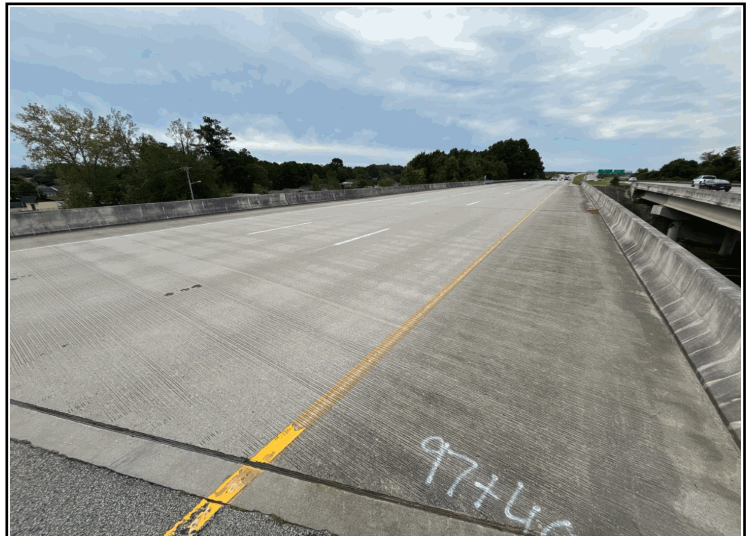
**Photo 12:**  
Concrete Bridge Deck

| ELEM/ENV | ELEMENT NAME | QUANTITY | UNITS | QTY ST 1 | QTY ST 2 | QTY ST 3 | QTY ST 4 |
|---|---|---|---|---|---|---|---|
| (3) Spans (Span 1 and 3at 60ft 6in L, Span 2 at 100ft L) for a total length of 221ft L; Reinforced Concrete Deck (59ft-4in W x 8-1/4in thick) with SIP forms.<br><br>Top of Deck:<br>All spans, scattered throughout, map cracking (10% x hairline). [1130, CS2, Q1311] | | | | | | | |

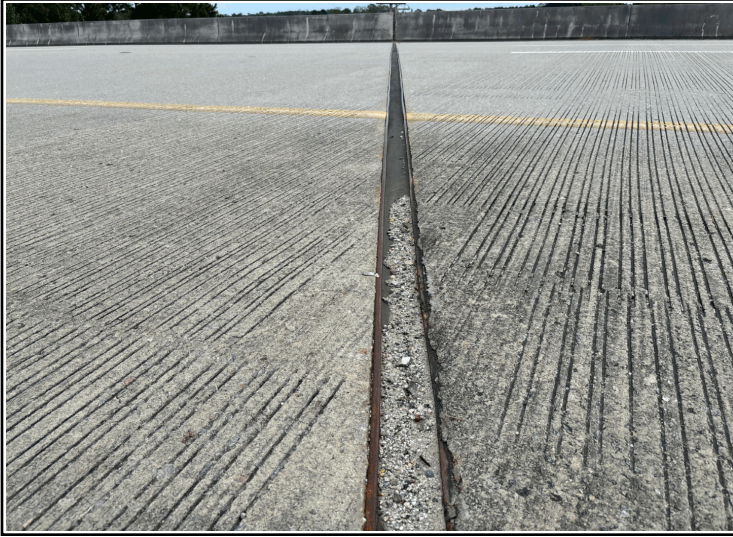
**Photo 13:**  
Typical Compression Joint (Bent 2 shown)

(4) Compression seal joints (63ft L) over all bent.

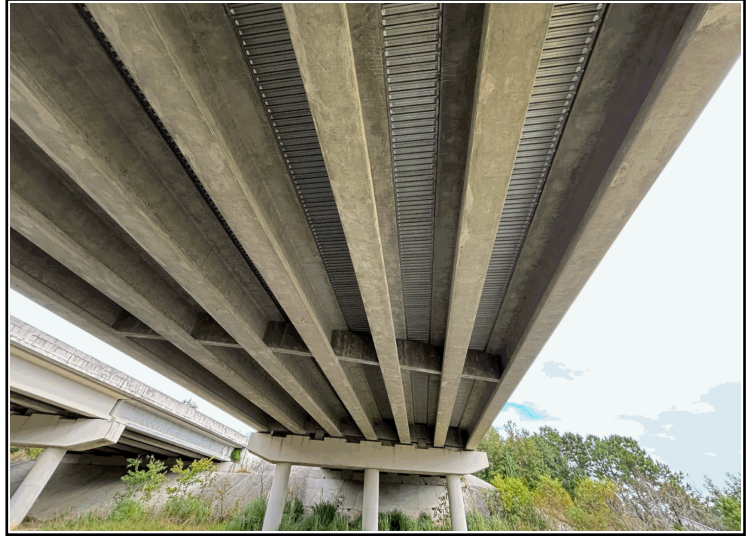
**Photo 14:**  
Typical Superstructure (Span 2 shown)

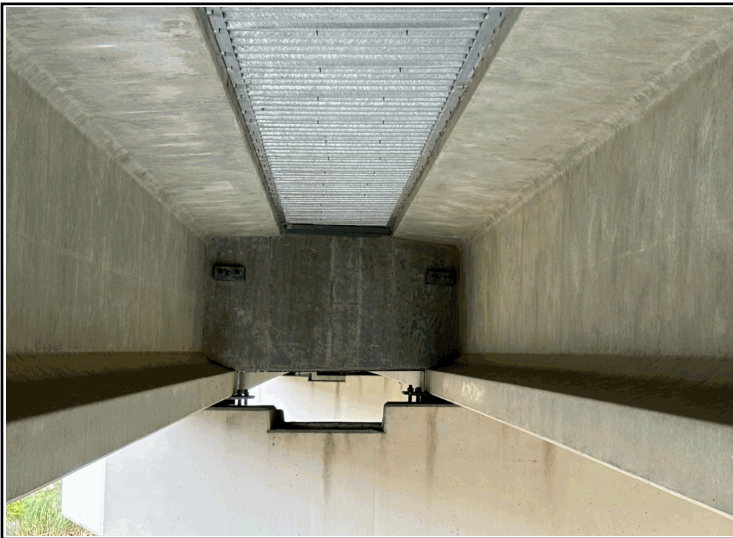
**Photo 15:**  
Typical Reinforced Concrete End Diaphragm

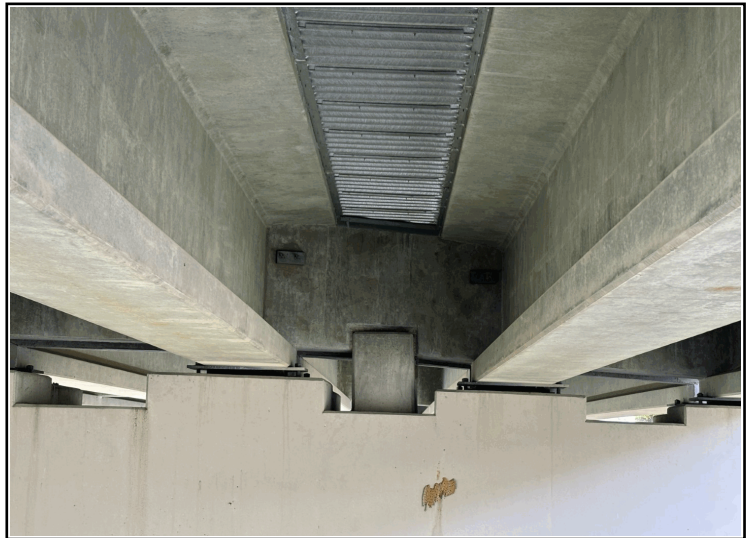
**Photo 16:**  
Reinforced Concrete End Diaphragm with Seismic Restrainer at Bay 2 and 5

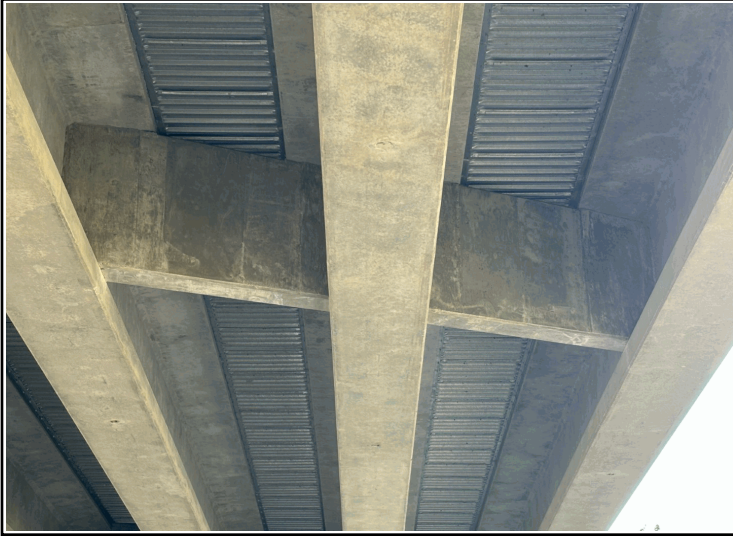
**Photo 17:**  
Typical Reinforced Concrete Intermediate Diaphragm

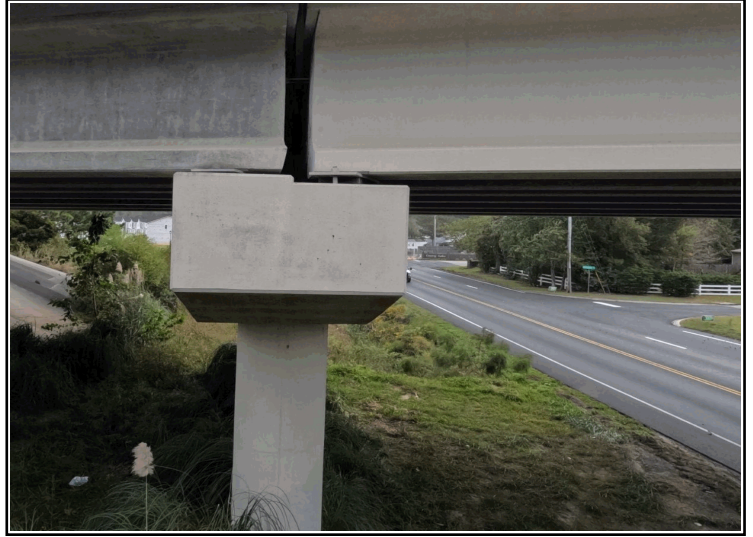
**Photo 18:**  
Typical Beams over Bent (Bent 2 Shown)

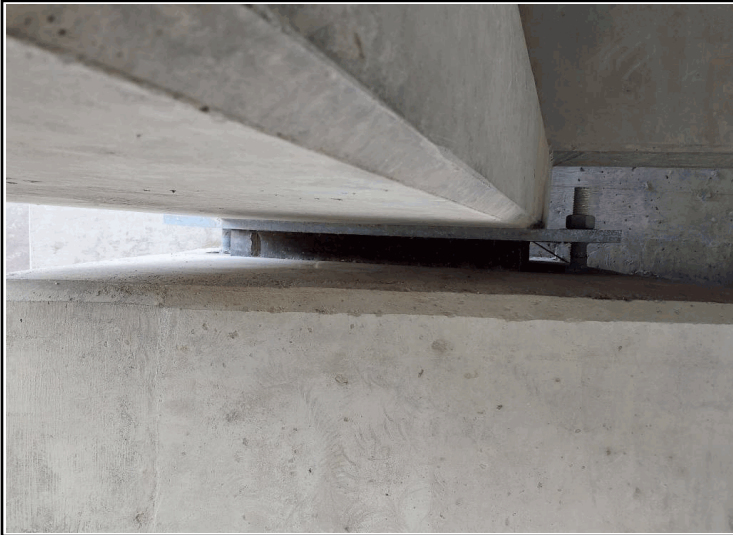
**Photo 19:**  
Typical Elastomeric Bearing with Metal Plate (BRG 1-7 Shown)

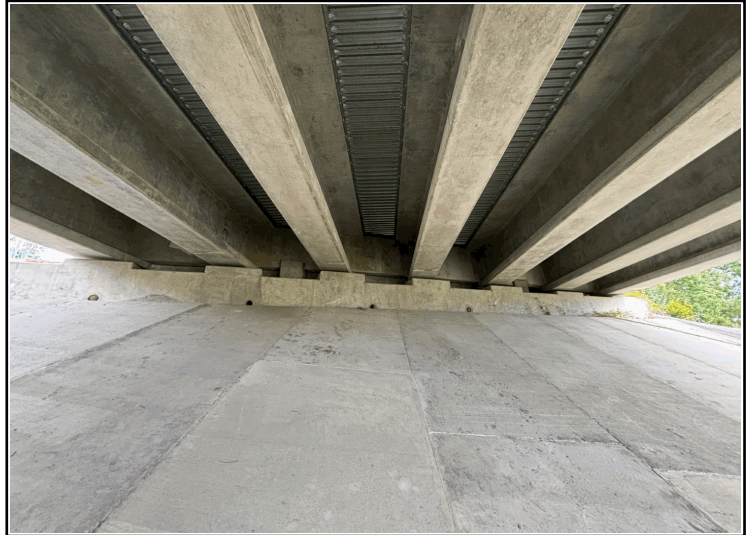
**Photo 20:**  
Typical End Bent (End Bent 1 shown)

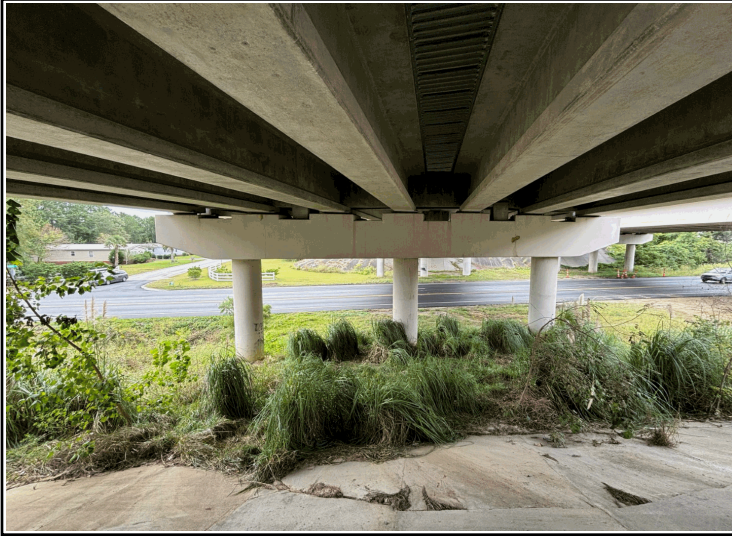
**Photo 21:**  
Typical Substructure (Bent 2 shown)

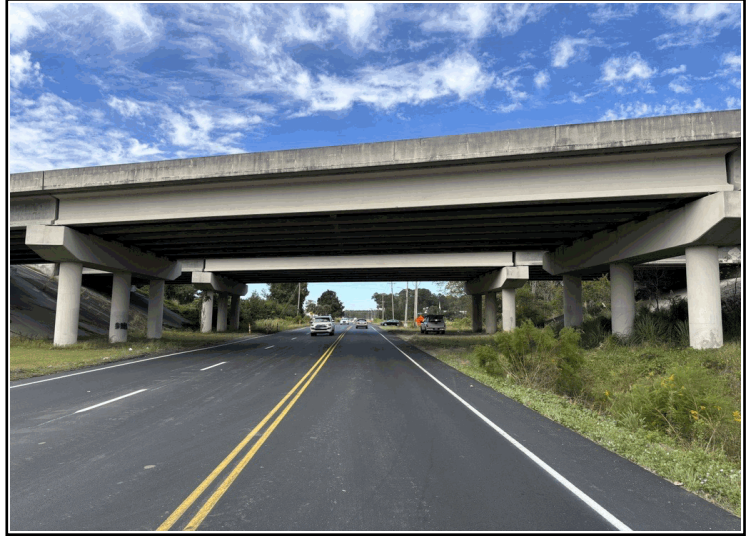
**Photo 22:**  
Looking West thru Span 2 (SC 90)

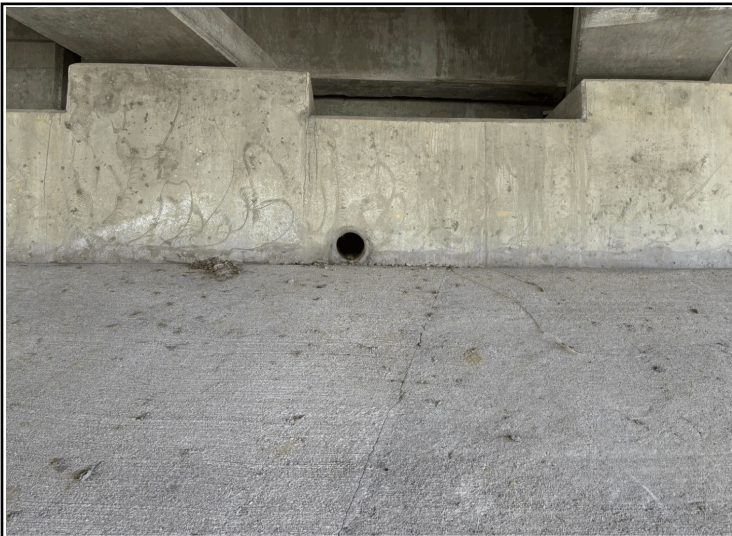
**Photo 23:**  
(6) PVC lined Weep holes (6in diameter) at each End Bent

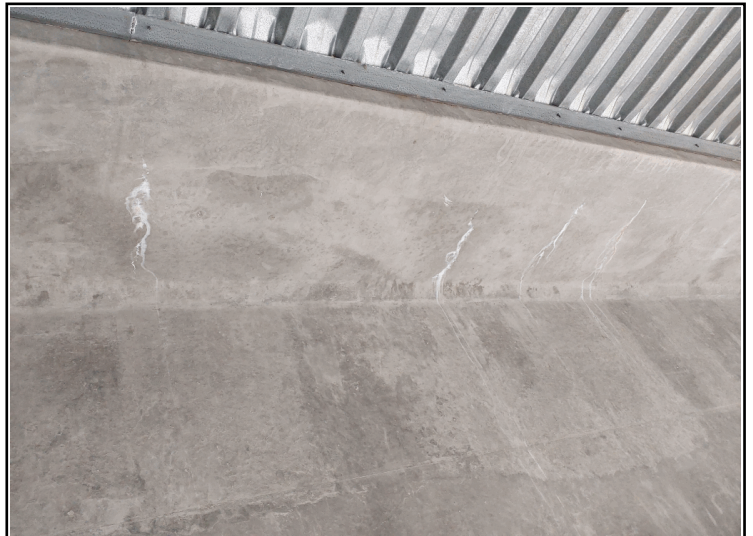
| ELEM/ENV | ELEMENT NAME | QUANTITY | UNITS | QTY ST 1 | QTY ST 2 | QTY ST 3 | QTY ST 4 |
|---|---|---|---|---|---|---|---|
| (7) Prestressed Concrete Beams (XB-63-59) (5ft-3-1/2in H x 2ft-7in W at bottom x 4ft-11in W at top) in each span.<br><br>BM 3-2 at EB4, scattered transverse cracks (0.004in W) with efflorescence on underside of top flange. [1120, CS2, Q8]<br>BM 3-7 at midspan, scattered transverse cracks (0.004in W) with efflorescence on underside of top flange. [1120, CS2, Q6] | | | | | | | |

**Photo 24:**  
BM 3-2 at EB4, scattered transverse cracks (0.004in W) with efflorescence on underside of top flange.

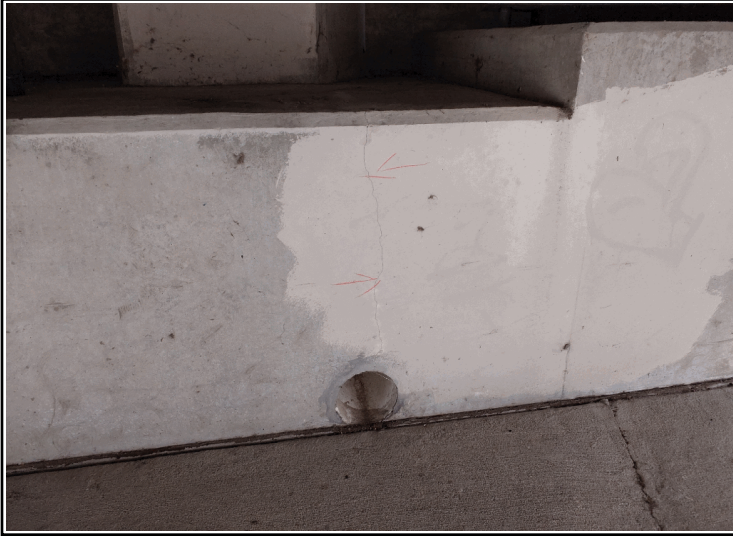
**Photo 25:**

| ELEM/ENV | ELEMENT NAME | QUANTITY | UNITS | QTY ST 1 | QTY ST 2 | QTY ST 3 | QTY ST 4 |
|---|---|---|---|---|---|---|---|
| (2) End Bents with Reinforced Concrete Caps (63ft L x 5ft-6in W x 4ft-8in H) on Reinforced Concrete Spread Footings (70ft-1-1/2in L x 12ft W x 3ft H) concealed by Reinforced Concrete slope protection.<br><br>EB4, Bay 5, vertical crack (full height x 1/32in W) extending onto top face (similar at Bays 2, 3, and 6). [1130, CS2, Q4] | | | | | | | |

EB4, Bay 5, vertical crack (full height x 1/32in) extending onto top face.

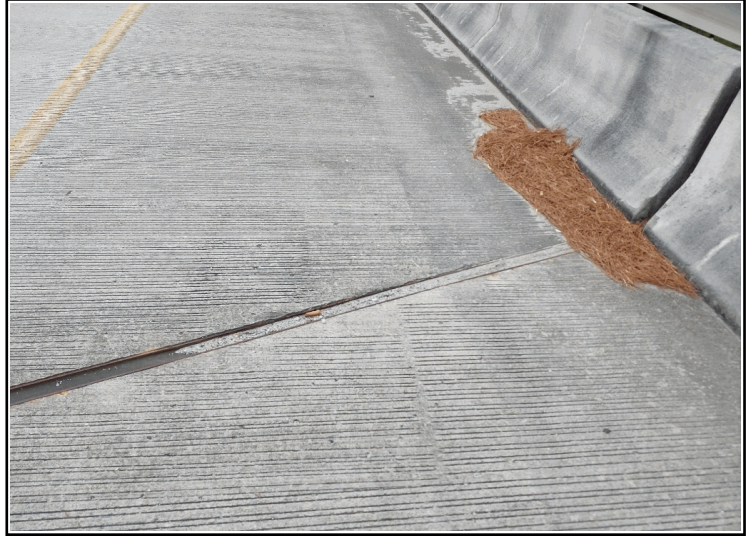
**Photo 26:**

All Joints, both shoulders, debris accumulation (10lf total). [2350, CS3, Q40]

All Joints, both shoulders, debris accumulation (10lf total) (Bent 2 shown).

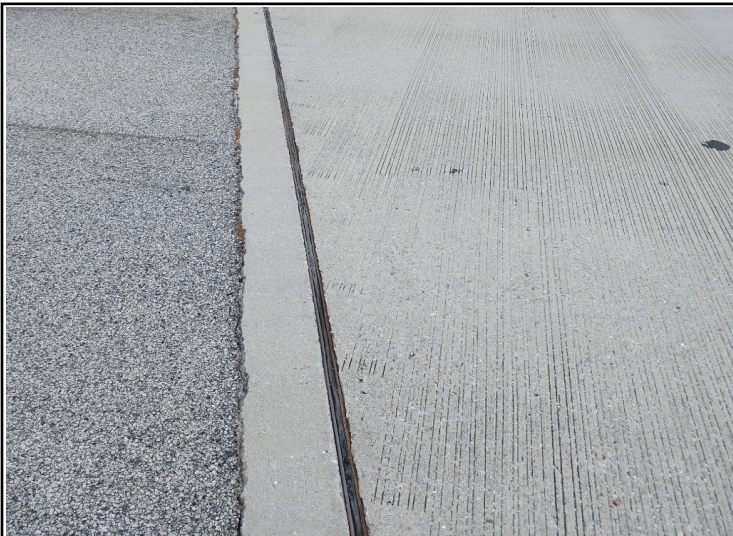
**Photo 27:**

JT 1, scattered throughout both lanes, seal damaged and torn (8lf). [2330, CS3, Q8]

JT 1, scattered throughout both lanes, seal damaged and torn (8lf).

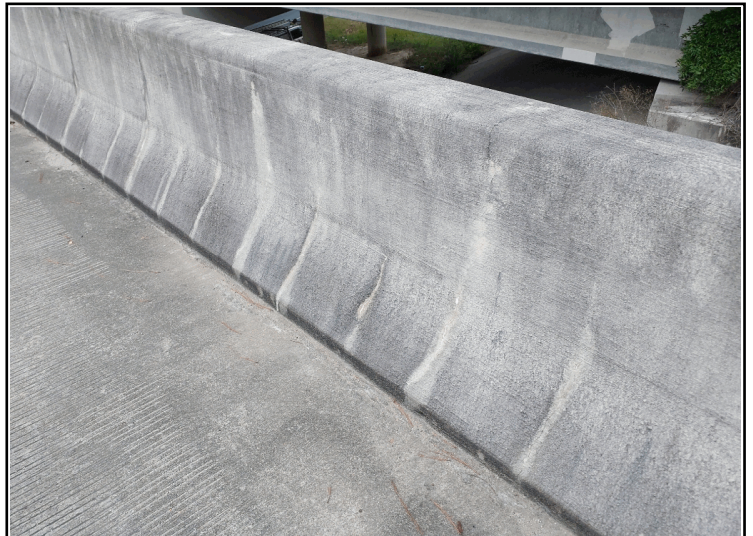
**Photo 28:**

| ELEM/ENV | ELEMENT NAME | QUANTITY | UNITS | QTY ST 1 | QTY ST 2 | QTY ST 3 | QTY ST 4 |
|---|---|---|---|---|---|---|---|
| All spans, both rails, scattered throughout, vertical cracks (full height x up to 1/32in) with efflorescence [1120, CS2, Q120] | | | | | | | |

All spans, both rails, scattered throughout, vertical cracks (full height x up to 1/32in) with efflorescence.

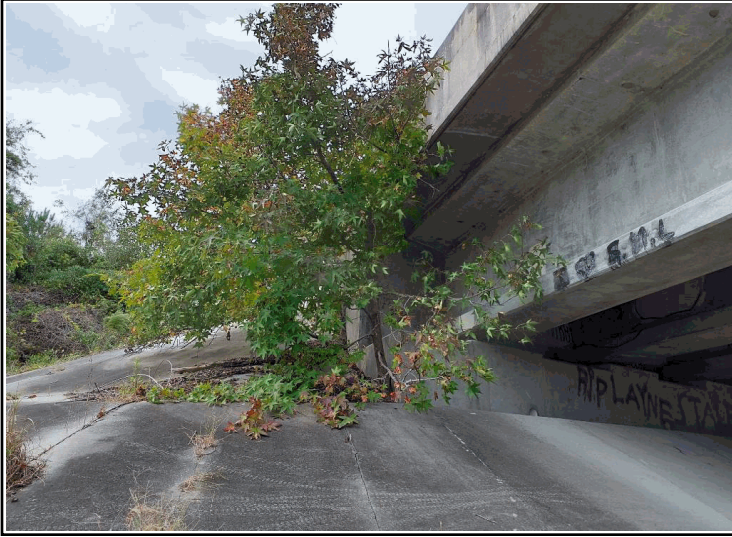
SW corner, washout (5ft x 4ft x 2ft deep).  
SE corner, vegetation growth.  
Slope protection interface with End Bent 1 cap and abutment, missing joint sealant (full length).

**Photo 29:**  
SE corner, vegetation growth.

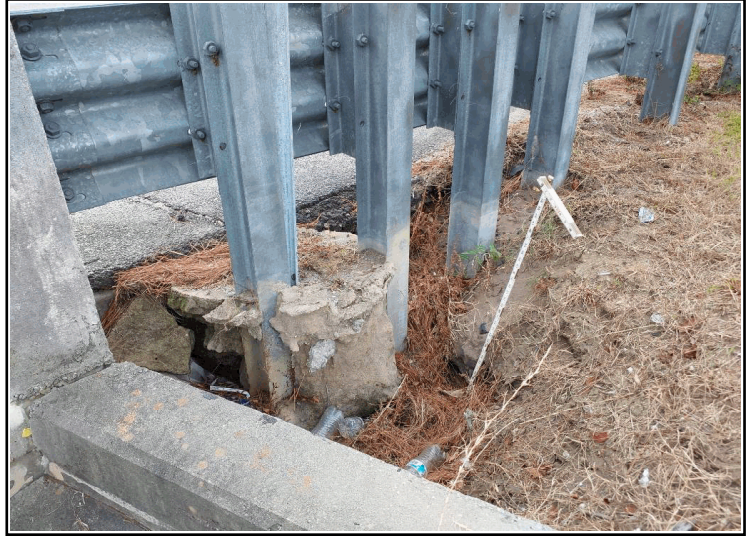
**Photo 30:**  
SW corner, washout (5ft x 4ft x 2ft deep).

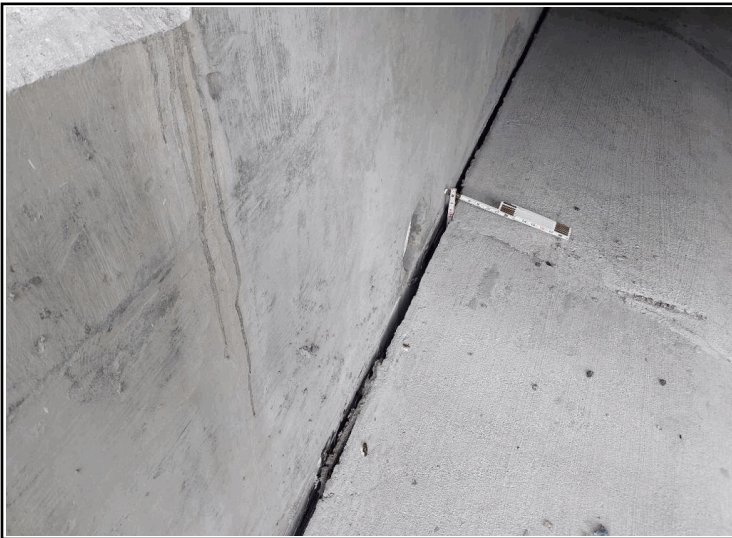
**Photo 31:**  
Slope protection interface with End Bent 1 cap and abutment, missing joint sealant (full length).

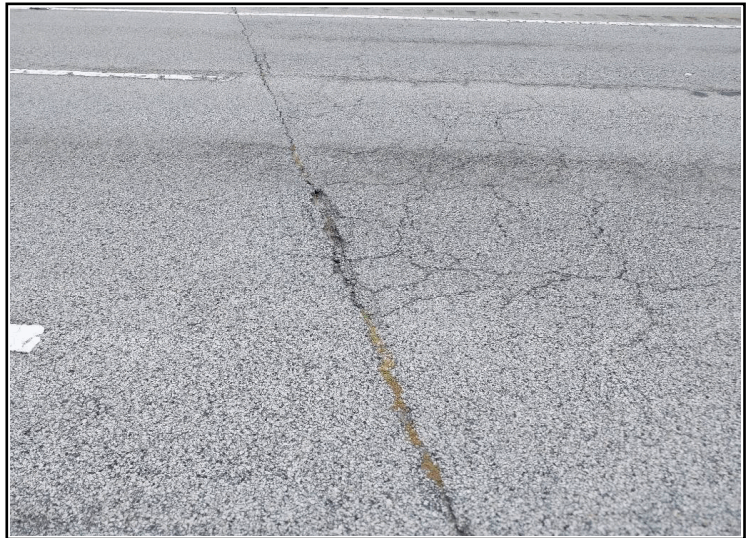
Both approaches at end of approach slab, transverse cracks (full width x 1/4in thick).

**Photo 32:**  
Both approaches at end of approach slab, transverse cracks (full width x 1/4in thick). (South Shown)
