# Bridge Inspection Report

09967

(7) Facility Carried: SC 31 NB

(6) Crossing: SC 22

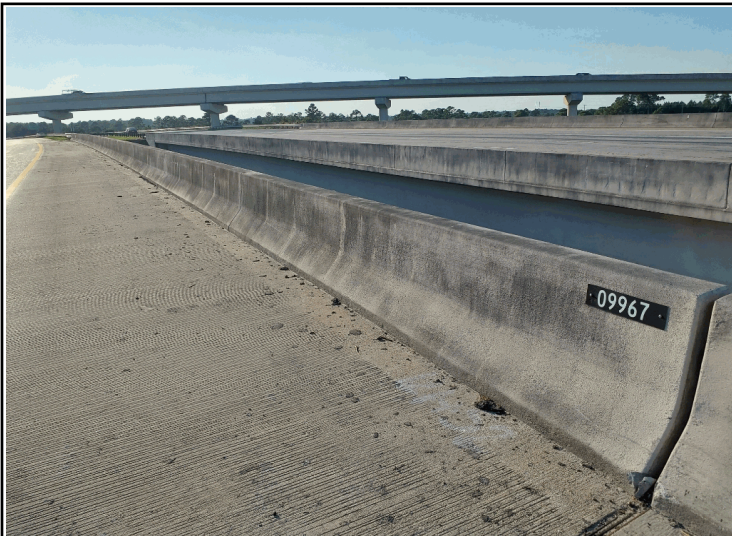
**Photo 11:**  
Typical Bridge Rail (North Shown)

| ELEM/ENV | ELEMENT NAME | QUANTITY | UNITS | QTY ST 1 | QTY ST 2 | QTY ST 3 | QTY ST 4 |
|---|---|---|---|---|---|---|---|
| (2) Reinforced Concrete Bridge Rails (2ft-8in H x 1ft-5in W).<br><br>Throughout all spans, both rails, spaced 4ft apart, vertical cracks (FH x up to 1/32in W) with efflorescence. [1120, CS2, Q108] | | | | | | | |

Throughout all spans, both rails, spaced 4ft apart, vertical cracks (FH x up to 1/32in W) with efflorescence.

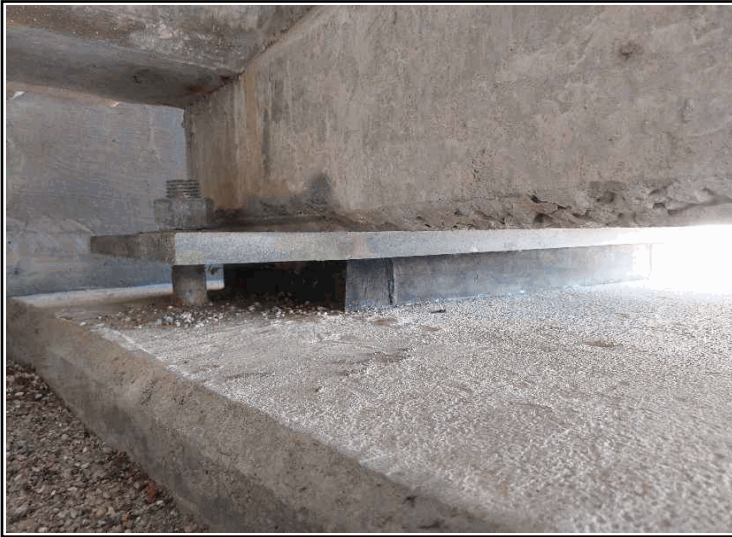
**Photo 17:**  
Typical Elastomeric Bearings

| ELEM/ENV | ELEMENT NAME | QUANTITY | UNITS | QTY ST 1 | QTY ST 2 | QTY ST 3 | QTY ST 4 |
|---|---|---|---|---|---|---|---|
| (32) Elastomeric bearing pads with metal plates; (16) per interior bent and (8) per end bent.<br><br>No significant deficiencies were noted at the time of inspection. | | | | | | | |

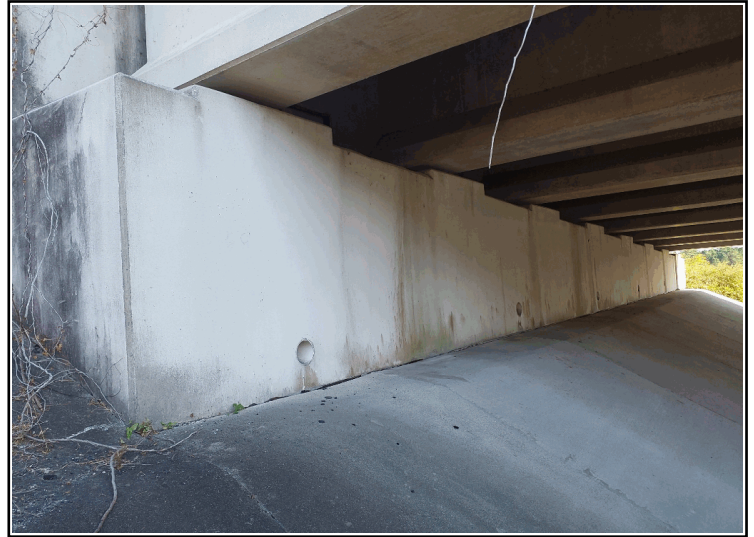
**Photo 18:**  
Typical End Bent (End Bent 1 Shown)

| ELEM/ENV | ELEMENT NAME | QUANTITY | UNITS | QTY ST 1 | QTY ST 2 | QTY ST 3 | QTY ST 4 |
|---|---|---|---|---|---|---|---|
| (2) Stub End Bents with Reinforced Concrete Caps (67ft 6-3/8in L x 4ft-1in W x 7ft-3in H) on (34) Prestressed Concrete Piles (18in x 18in) concealed by Reinforced Concrete slope protection.<br><br>Both end bents, along caps, vertical cracks (up to FH x up to 1/32in W) with efflorescence, up to (2-3) per bay. [1120, CS2, Q46] | | | | | | | |

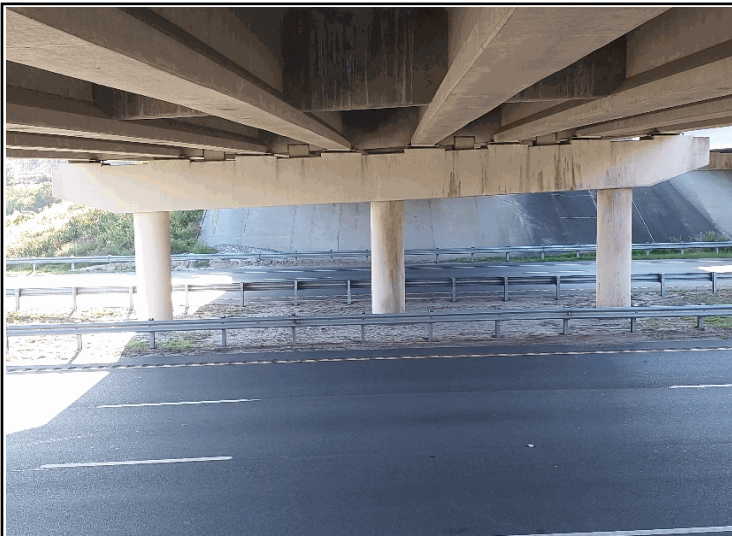
**Photo 19:**  
Interior Bent 2

| ELEM/ENV | ELEMENT NAME | QUANTITY | UNITS | QTY ST 1 | QTY ST 2 | QTY ST 3 | QTY ST 4 |
|---|---|---|---|---|---|---|---|
| (1) Interior Bent with Reinforced Concrete Hammerhead Caps (66ft L x 4ft-6in W x 3ft H).<br><br>BT2 Cap, both faces, vertical cracks (up to FH x up to 0.012in W) with efflorescence. [1120, CS2, Q8] | | | | | | | |

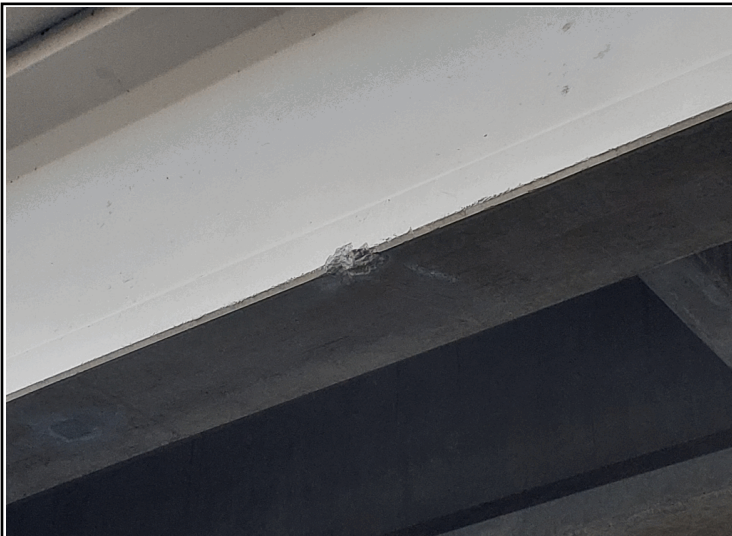
| ELEM/ENV | ELEMENT NAME | QUANTITY | UNITS | QTY ST 1 | QTY ST 2 | QTY ST 3 | QTY ST 4 |
|---|---|---|---|---|---|---|---|
| (8) (AASHTO Type VI) Prestressed Concrete Girders (6ft H x 2ft-4in W at bottom x 3ft-6in W at top) per span.<br><br>BM1-1 at midspan, South face of bottom flange, spall (8in L x 6in W x 1in deep). [1080, CS3, Q1] | | | | | | | |

**Photo 23:**  
BM 1-1, South face of bottom flange, at midspan, spall (8in L x 6in W x 1in deep)

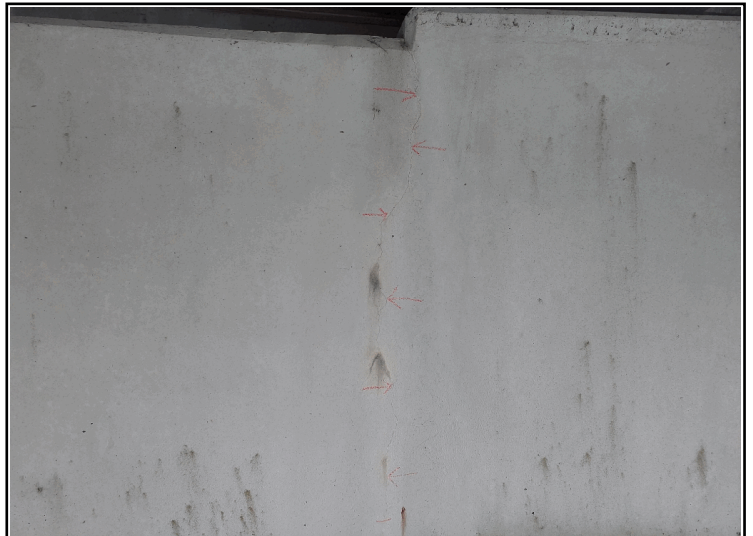
**Photo 24:**  
Both end bents, along caps, vertical cracks (up to FH x up to 1/32in W) with efflorescence, up to (2-3) per bay. (EB1, below BM1-4 shown)

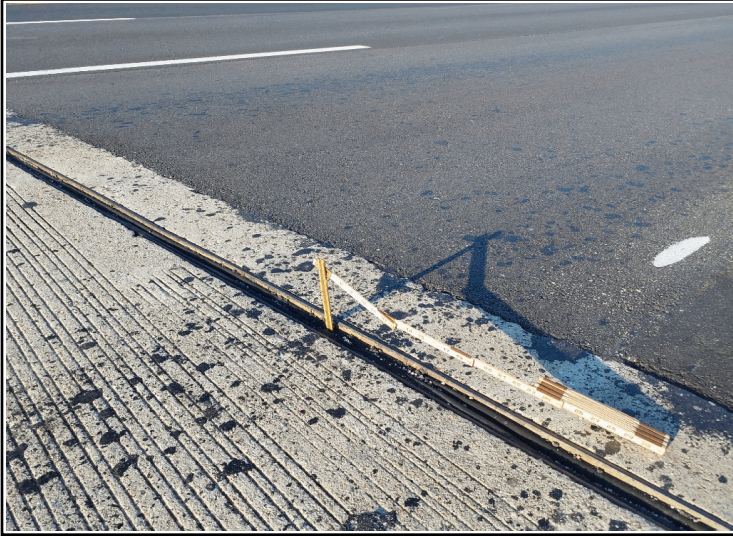
**Photo 25:**

| ELEM/ENV | ELEMENT NAME | QUANTITY | UNITS | QTY ST 1 | QTY ST 2 | QTY ST 3 | QTY ST 4 |
|---|---|---|---|---|---|---|---|
| (2) Compression Joint Seal Joints (64ft L) at End Bents.<br><br>Throughout JT1, debris accumulation (50ft total). [2350, CS2, Q44]<br>JT1, beginning at South edge of ramp lane, loss of adhesion (20ft L x full depth). [2320, CS4, Q20]<br>JT3, at center, loss of adhesion (3ft L x partial depth) with settlement (up to 1-1/2in). [2320, CS3, Q3] | | | | | | | |

JT1, beginning at South edge of ramp lane, loss of adhesion (20ft L x full depth).

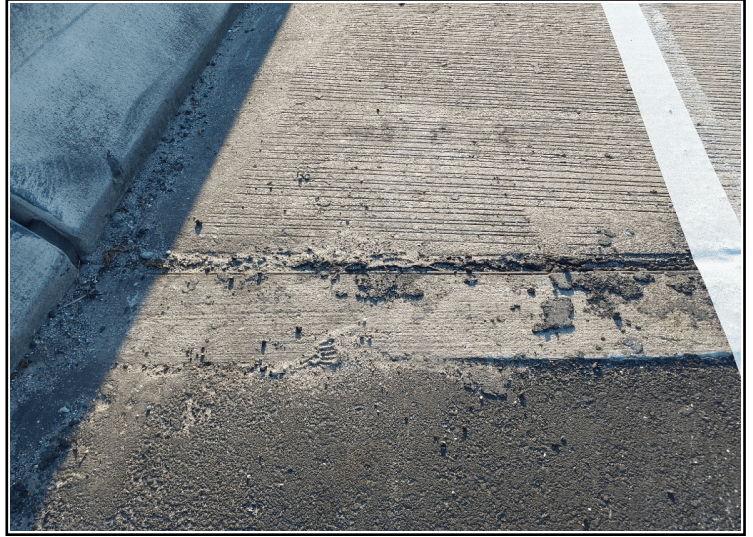
**Photo 26:**

Throughout JT1, debris accumulation (50ft total).

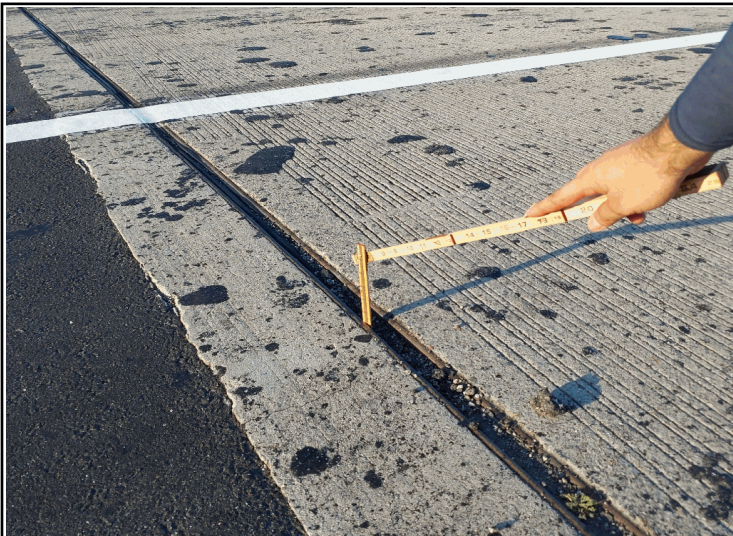
**Photo 27:**

JT3, at center, loss of adhesion (3ft L x partial depth) with settlement (up to 1-1/2in).

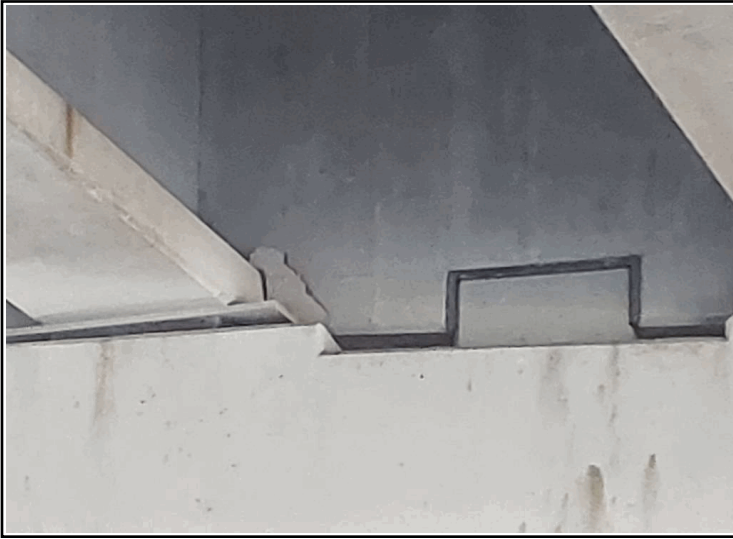
**Photo 29:**

BT2, West face, Bay 5 end diaphragm, adjacent to BM2-6, delamination (up to 10in L x 1ft-4in W).
