# Bridge Inspection Report

**180610008113133**

**IH 35W NBML**

**KSC Railroad**

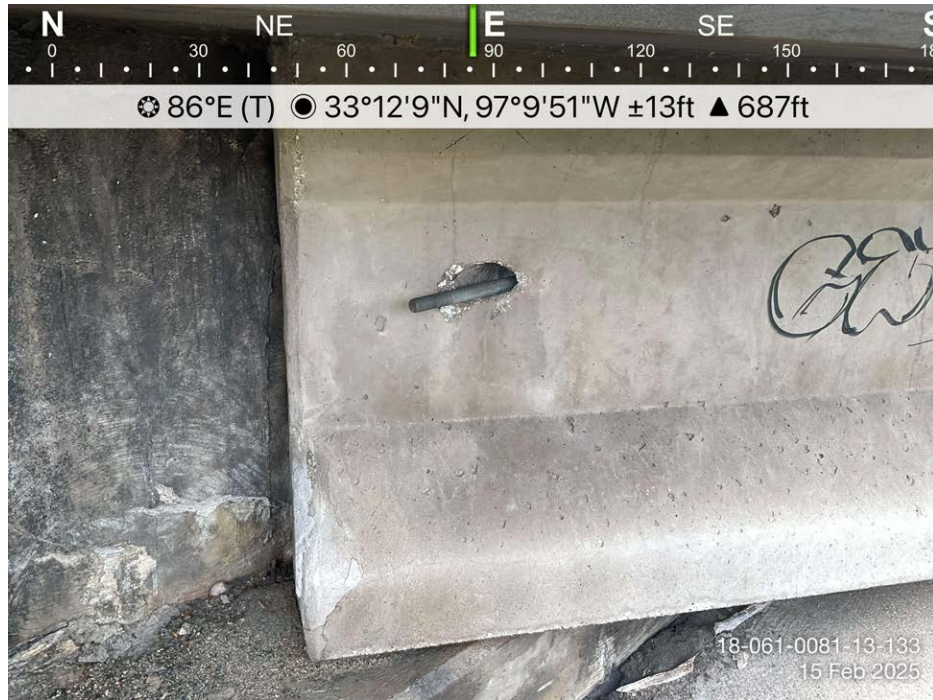
PHOTO 1 Recommended Maintenance Needs, Defect

2023: Several nuts are missing at diaphragm connections.

2025 Update: Nuts are missing at multiple diaphragm connections.

Description Missing diaphragm nut on exterior face of Beam 1 in Span 7 near Abutment 8, looking east.  
(Condition Rating: 7)

Nuts are missing at multiple diaphragm connections.

Recommendation: Replace missing nuts and washers at diaphragm connections.

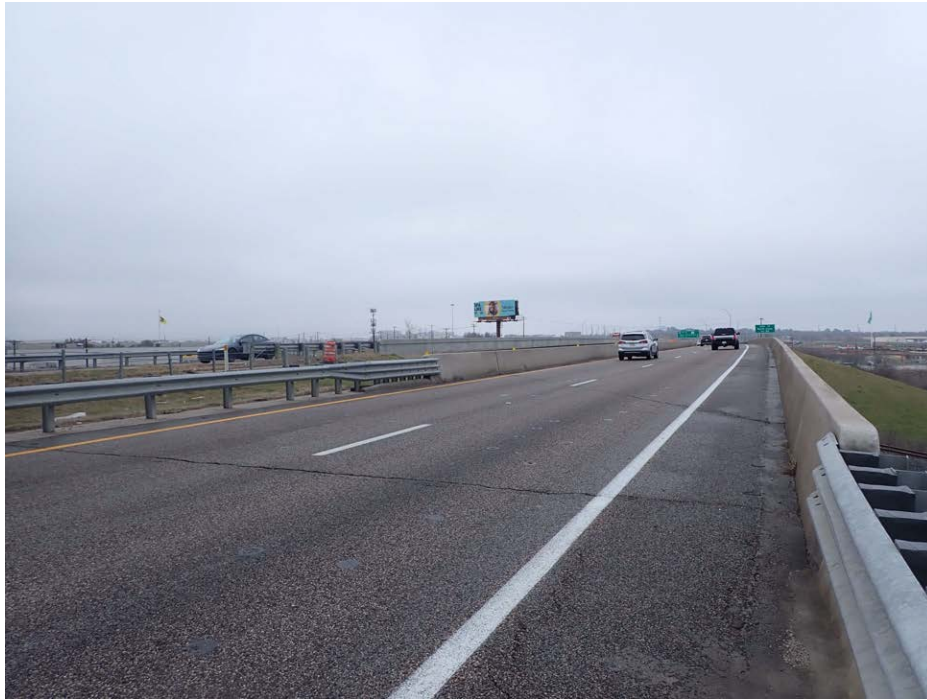
PHOTO 1 Roadway View

Description Roadway view, looking north.

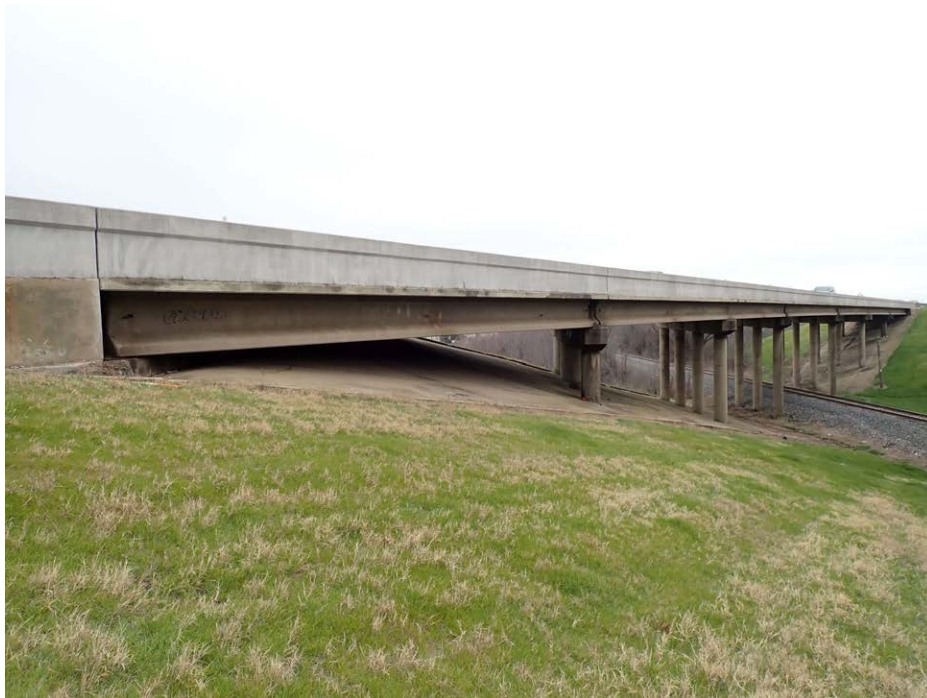
PHOTO 2 Elevation View

Description West bridge elevation, looking southeast.

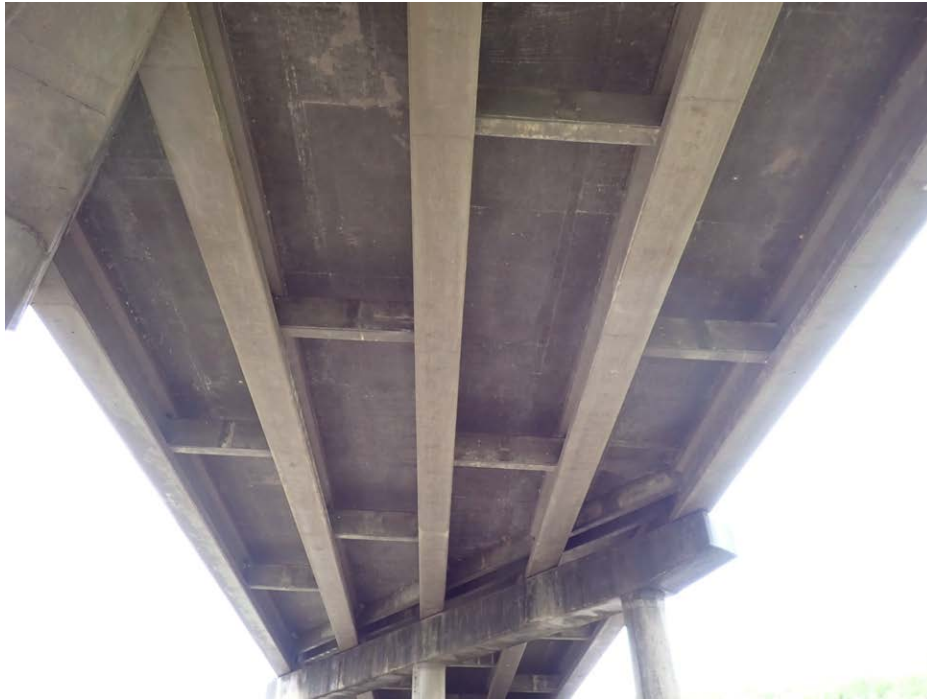
PHOTO 3 Superstructure View

Description Underside of superstructure in Span 2, looking south.

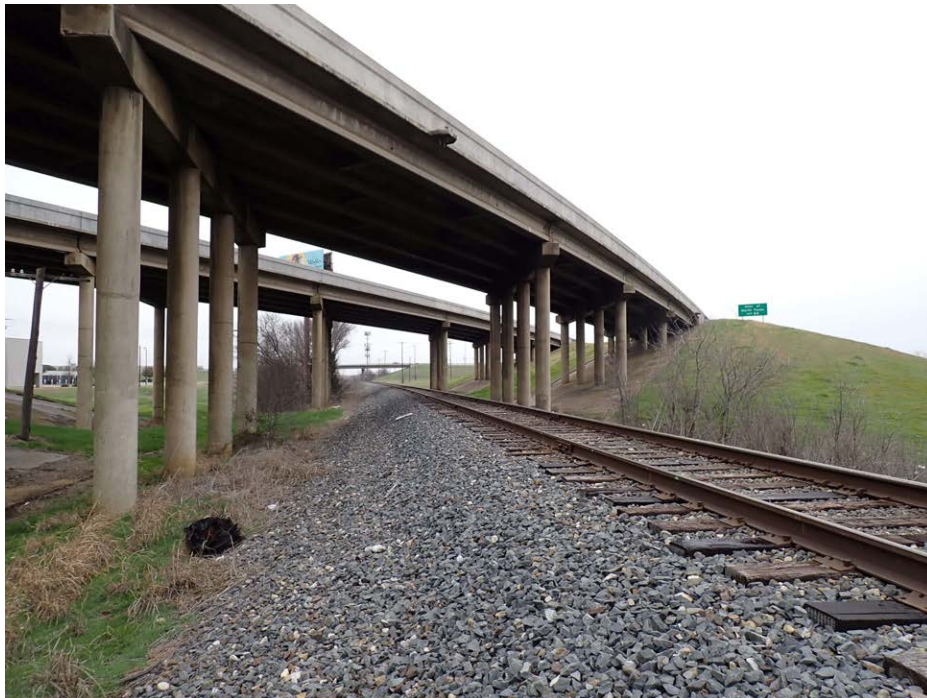
PHOTO 4 Railroad Under View

Description Railroad (KCS) under view in Span 4, looking northwest.

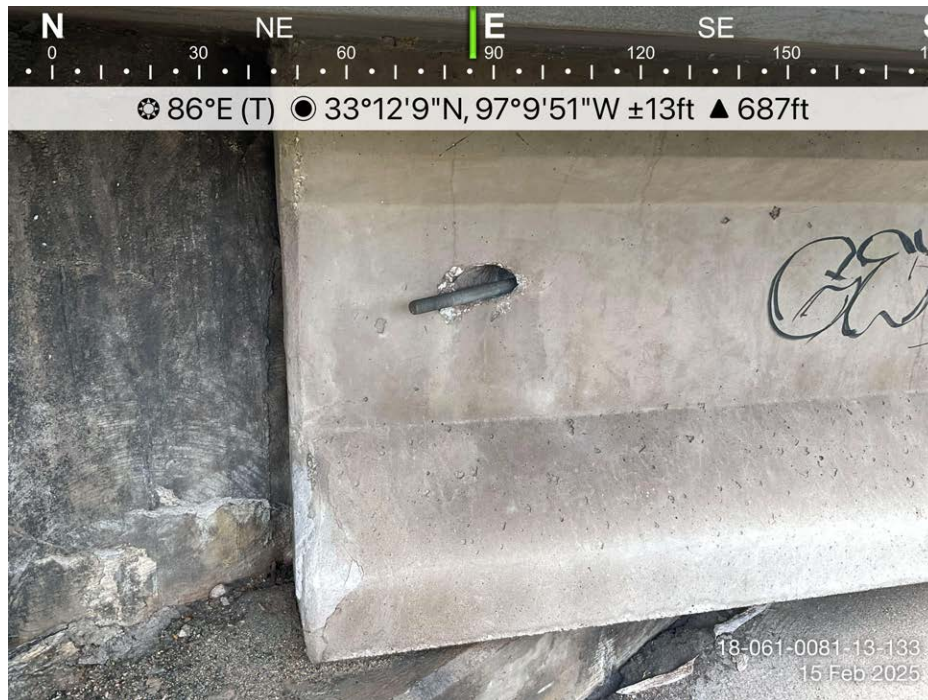
PHOTO 5 Recommended Maintenance Needs, Defect

Description Missing diaphragm nut on exterior face of Beam 1 in Span 7 near Abutment 8, looking east.  
(Condition Rating: 7)
