If the left-side light strip fails to light up

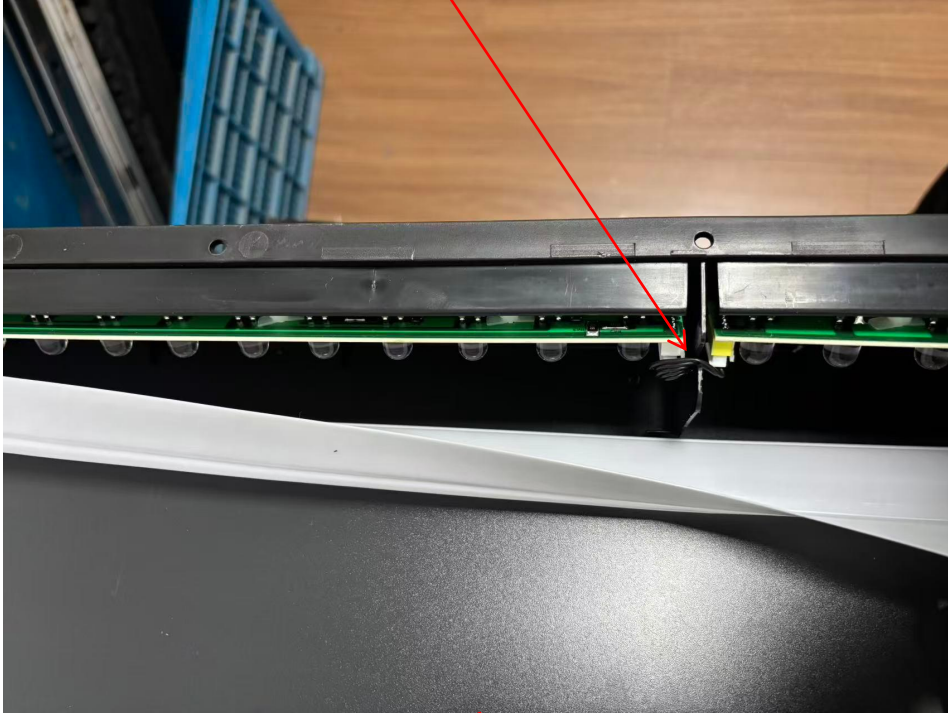
It is very likely that there is an issue with the connecting wire here.

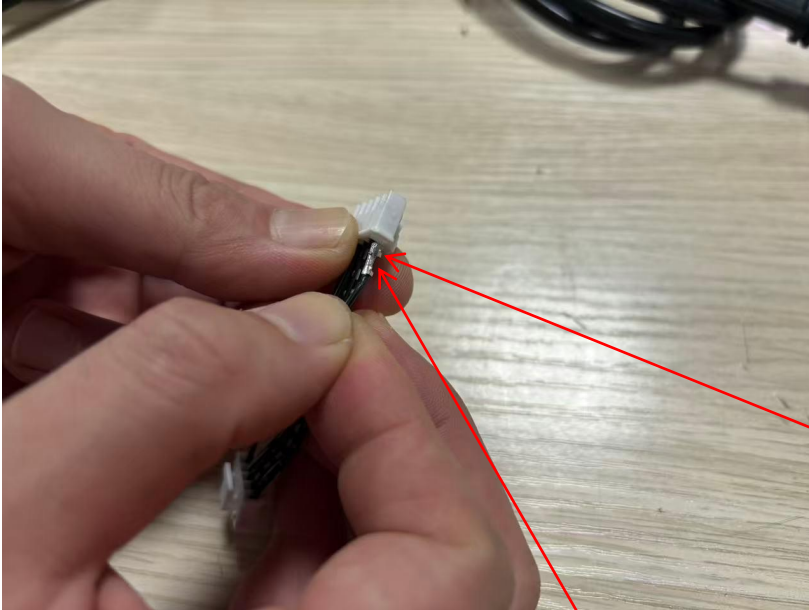
If the ribbon cable becomes loose or disconnected

Align the ribbon cable with the socket and press it firmly into the connector.

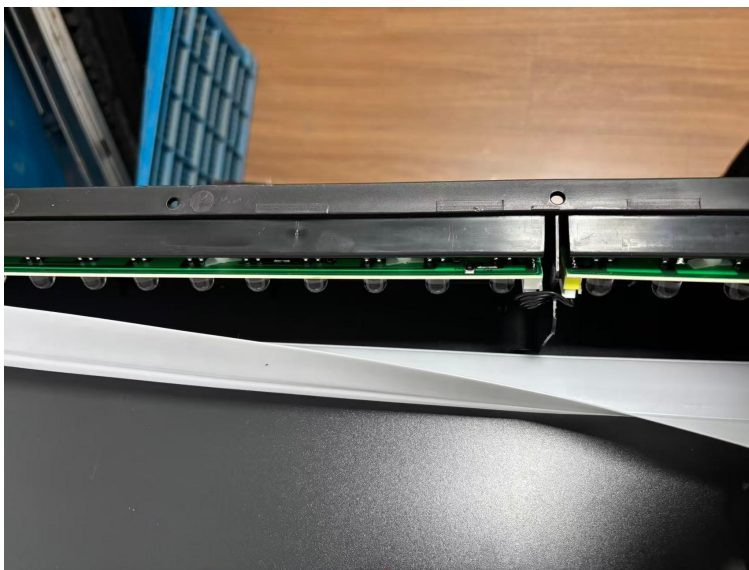
After proper installation, this is the final result:  
The cable end cannot be pulled out when  
tugging both ends.
