# QER11749

QER : JULIMAR DEVELOPMENT PHASE 3 SF301229C002.03 - Zeta wire damaged

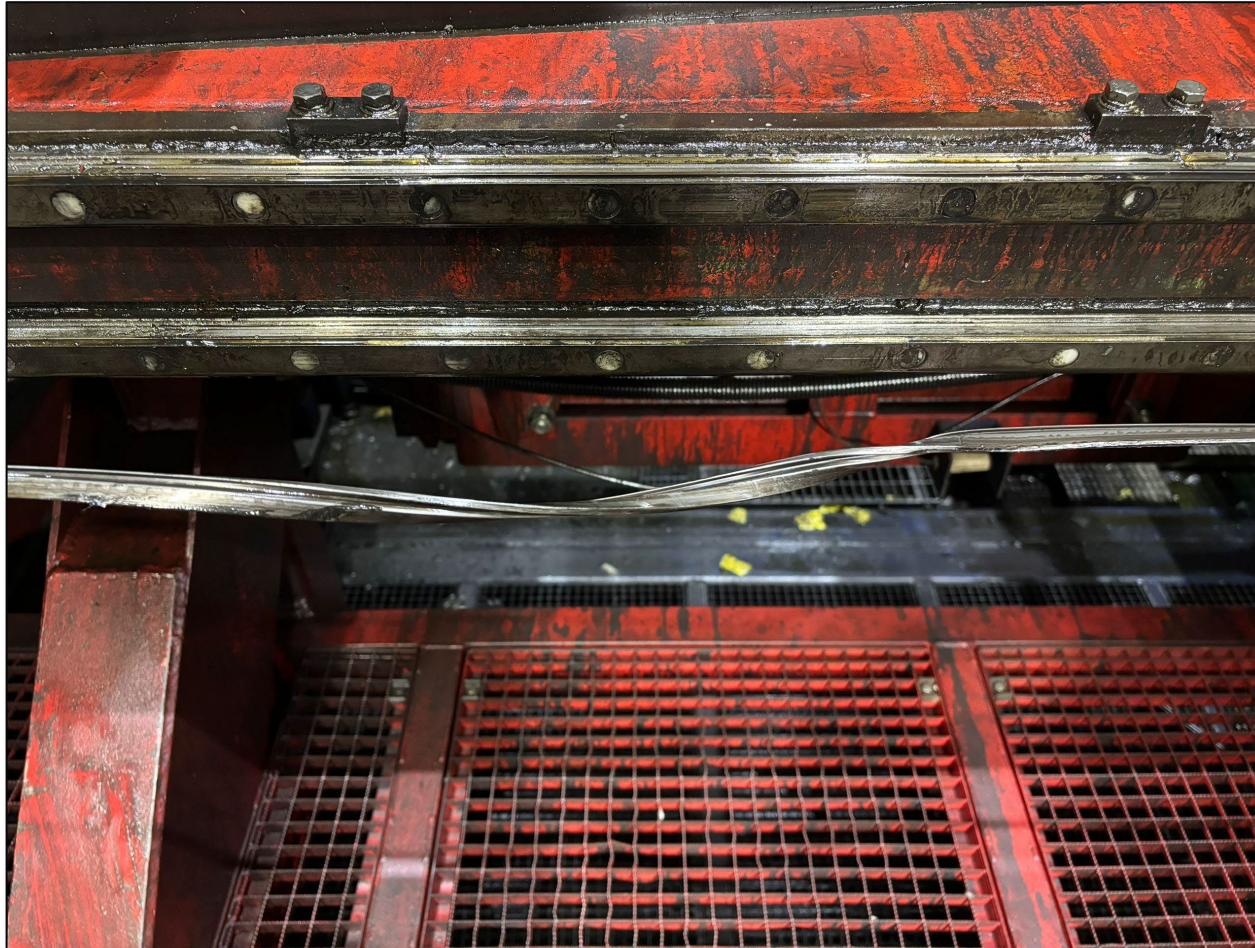
During the zeta spiraling of JULIMAR DEVELOPMENT PHASE 3 SF301229C002.03 (ST203.72124), zeta wire damage was detected after accumulator at length 768.2m.

**Figure 1** : Zeta wire damage was detected after accumulator at length 768.2m.

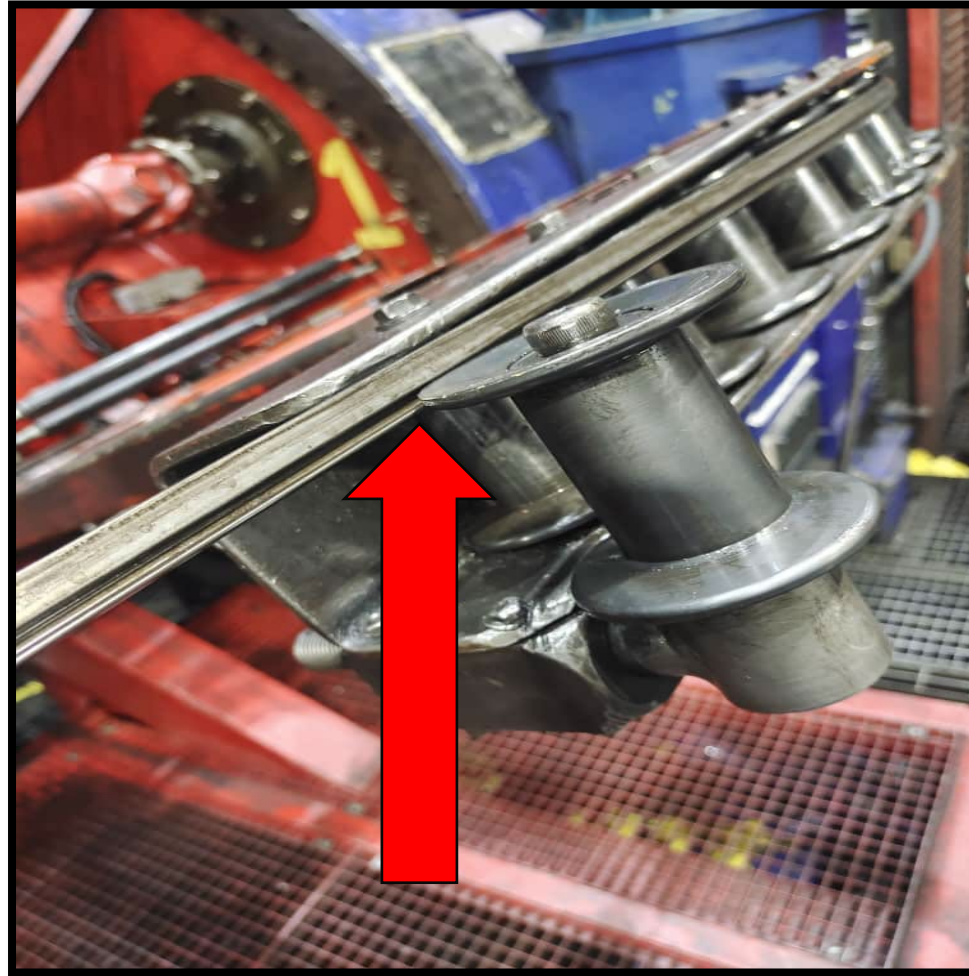
The root cause was identified due to zeta wire offset/dislocated from roller accumulator and lead the wire damaged. The wire was dislocated due to gap for adjustment roller is too big (Original Design).

**Figure 2 :** The root cause was identified due to zeta wire offset/dislocated from roller accumulator and lead the wire damaged.

Fabricate new design for accumulator adjustment shaft.
